ORNL-5039  
UC-41-Health and Safety

HEALTH PHYSICS DIVISION  
EMERGENCY TECHNOLOGY SECTION

EXPEDIENT SHELTER CONSTRUCTION AND  
OCCUPANCY EXPERIMENTS

Cresson H. Kearny

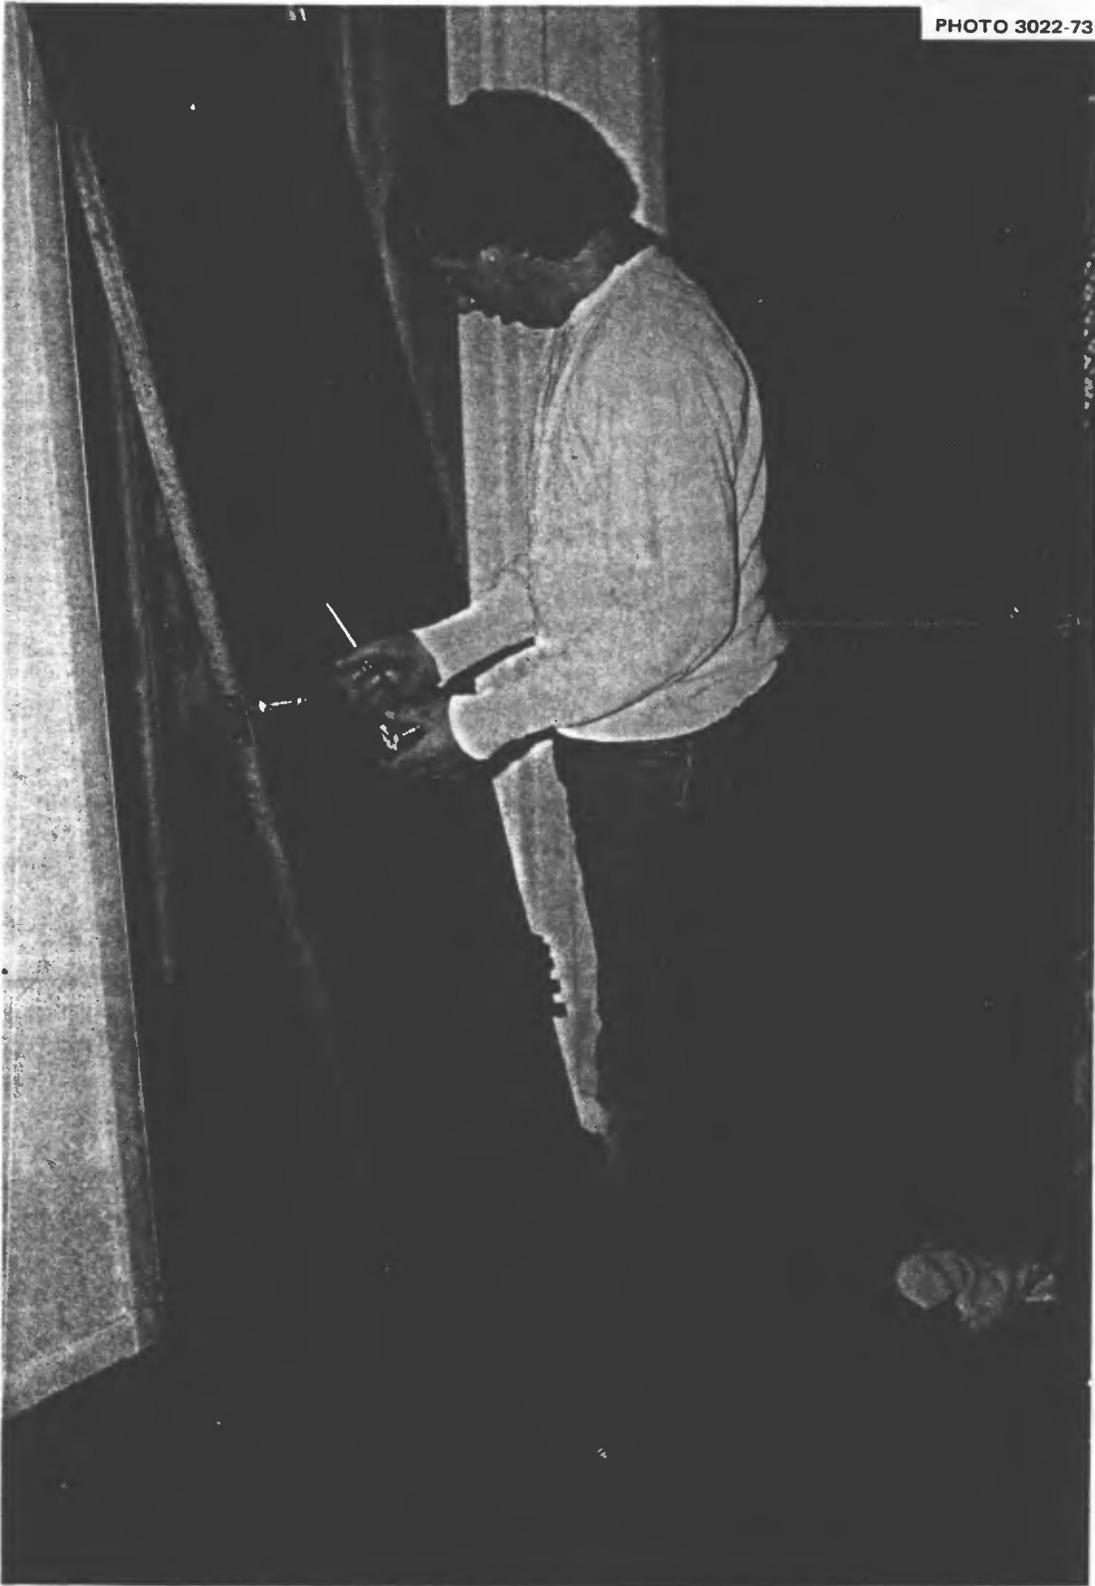
**Fig. 2.1.** Start by an untrained, unskilled family of the second proof-testing of the written instructions for building a Door-Covered Trench Shelter. Starting at 6 AM on November 24, 1973, son Tad, age 14, and other children removed the doorknobs from one of the six interior doors that this fatherless family of six readied for use.

The six doors actually used were all new, inexpensive, hollow-core interior doors, 32 in  $\times$  6 ft 8 in.  $\times$  1 $\frac{3}{8}$  in., with  $\frac{1}{8}$  in. mahogany veneer, and weighing 20 $\frac{1}{2}$  lb each.

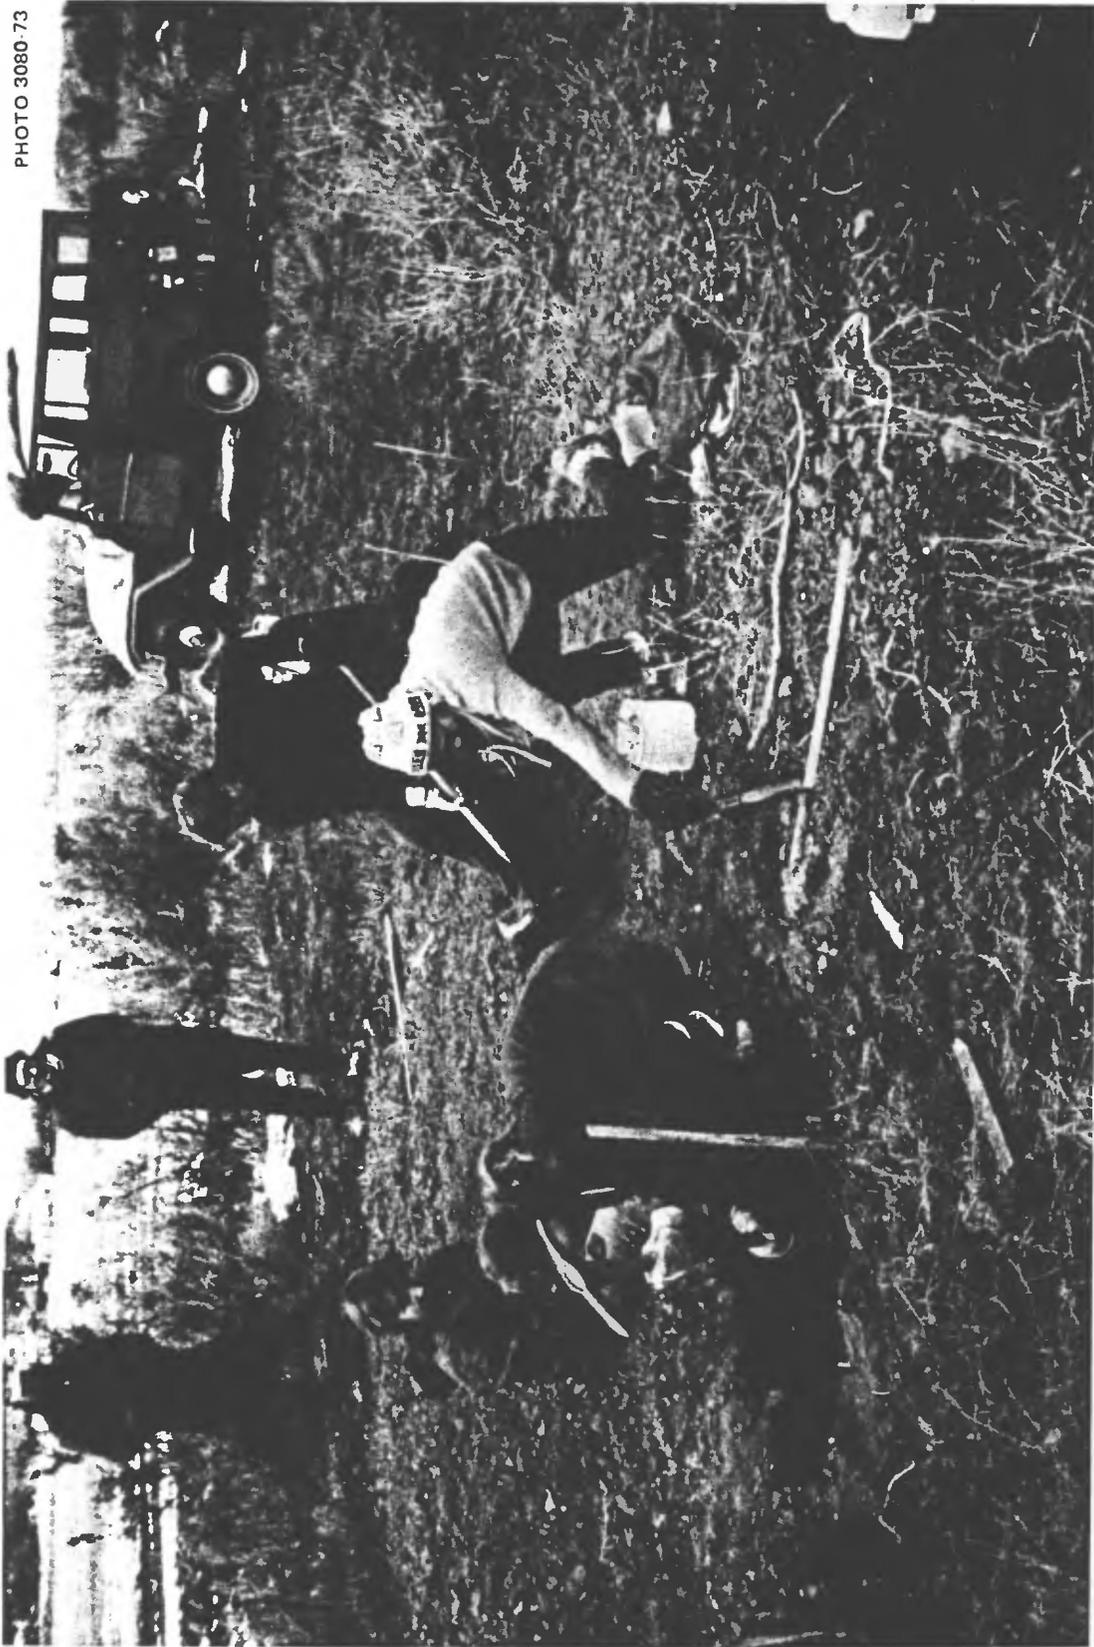
Fig. 2.3. The mother dug inefficiently with her dull shovel by pushing it with her foot. She dug the trench too narrow until it was almost completed – in spite of having read the instructions to the contrary. Until the second day, no member of this family learned to swing their dull old pick properly, by letting one hand slip toward the other as the pick descended. Nor did they know how to use their other tools properly.

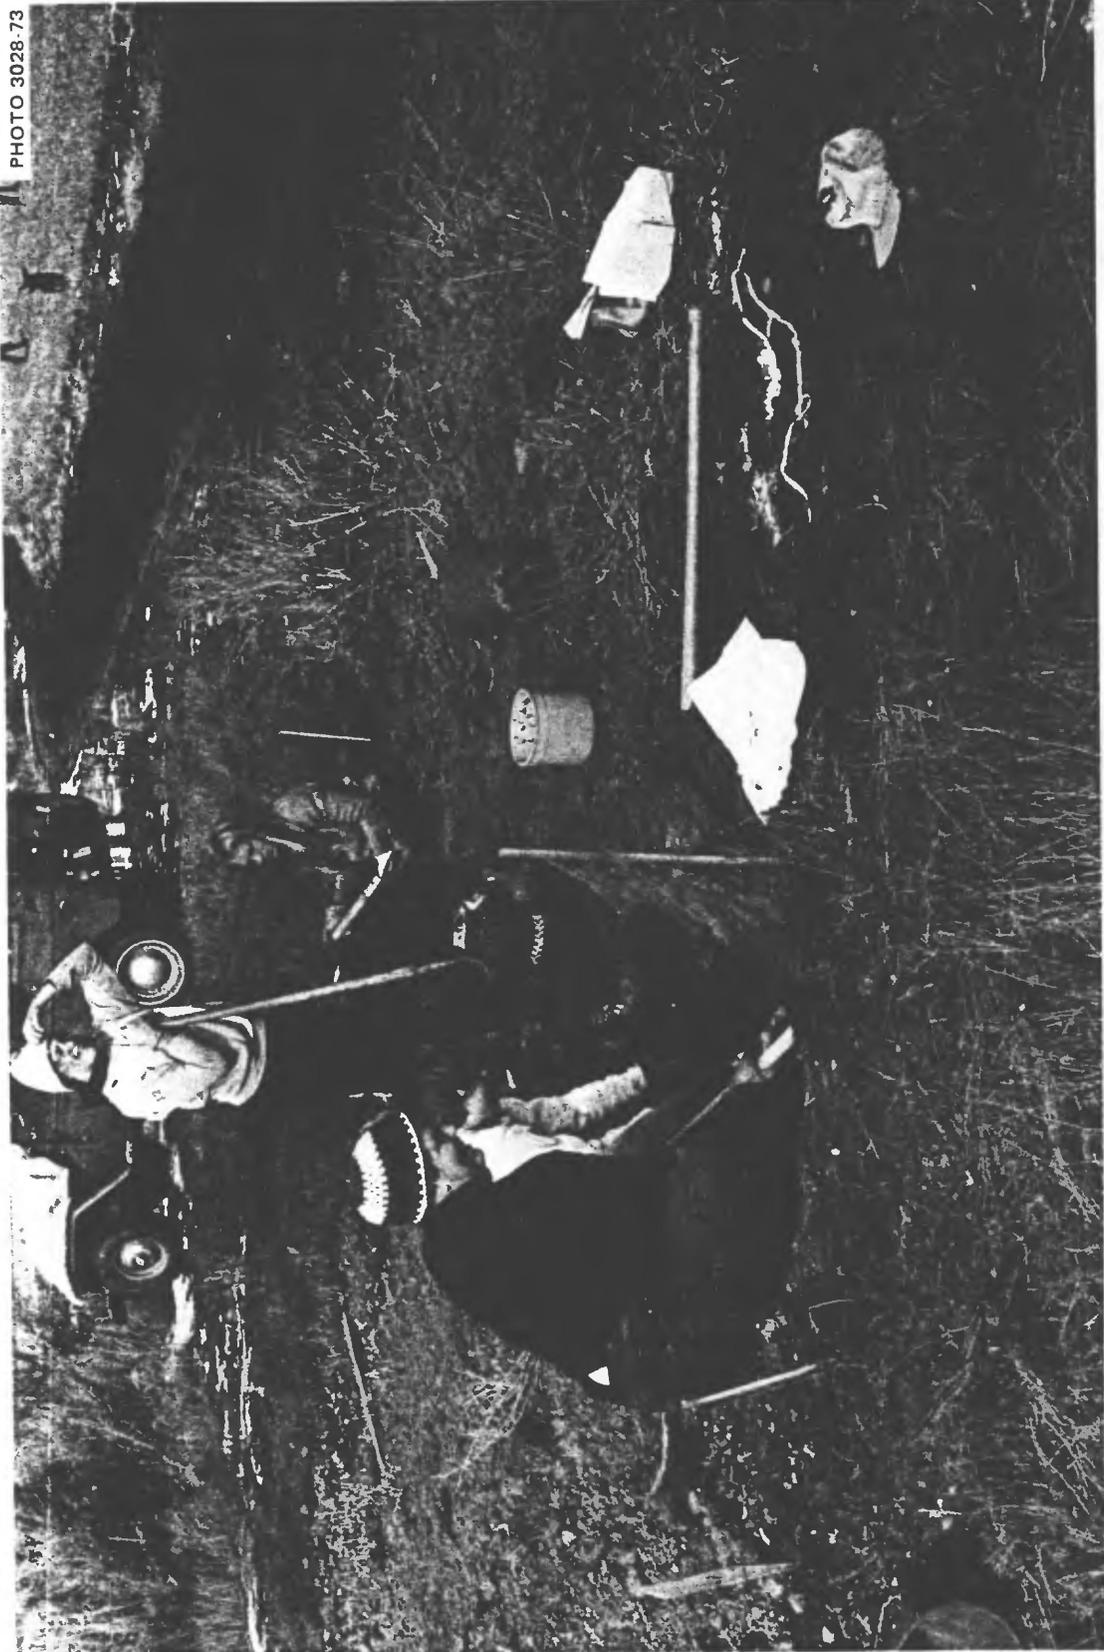
Fig. 2.4. No member of this family was used to hard, physical labor. Within two hours of beginning digging, they were so tired they frequently sat down to dig! In an ill-conceived attempt to keep everybody working together, on the first day they mostly dug all at the same time while facing across their small trench, and all rested or ate at the same time.

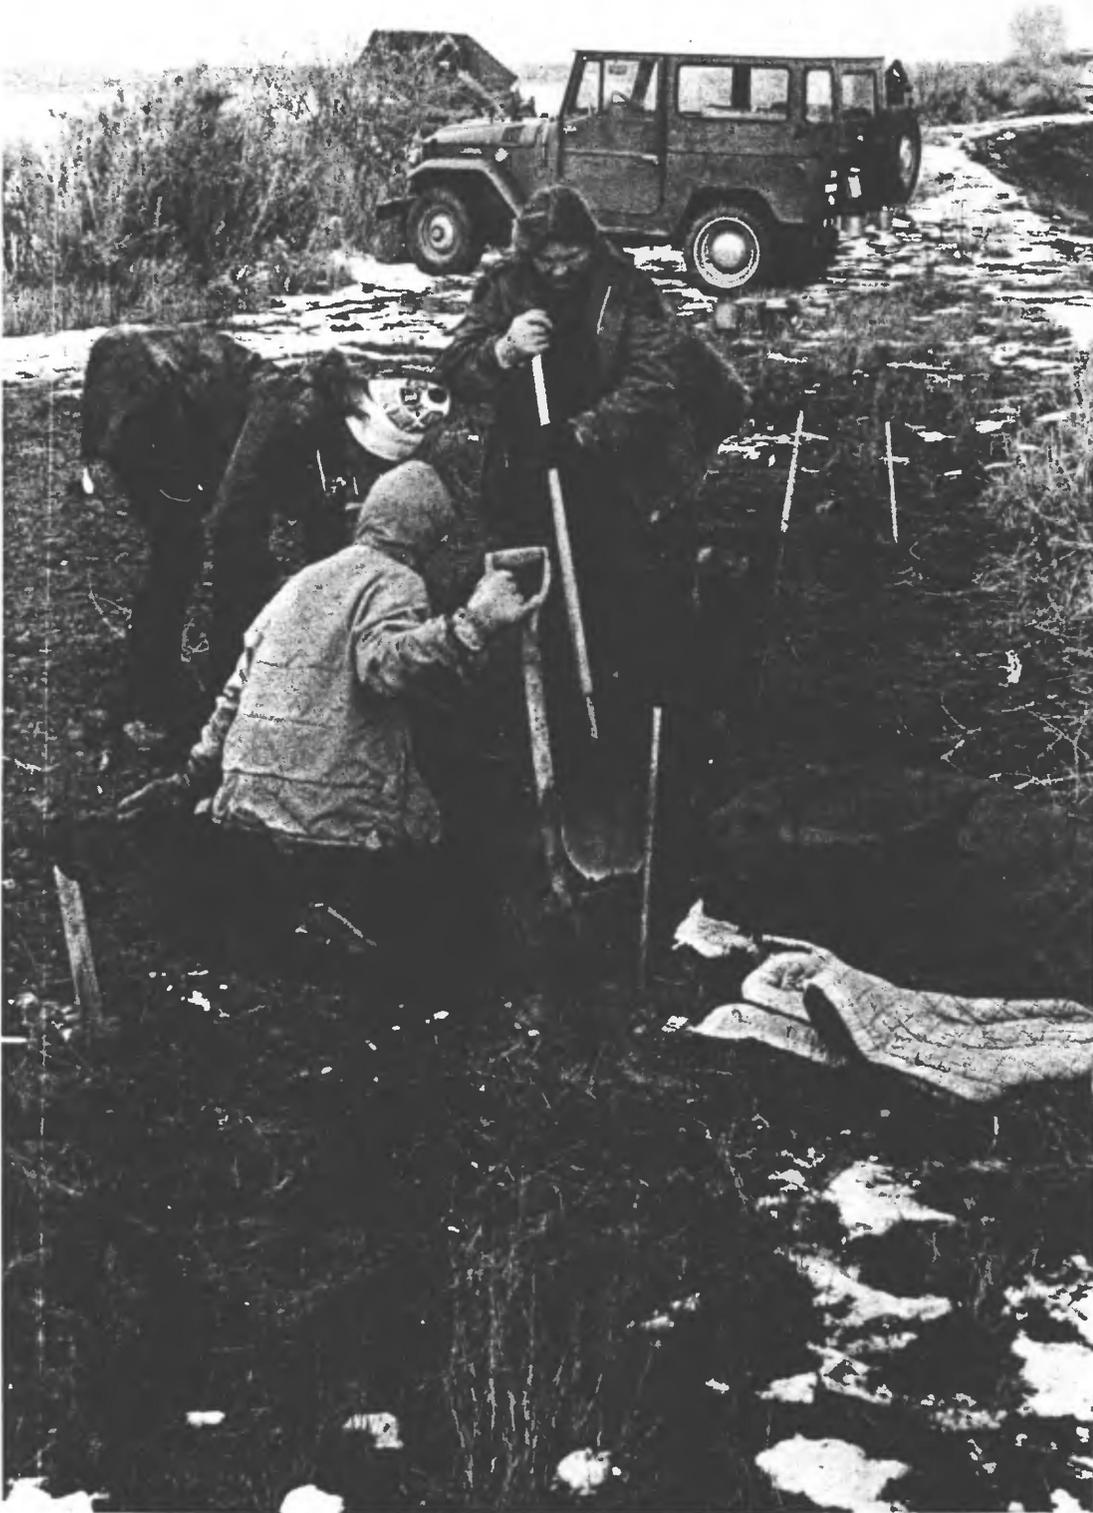
Fig. 2.5. Instead of sharpening their pick and using it, this family mostly pried and scraped away the dry, hard clay-loam with shovels, inch by inch.

Note how the trench narrowed downward, an error that later required several person-hours of work to correct.

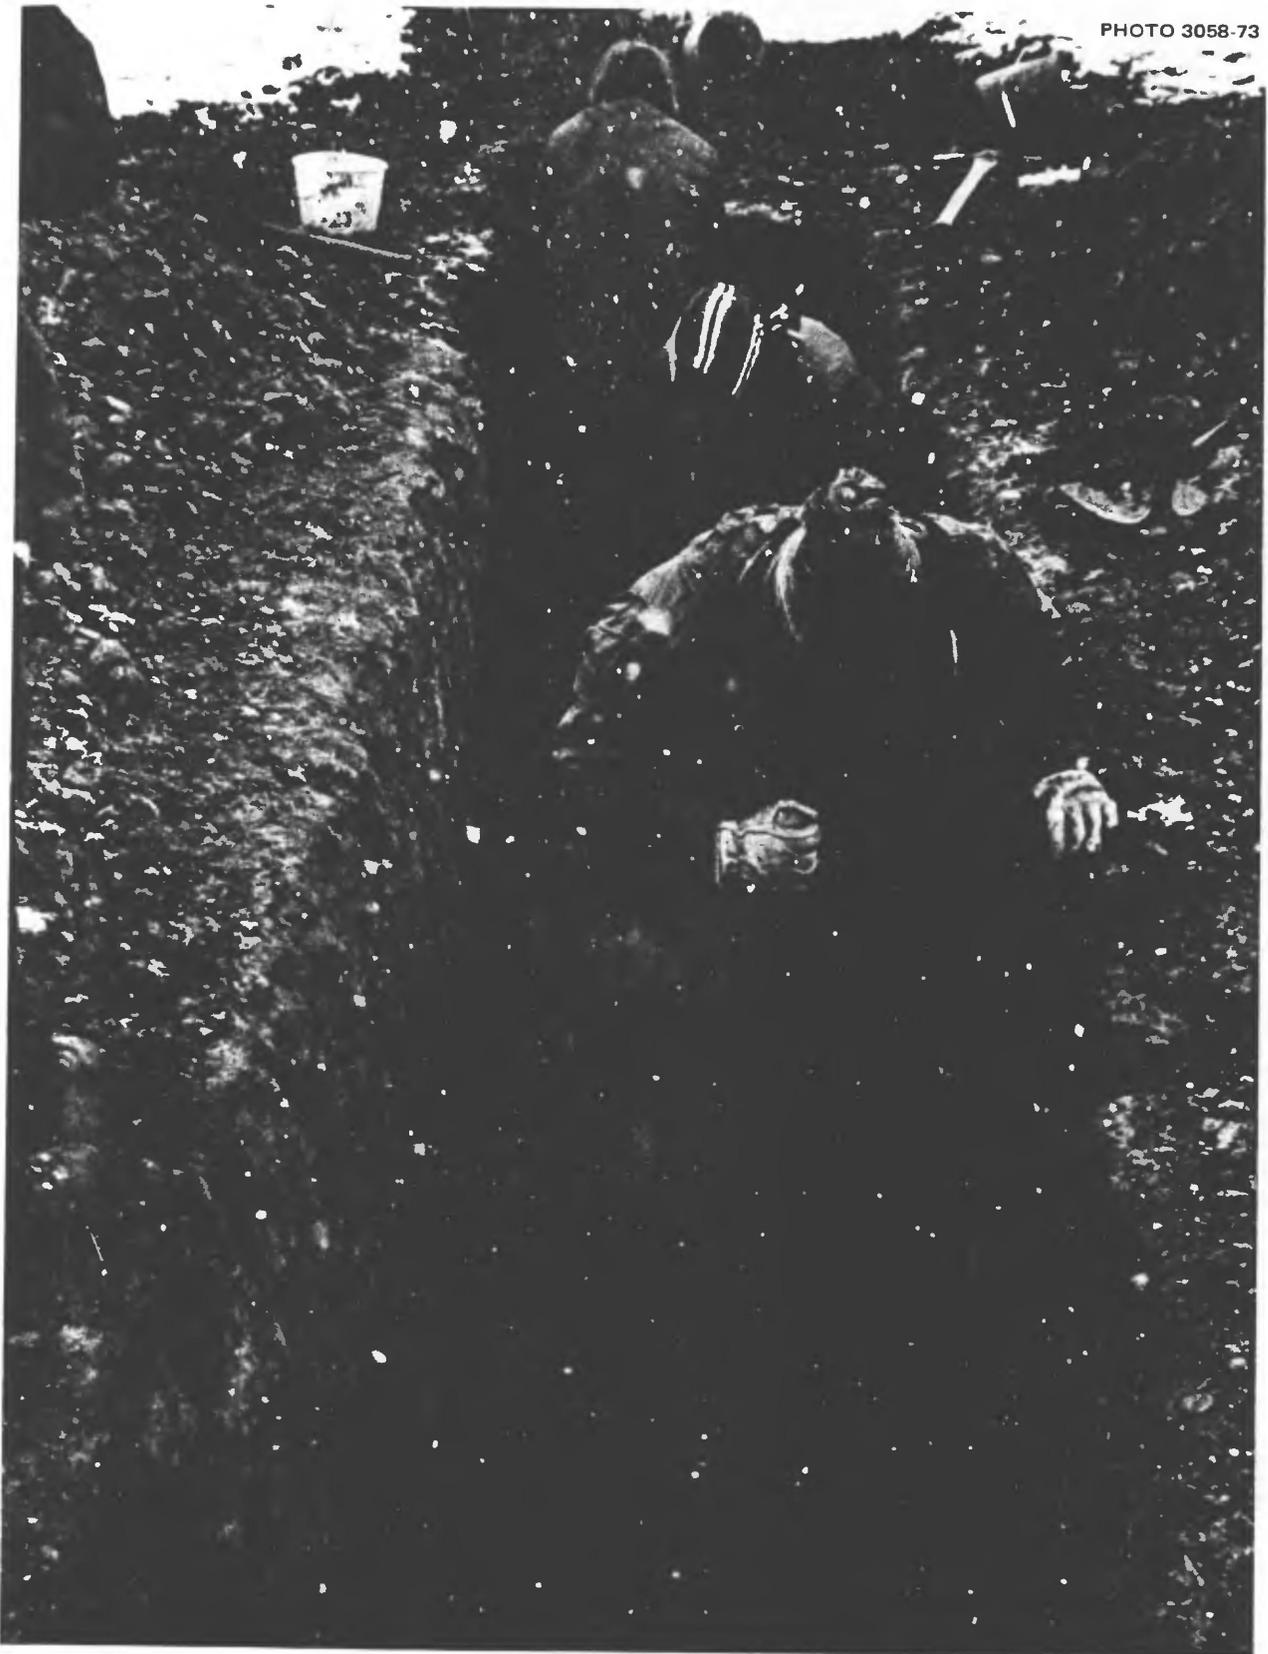
Fig. 2.7. At 8 AM on the second day, when the trench was about 3 ft deep, this family had the good fortune to get below the dry, hard clay-loam and into a slightly sandy clay-loam. The mother could dig this very stable but not-so-hard earth by standing on the shovel and slicing and prying off rows of chunks from the edge of a 6-in.-high earth step.

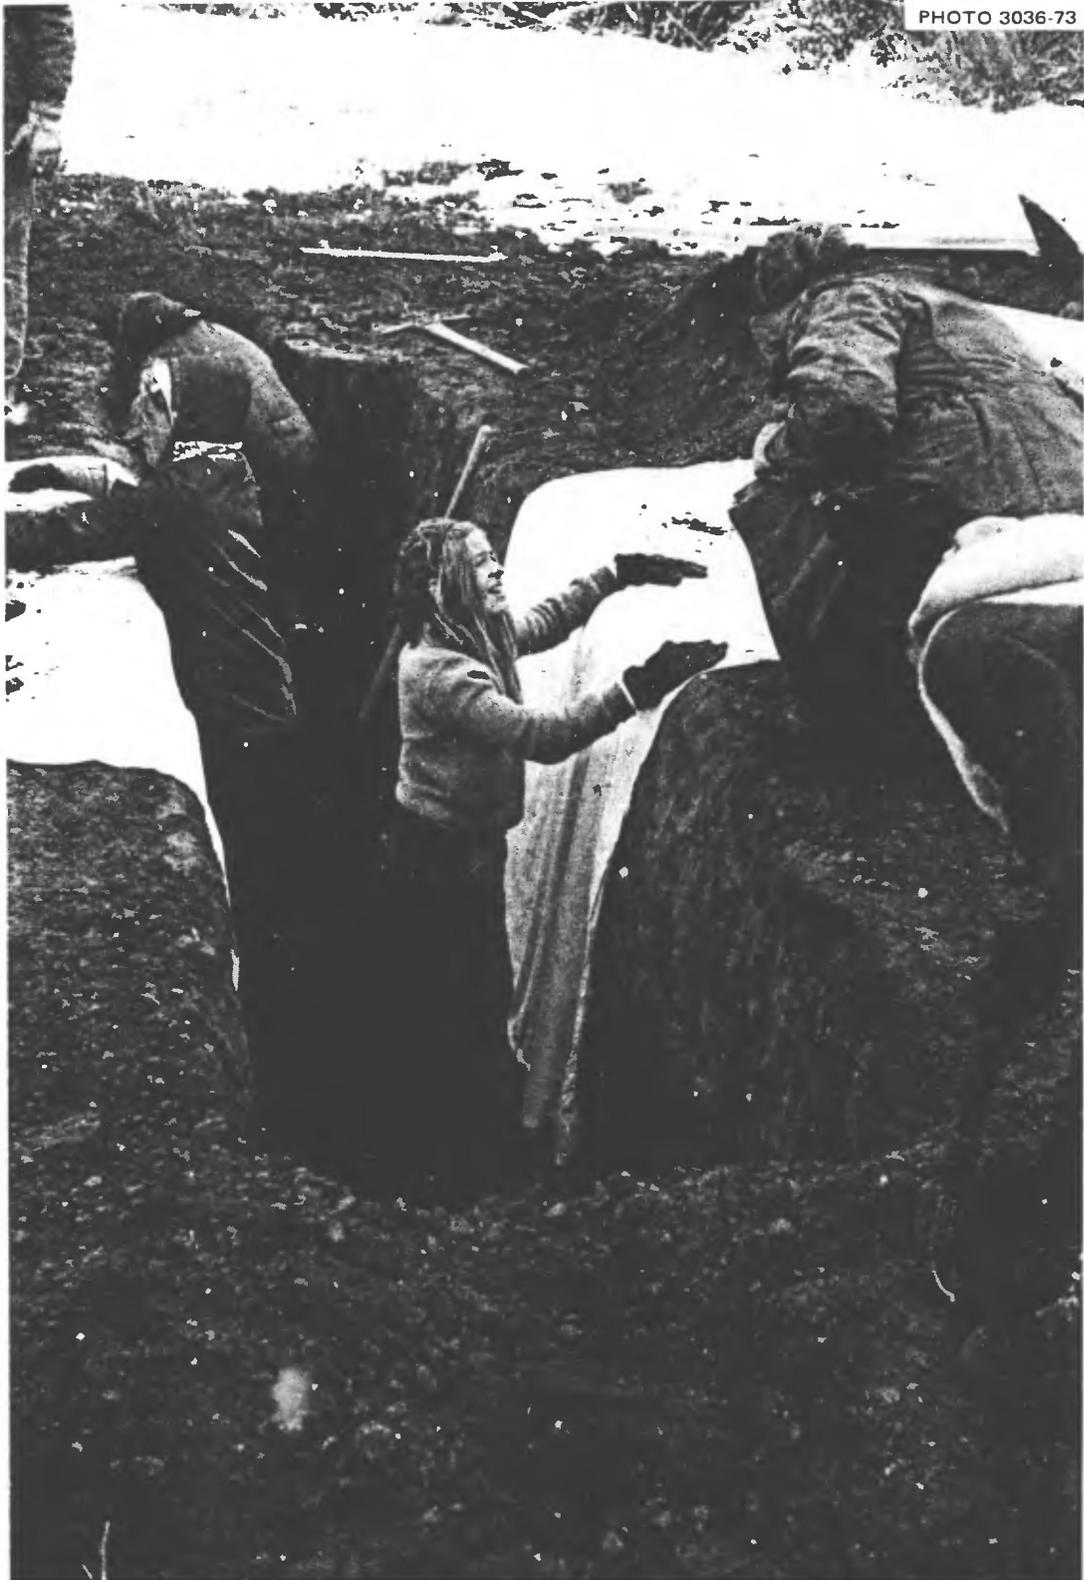
**Fig. 2.8.** Placing bedsheet coverings on the  $4\frac{1}{2}$ -ft-high trench walls. Such coverings make the trench cleaner, warmer, and easier to illuminate.

At the far end of this 15-ft-long, 3-ft-wide, and  $4\frac{1}{2}$ -ft-deep main trench, Tad is digging the steps in the 18-in.-wide, 24-in.-long entryway trench.

The trench was completed at 11:55 AM on the second day, 30 hours after Kearny handed this family the building instructions.

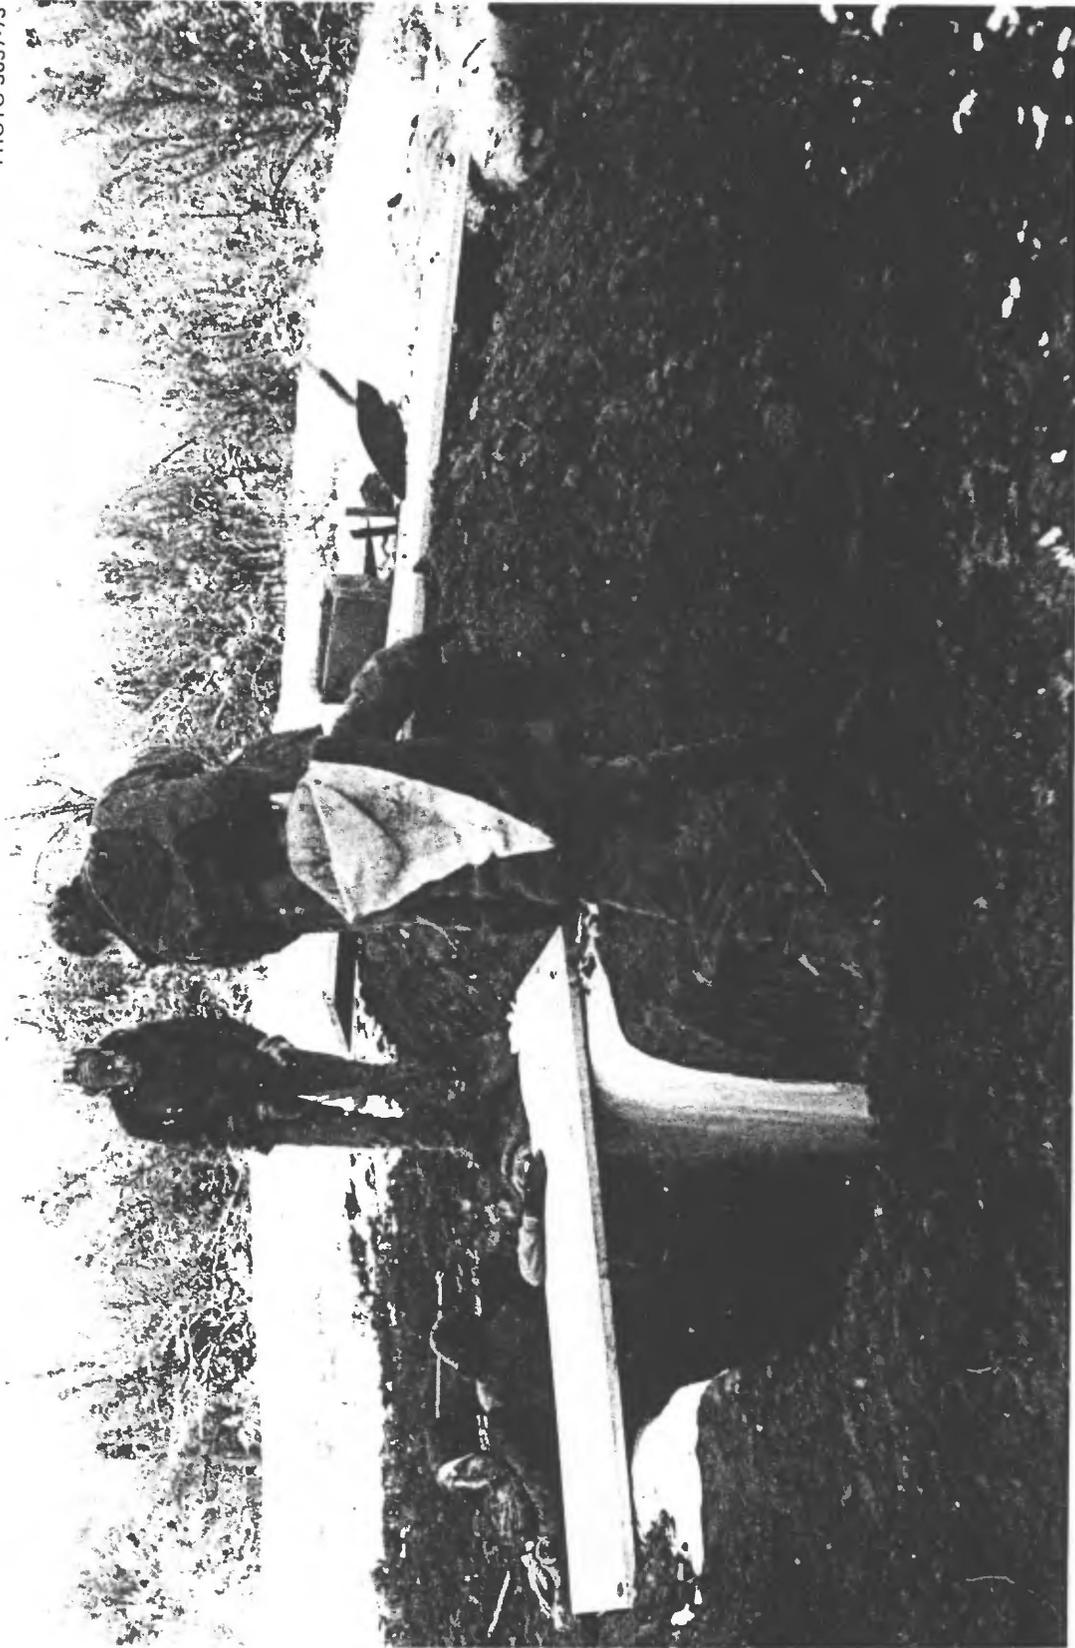
Fig. 2.9. Placing the first of six interior, hollow-core doors over the completed trench. The earth on the wall-lining sheet was removed before the second door was positioned.

Although the trench was dug to be only 36 inches wide, in places some of the doors had to span more than a 48-in. width before they were covered with earth. The weight of the covering earth bowed some doors down almost an inch, until a part rested on the edge of the trench — thus reducing the effective span to about 40 to 42 inches.

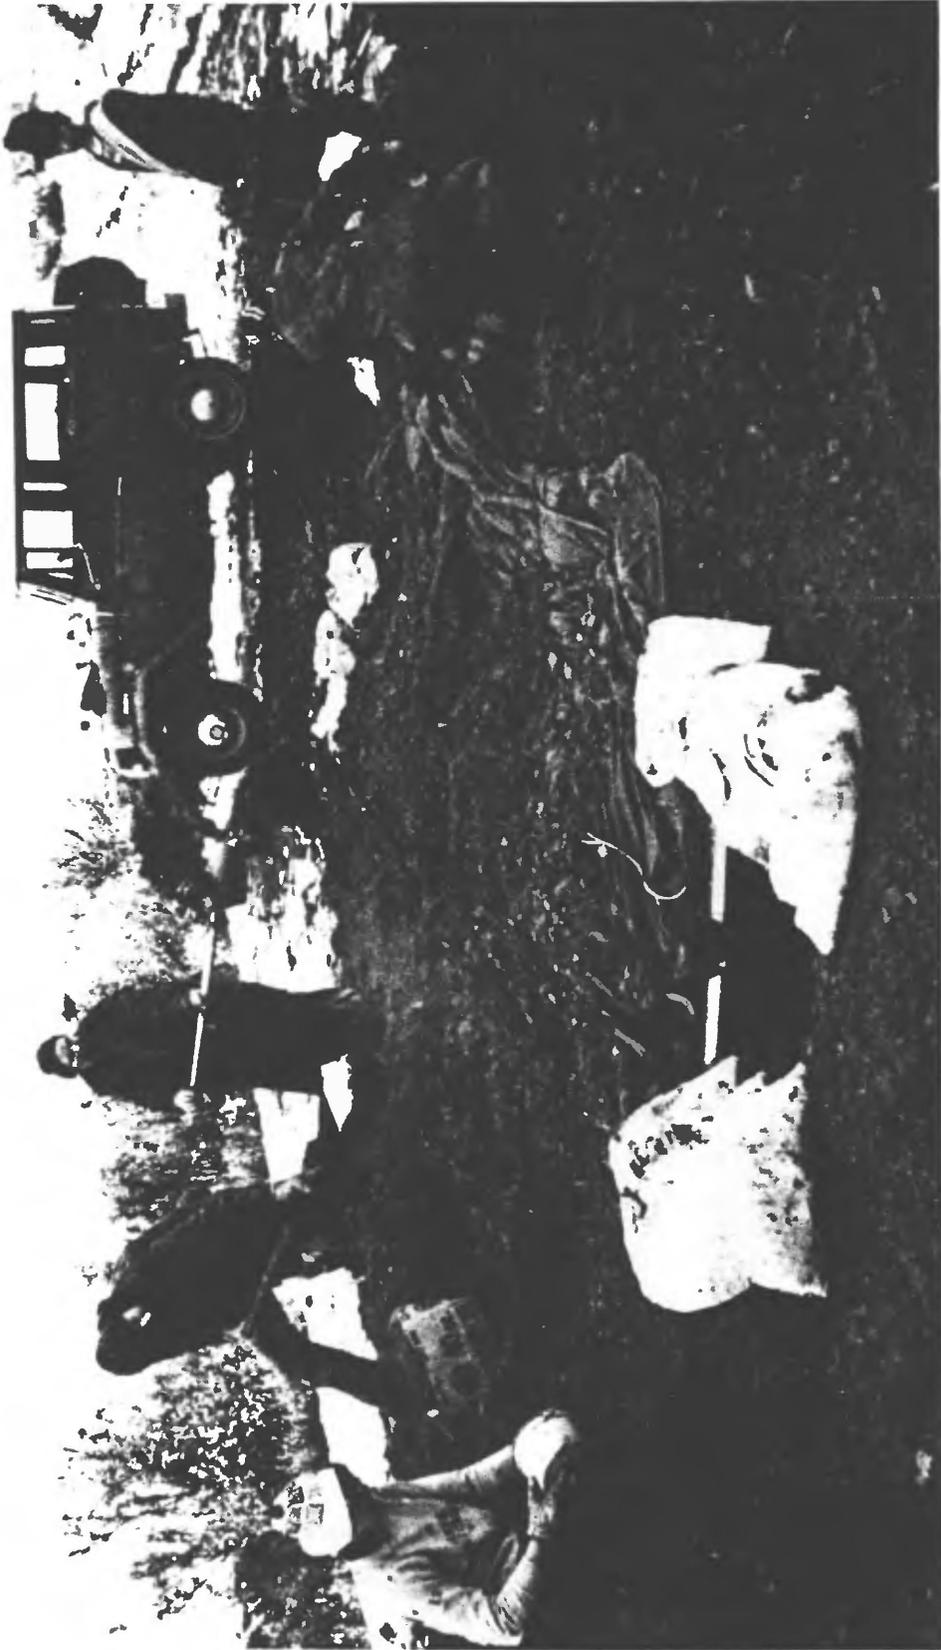
**Fig. 2.10. Covering the water-shedding "buried roof."** This family used a tent, due to a desire to save their shower curtains and most of their plastic table cloths, etc.

By far the worst error made by this family was putting the tent directly on top of the horizontal doors and starting to cover it as the "buried roof." At this point Kearny corrected them, for the first and only time, by asking the mother to reread the instructions. The sandbags around the partially completed 18 x 20 in. entryway are earth-filled pillowcases, which, along with the tent, were recovered undamaged.

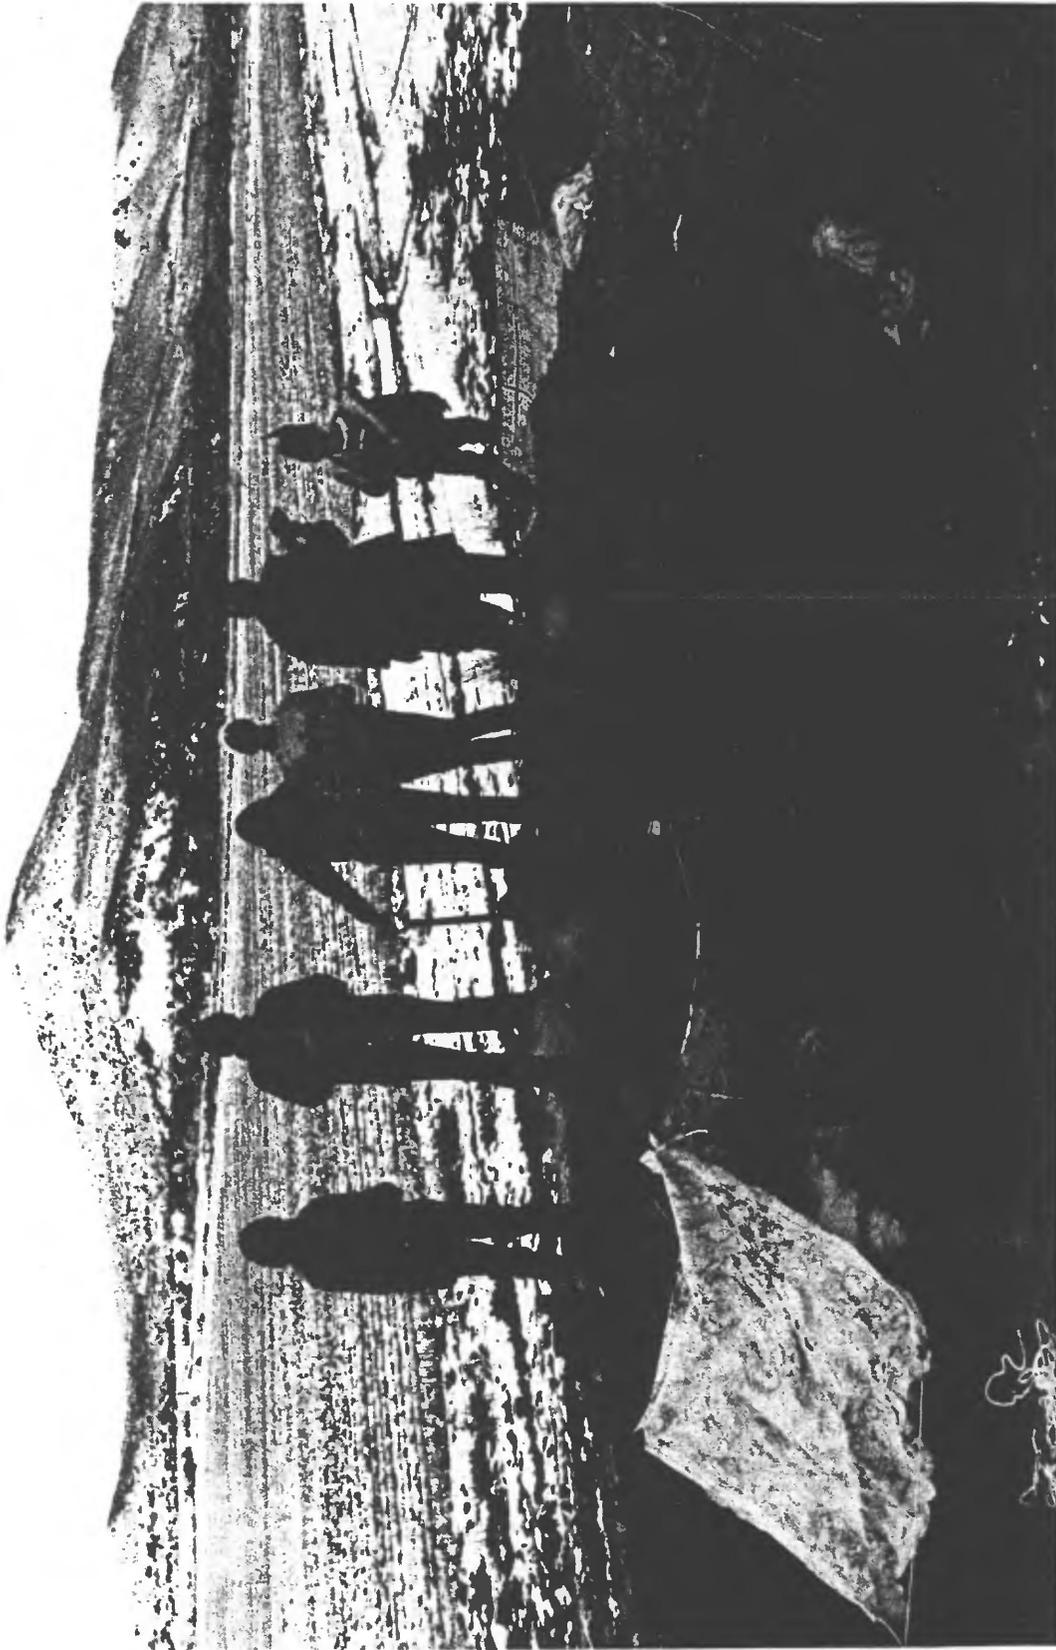
Fig. 2.11. Completed Door-Covered Trench Shelter, with canopies made of plastic tablecloths inexpertly rigged over the two openings.

Because at this date Kearny did not realize what great depths of earth covering such hollow-core doors bridging a narrow trench would hold, the instructions given to this family specified only an 18-in. covering. This family, so tired by this time that they were shouting at each other, shoveled only about 15 in. of earth over the doors.

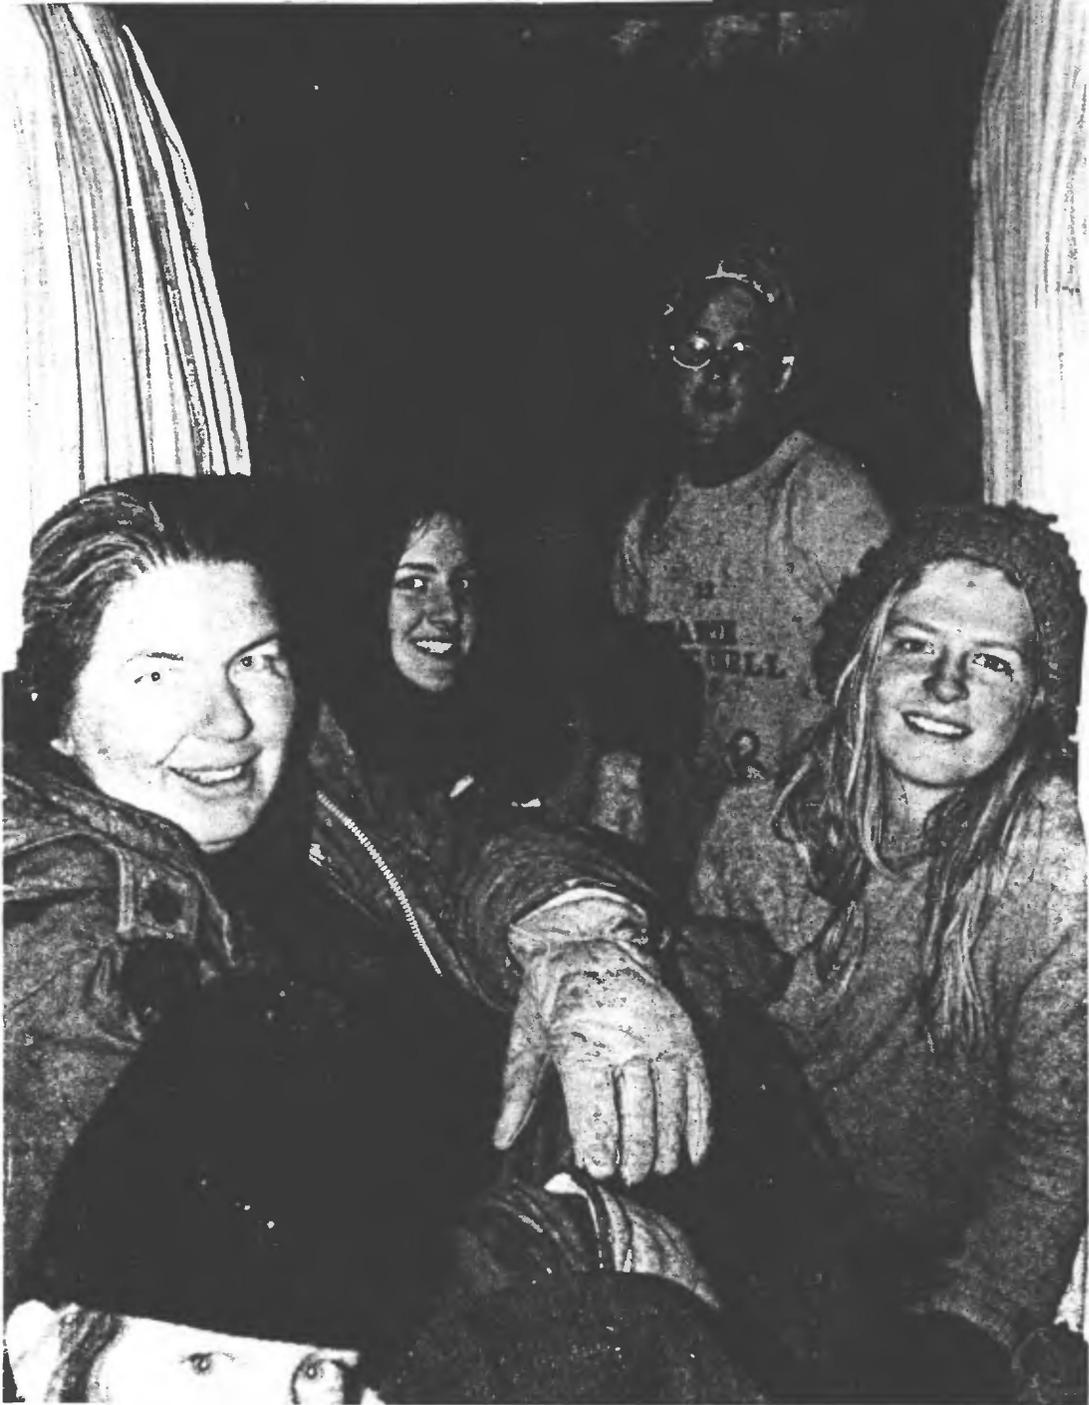
Fig. 2.12. Inside their completed Door-Covered Trench Shelter, and all pepped up by their success in finishing an unexpectedly hard job. They completed their shelter at 3:50 PM on November 25, about 34 hours after first receiving the instructions on November 24.

**CONCLUSION:** Not only does this shelter afford fallout protection (about PF 250) in line with the current threats, but also it gives much better fire and blast protection than do most basements. In a Defense Nuclear Agency blast test, a Door-Covered Trench Shelter withstood 5 pounds per square inch blast overpressure. The shock and drag effects accompanying a 5 psi overpressure from a large nuclear weapon would topple a strongly built high-rise building.

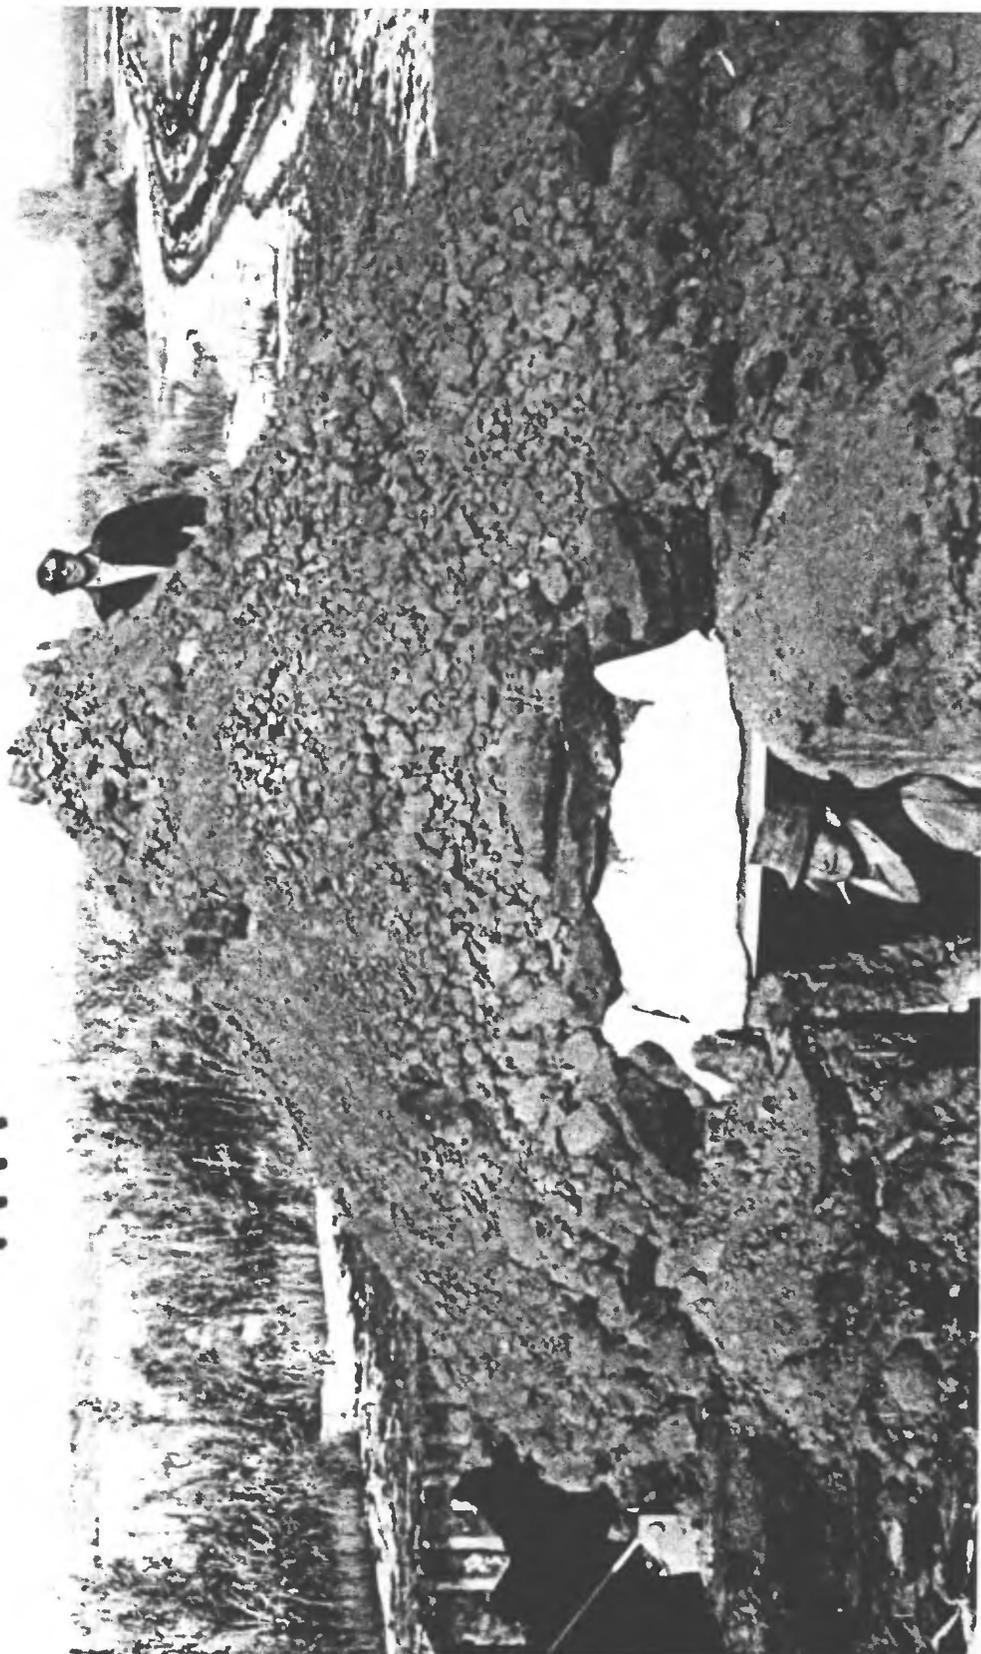
**Fig. 3.2. View of the same shelter from the entryway end. An observation trench had been dug out from the entryway, so that deflections of the roof doors could be observed safely.**

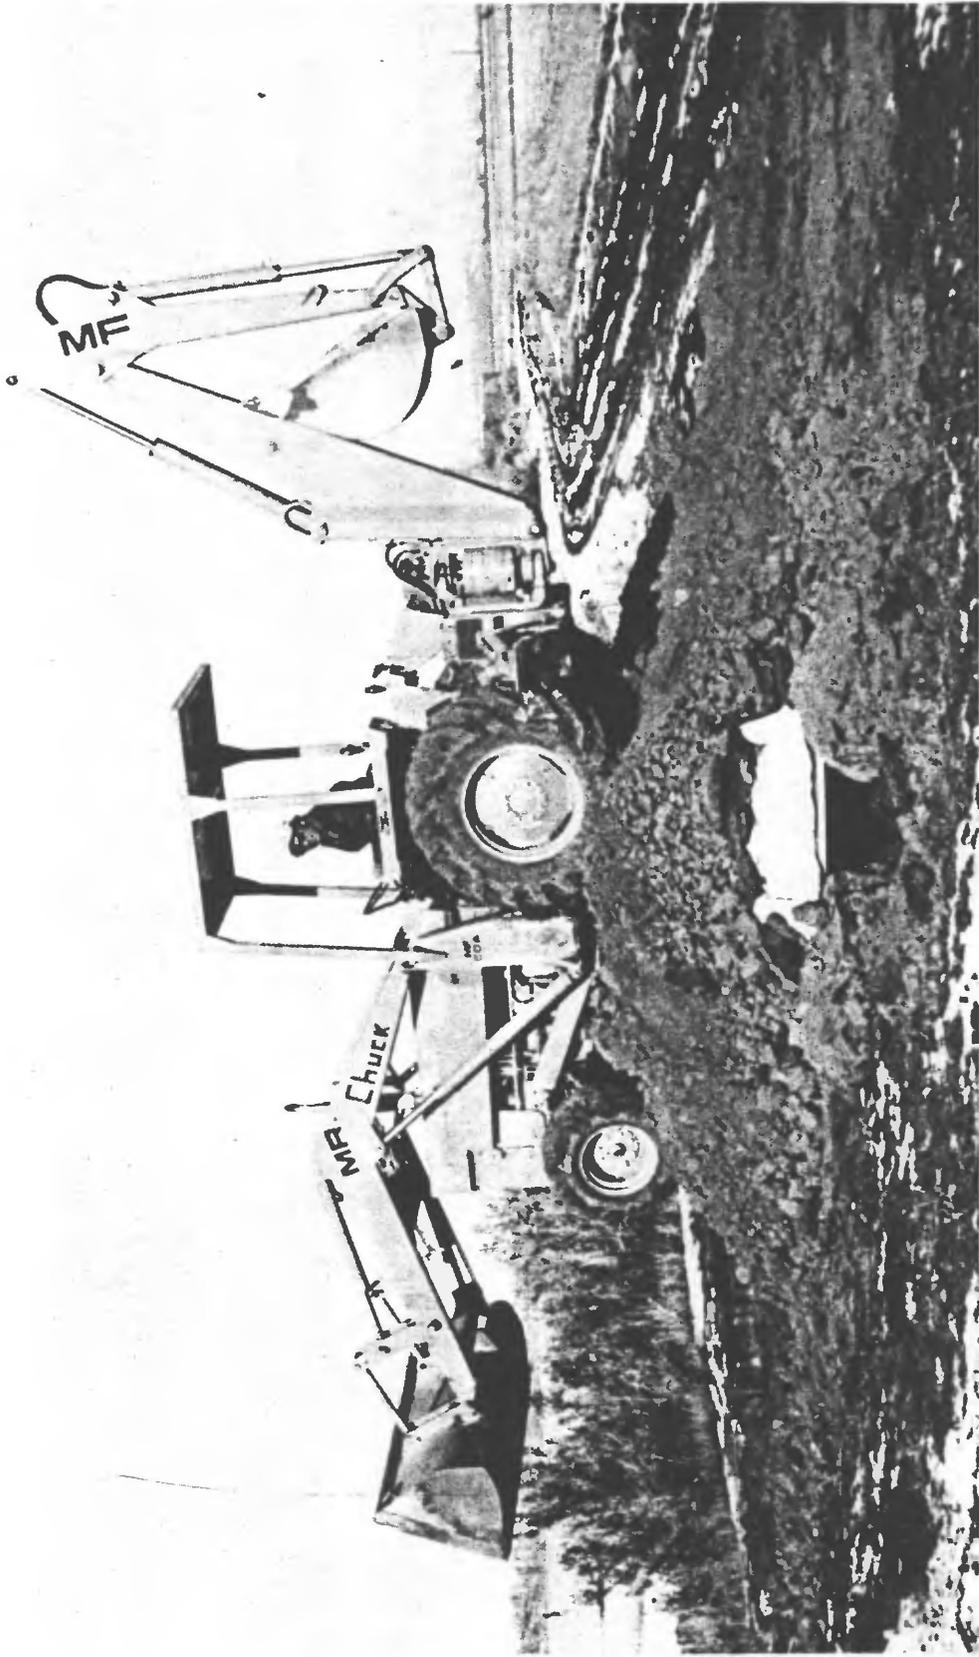
Fig. 3.3. An 8-ton backhoe on top of what was originally the 6½-ft-deep pile of earth over the shelter. Before this picture was taken, this machine had been driven back and forth several times over the mounded earth. The roofing doors remained undamaged, and were not observed to be bowed downward any more than when only the 6½-ft mound of earth was over them.
