ORNL-5039  
UC-41-Health and Safety

HEALTH PHYSICS DIVISION  
EMERGENCY TECHNOLOGY SECTION

EXPEDIENT SHELTER CONSTRUCTION AND  
OCCUPANCY EXPERIMENTS

Cresson H. Kearny

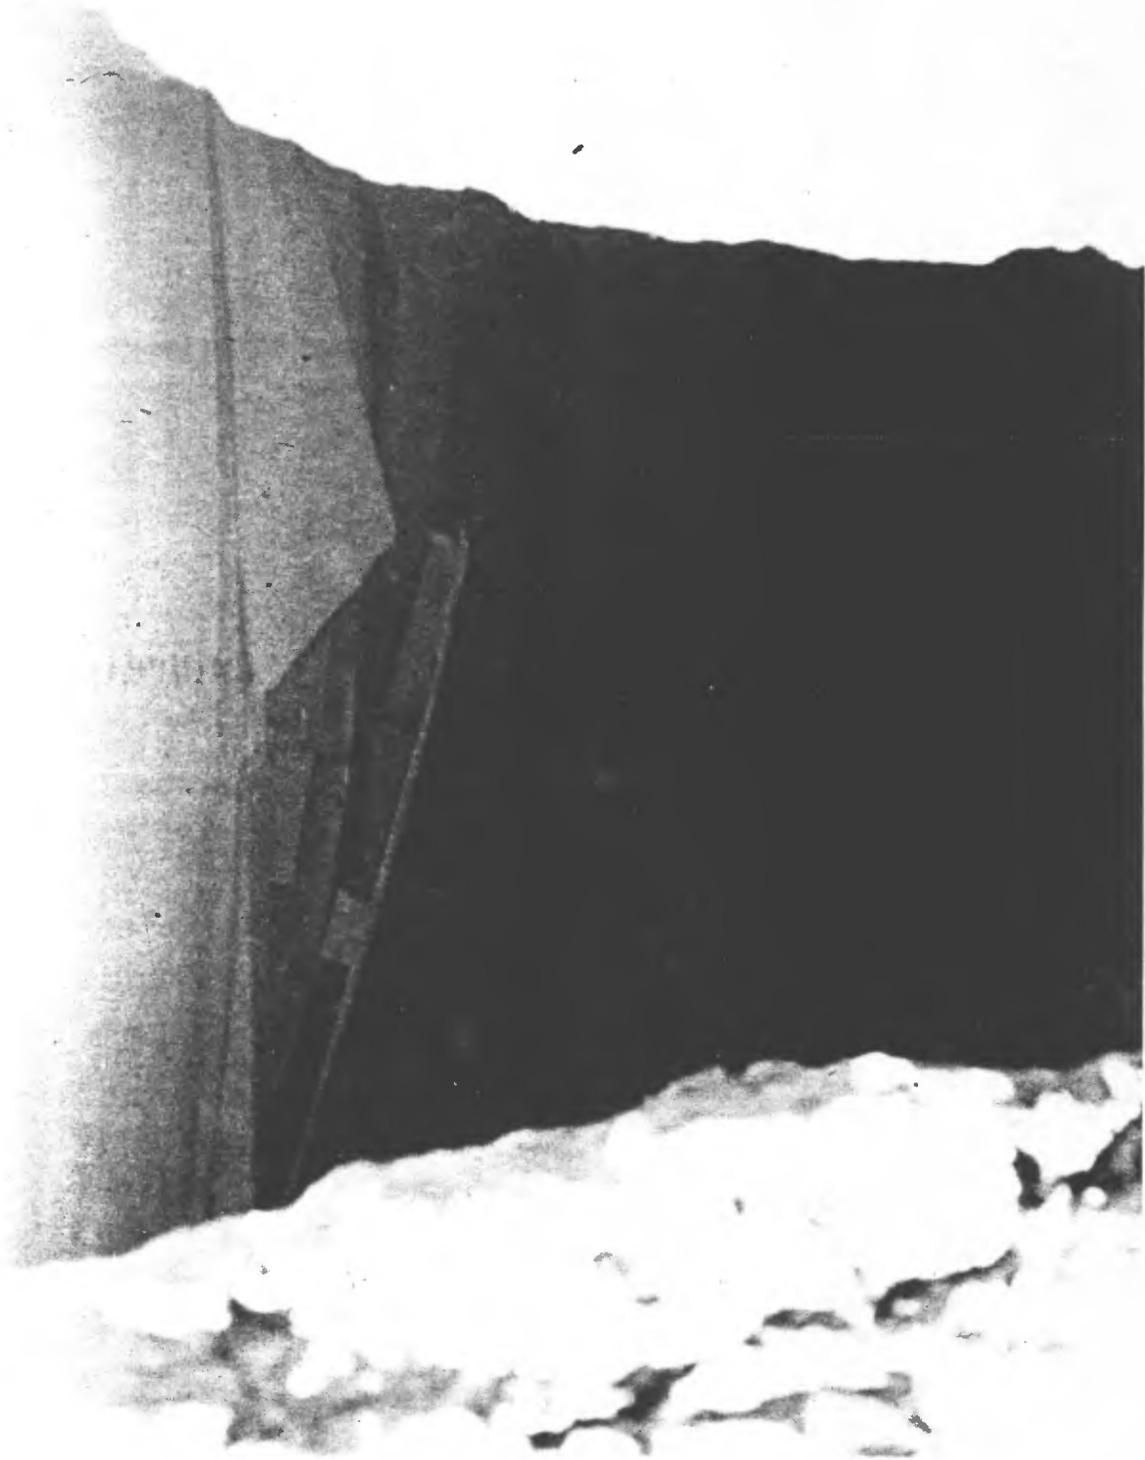
PHOTO 3082-73

**Fig. 3.6. Looking into the shelter after the rupture of the lower plywood-veneer sides of the doors. Since the veneer on the upper sides of the two partially broken doors and of two cracked doors remained intact, no earth fell into the shelter, and occupants would not have been injured by this unexpected type of failure of the most stressed of these very light hollow-core interior doors used for trench roofing.**

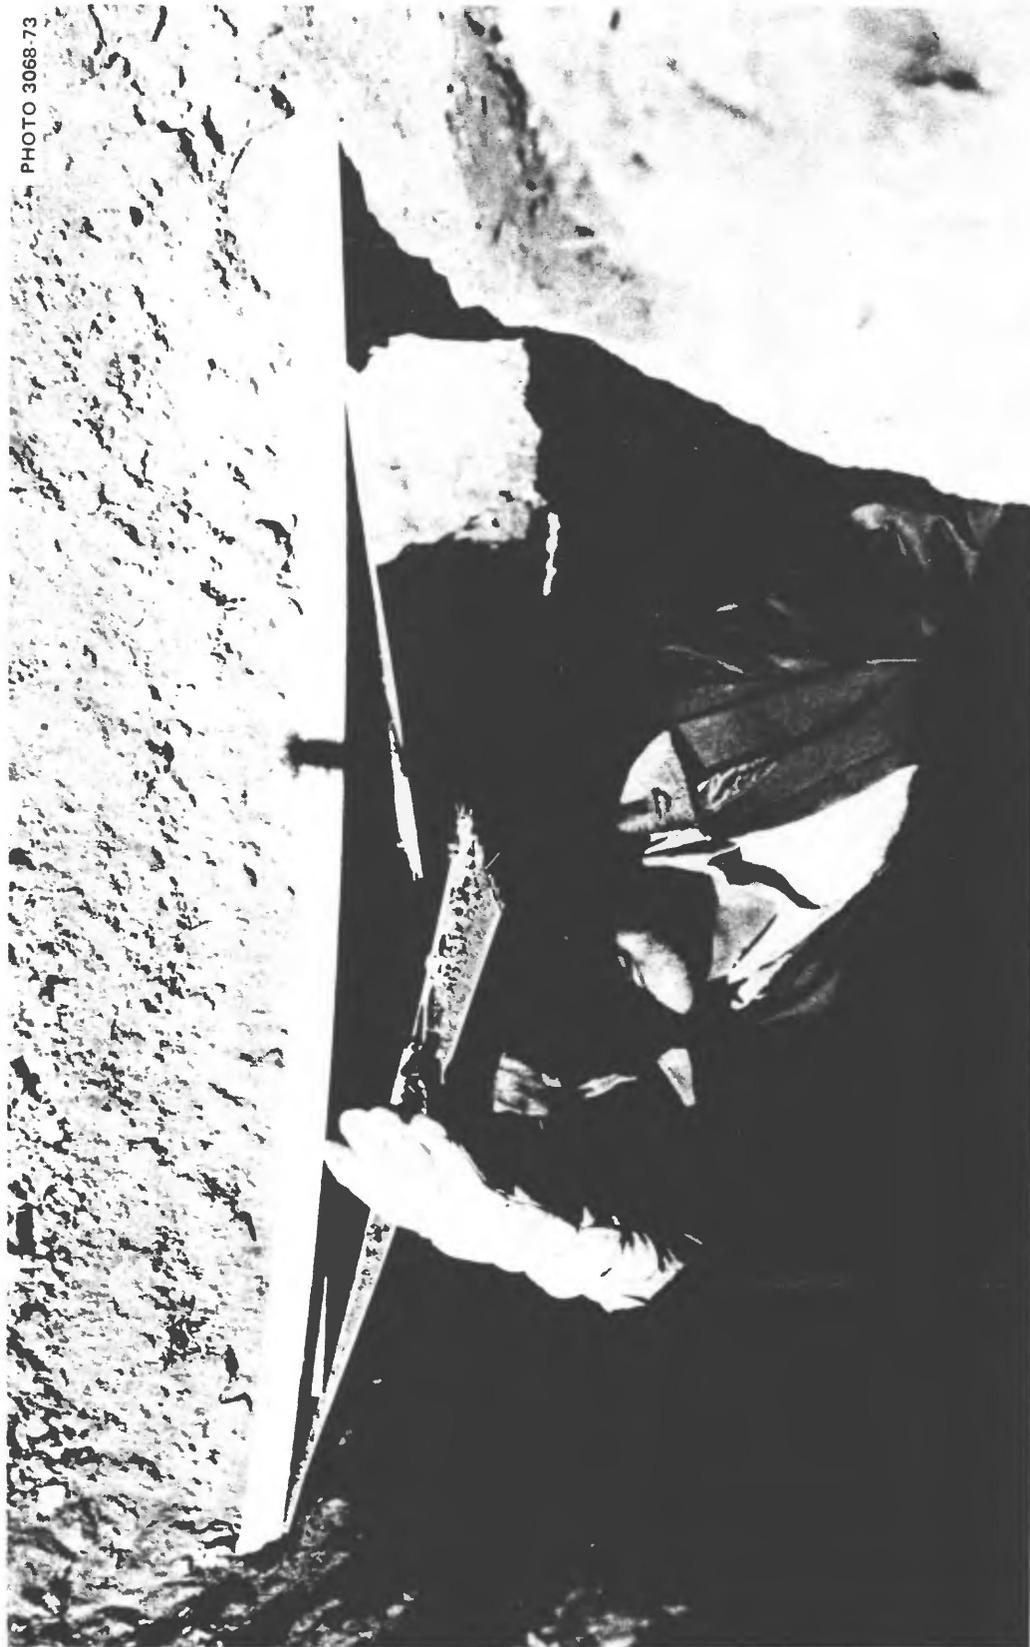
Fig. 3-9. View of the most damaged door after the removal of the adjacent door. Removal of some of the weight on the  $1\frac{1}{2}$  x  $1\frac{1}{2}$ -in. pine board that formed the unbroken frame of this door resulted in its becoming less bowed. The dry-earth bank pictured above this door appears to be vertical but actually was not. Kearny concluded that all that is needed to build a blast shelter in areas with stable and adequately deep earth is: (1) a deformable membrane (such as a tarp or rug) strong enough to support the weight of earth between it and the bottom of the earth arch formed by downward stresses and strains in the earth above the membrane; (2) the earth itself plus some practical although uncommon knowledge of how to use merely such a deformable membrane and earth to build a blast-protective roof over a trench.

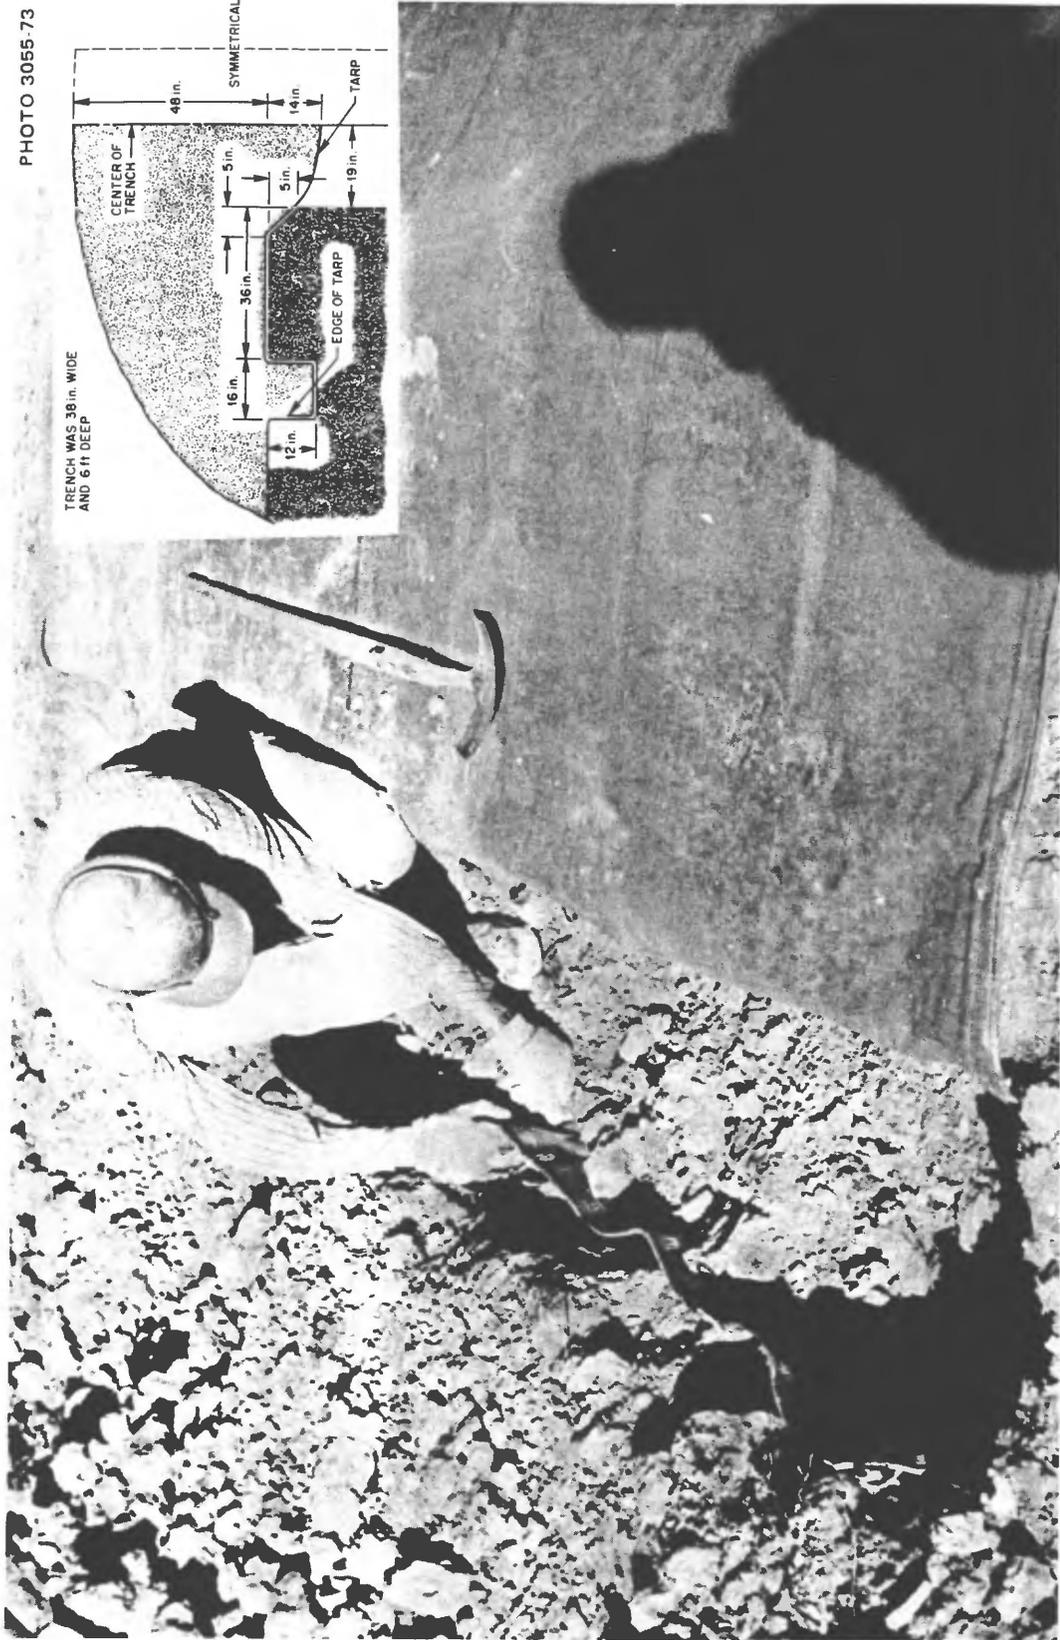
Fig. 3.11. Building the best of two successful Tarp-Roofed Trench Shelters constructed on Dec. 1, 1973, on the Kearny farm near Montrose, Colorado. C. H. Kearny designed this shelter after the November tests of the Door-Covered Trench Shelter had convinced him that, if the principles of earth arching and friction are used properly, then blast shelters can be built in many areas by roofing a trench with only a tarp or a strong rug, and then intelligently covering the tarp or rug with earth. A workman is shown placing dry, crumbly clay-loam earth over one edge of the tarp. This edge had been placed in one of the two rectangular side trenches, as indicated by the sketch.

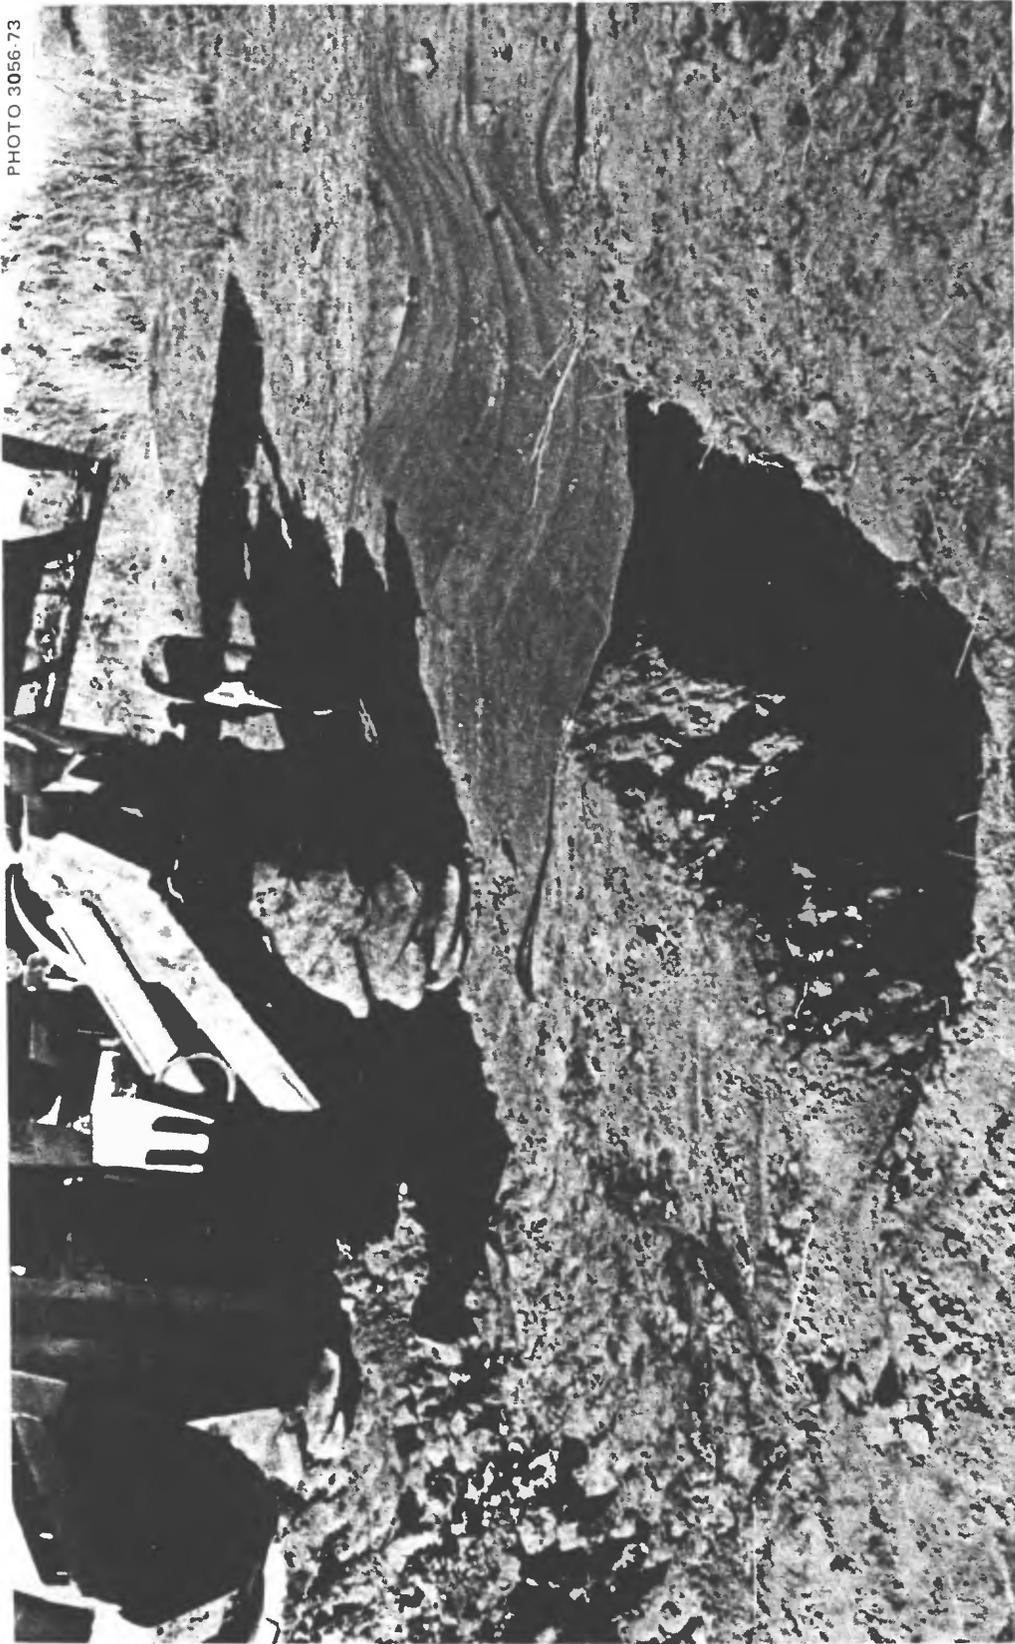
**Fig. 3.12. Compacting the earth over one edge of the tarp.** This edge has been placed in one of the two 16-in.-wide by 12-in.-deep rectangular trenches, each of which was dug parallel to and 3 ft from the vertical walls of the shelter trench. Packing with this wide-wheeled backhoe did not compact the earth as well as hand-tamping it with a pole.

The shelter trench was 3 ft wide. The tarp was of 12-ounce cotton duck and measured 11 ft 4 in.  $\times$  15 ft 4 in. This new, inexpensive tarp was laid with its length (which was the direction of its three-component stitched-together strips) across the trench. The downward bow, or sag, of the uncovered tarp, as pictured, was 6 to 8 in.

Two-inch-wide strips cut from this 12-oz cotton duck tarp were subsequently stressed to failure in the Metallurgy Test Laboratory of ORNL. The ultimate strength was found to average only about 190 lb per 2-in.-wide strip, or 1140 lb per 12-in.-wide strip when subjected to ideal straight-pull stressing.

Calculations using these optimum figures show that without earth arching the Tarp-Roofed Trench Shelter would have failed under the loads it was subjected to on December 1.

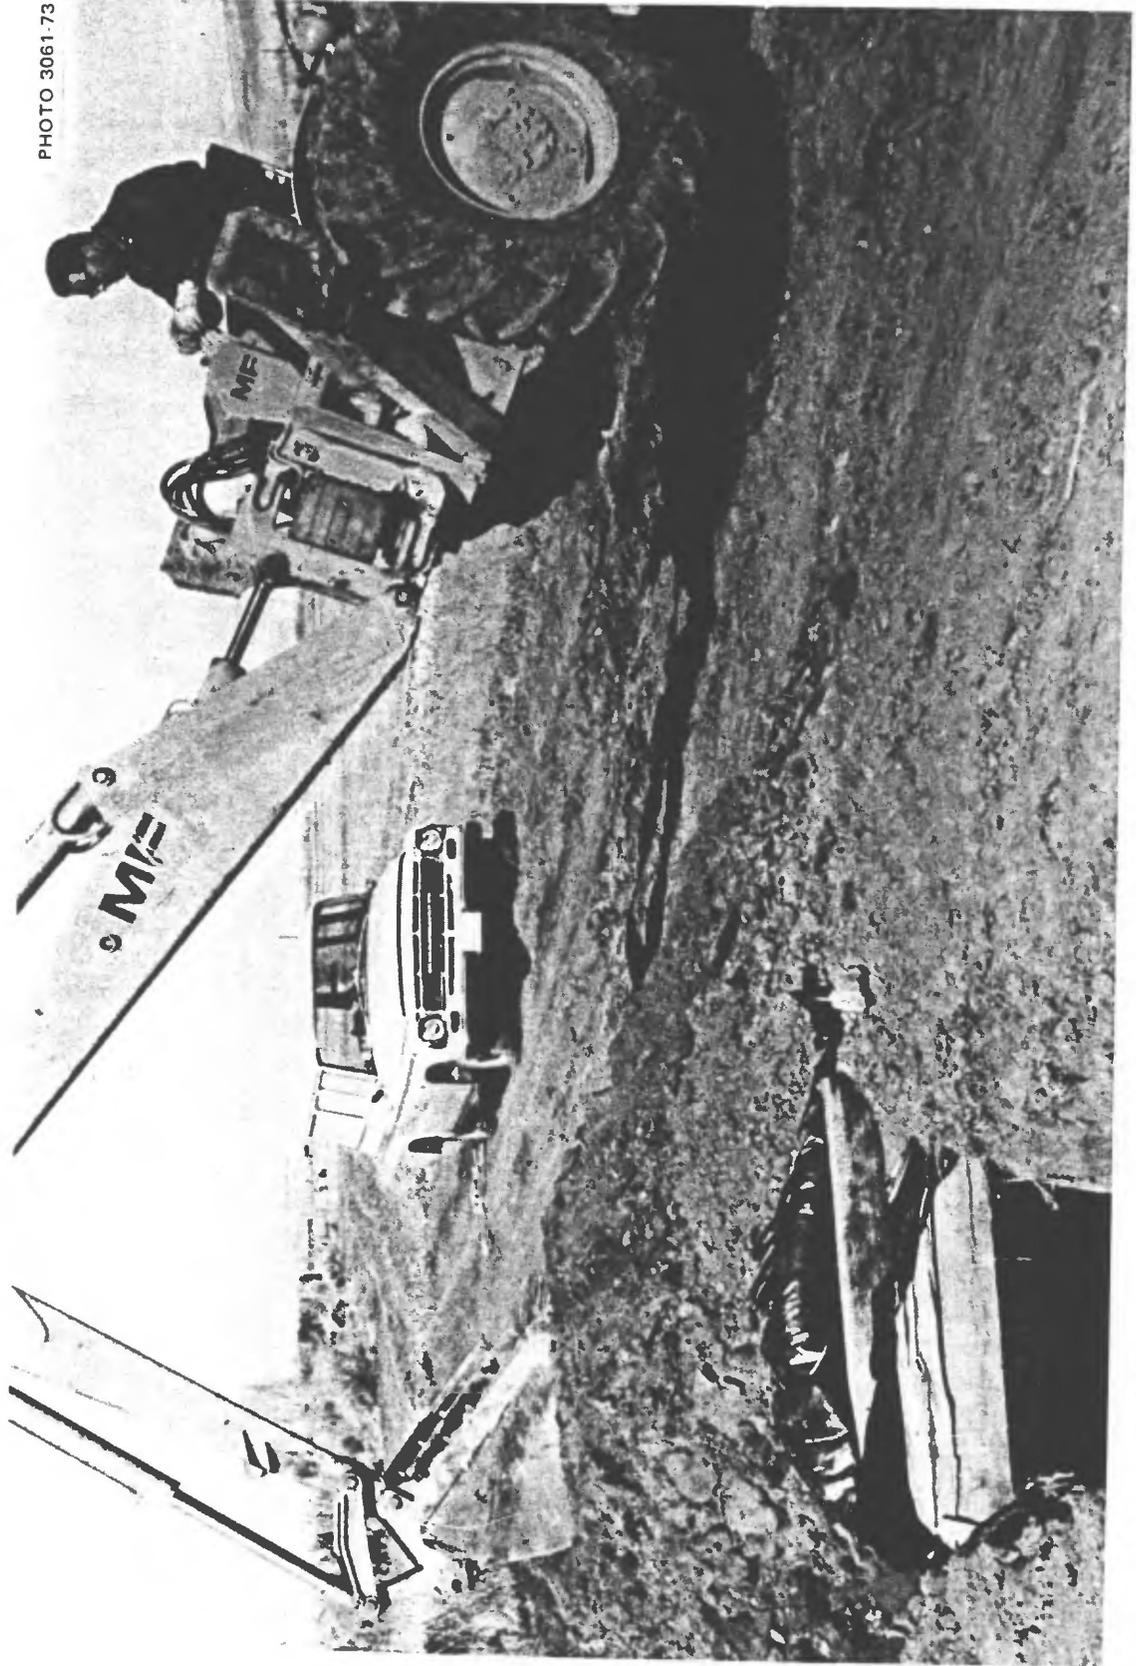
PHOTO 3061-73

Fig. 3.13. Stressing the Tarp-Roofed Trench Shelter, a 6-ton backhoe, supported only by its buckets, pressed down repeatedly with its front bucket on a 62-in.-deep mound of loose earth. The mounding of loose earth caused the tarp to bow downward (sag) into a catenary curve. The compaction caused the tarp to stretch, resulting in an increase of the maximum sag from 8 to 14 in.

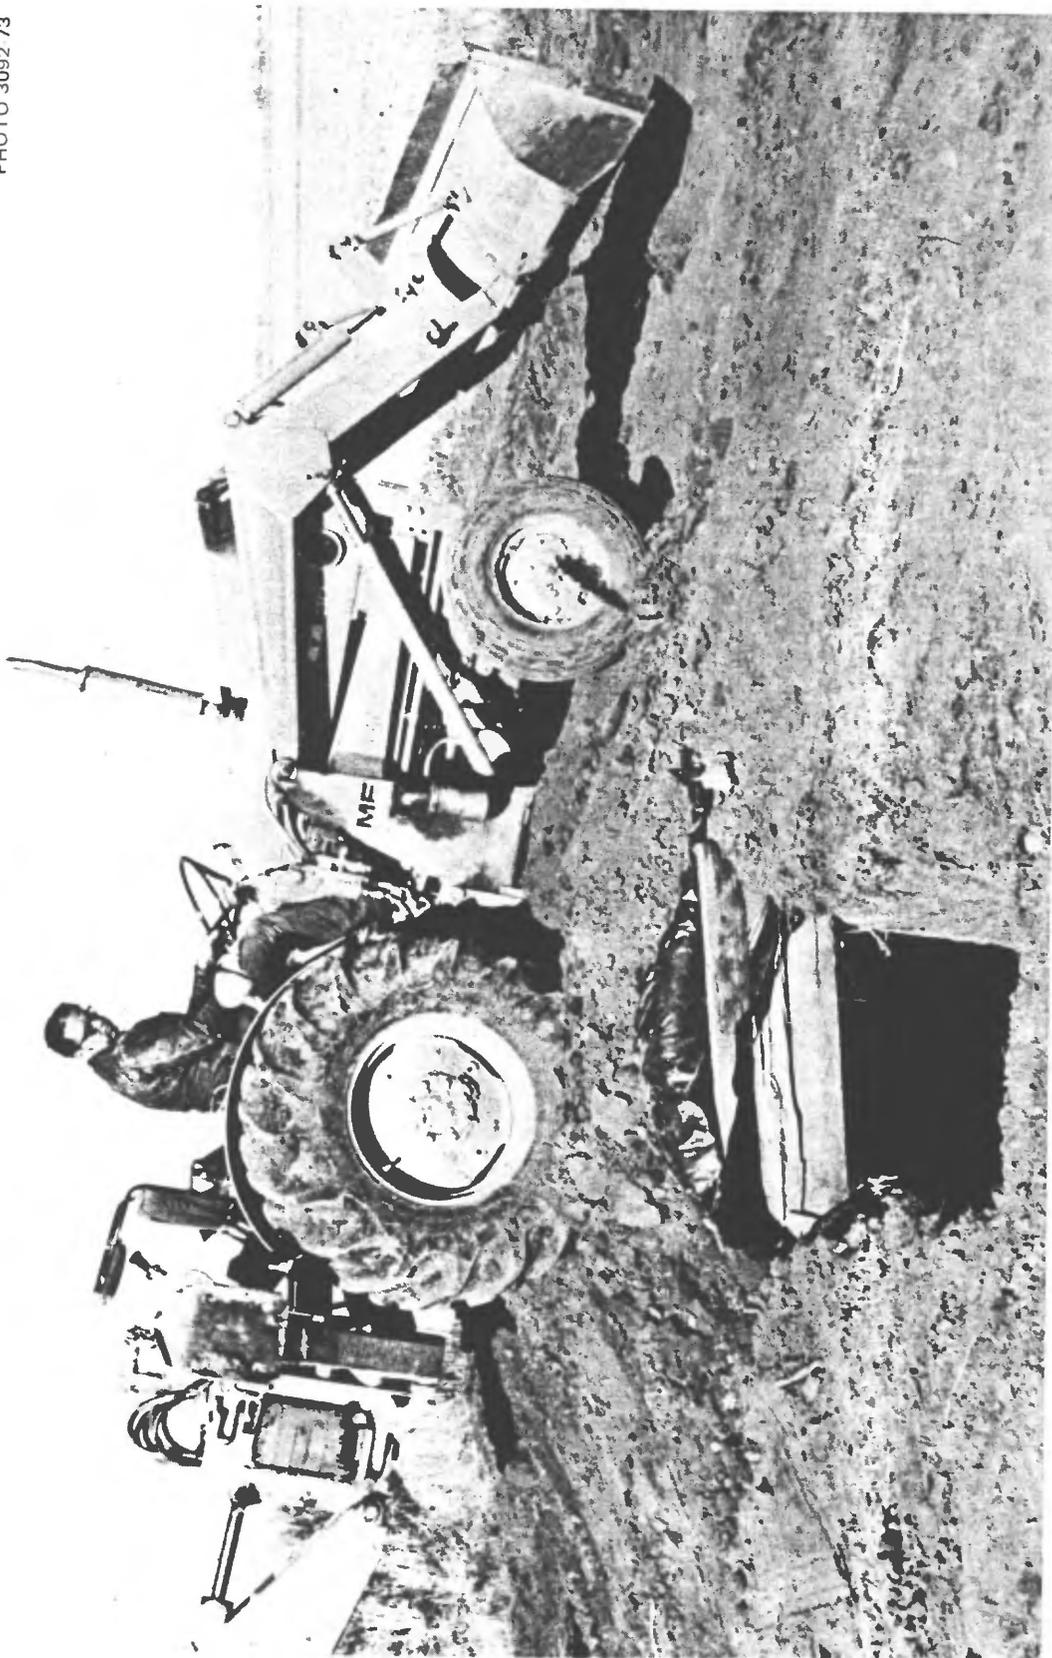
**Fig. 3.14.** Stressing the Tarp-Roofed Trench Shelter, after the thickness of its earth cover had been reduced to about  $3\frac{1}{2}$  ft, by driving a 6-ton MF-30 backhoe back and forth across it. The downward bow, or sag, of the tarp catenary remained the same (14 in.). Because Kearny wanted to see whether or not the tarp edges in the small earth-filled side trenches had moved, no more of the earth cover was removed preparatory to more severe loading tests. The tarp was unearthed by the backhoe and hand labor; the tarp edges in the small trenches had not been moved, nor had the compacted earth in the two small side trenches been disturbed by the inward pulls on the tarp produced by the loading tests.

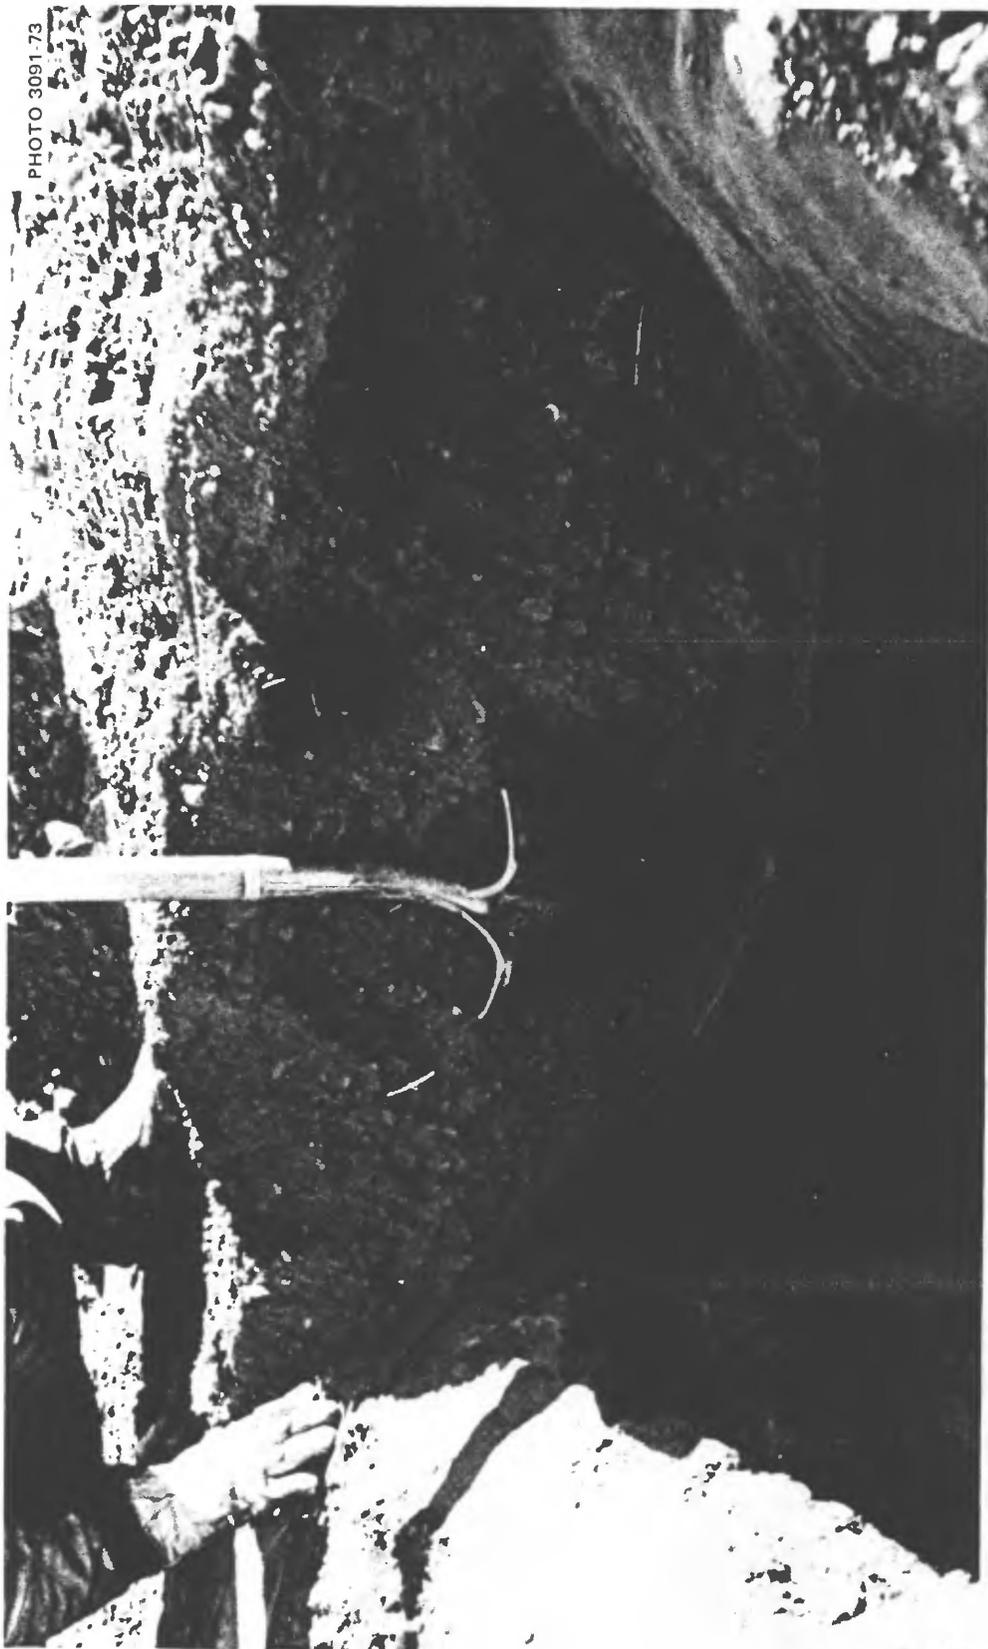
**Fig. 3.15. View of the tarp catenary after the backhoe (that was removing the earth cover) had accidentally snagged part of the tarp and torn it. Note the 45° beveled edge of the trench.**

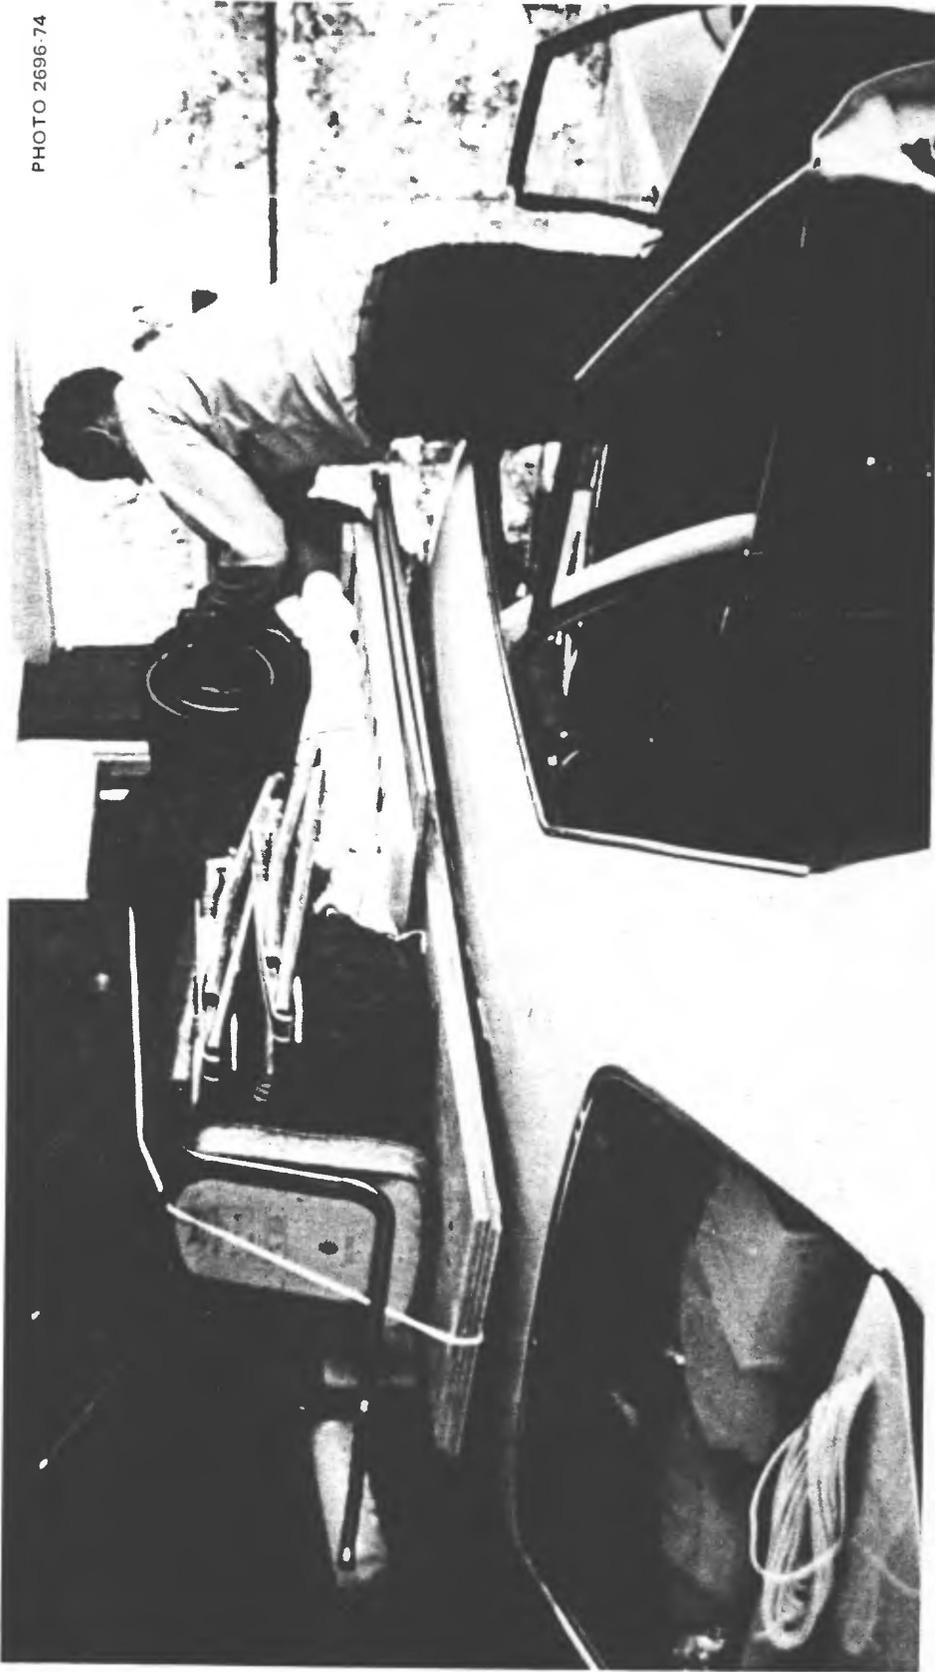
**Fig. 4.1.** Loading the family car, a 4-door Maverick, preparatory to evacuating. Ten days before the agreed starting date (August 13, 1974) of this test, this 6-person family had agreed to build a trench shelter  $3\frac{1}{2}$  ft wide,  $4\frac{1}{2}$  ft deep, and 15 ft long, with an entrance trench 22 in. wide. No plans or instructions were supplied before the starting hour, 5 PM on August 13. Therefore, the prudent father of this family had built, before August 13, an essential ventilating pump (a KAP, 20 in. wide x 36 in. high) and prefabricated components of a 21-in.-wide, double-deck bunk. Also, he sawed plywood into several threshold boards to keep the edges of earth steps and ledges from being broken off. Furthermore, after having built a rough mockup of this small shelter in his home basement, he had decided to carry on top of the family car three folding chairs and one straight chair, to avoid getting sore backs from sitting for days with no good back support.

Between the car top and the plywood, the father sensibly placed a narrow shag rug. The sleeping bags also provided resiliency that kept the load on top from slipping after it was tied on.

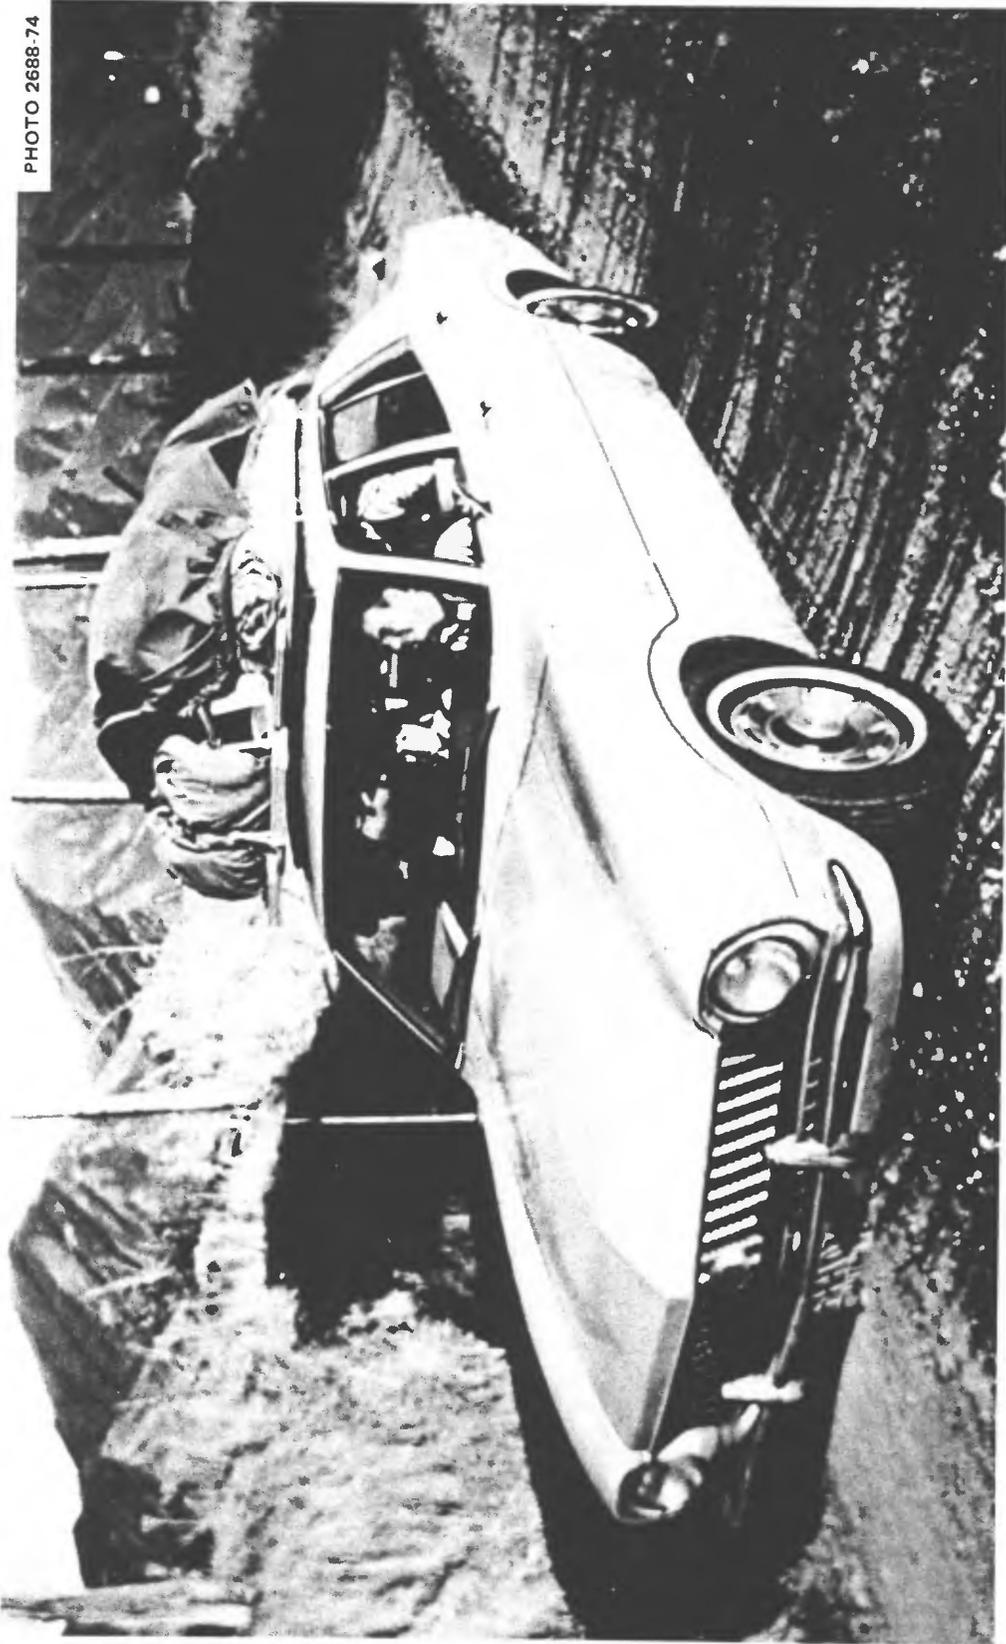
**Fig. 4.3.** The 6-person family just before reaching the shelter-building site on a farm near Spanish Fork, Utah, at 7:48 PM. Most of the 64-mile drive (evacuation) was on an interstate, moving with the traffic at 55 to 60 mph. To provide space in their crowded car, they left the back seat at home.

Note that the load on top of the car was first tied together with cord. Then, after being covered with a small piece of canvas, it was tied to the top of the car with two pieces of light rope. These ropes encircled the top of the car, before the four doors were closed. The father made a loop on one end of each piece of rope, so that he was able to cinch each of these ropes tightly around the purposely resilient load. Obviously, many city people would need to read and follow instructions to enable them to tie bulky loads securely on their car roofs.

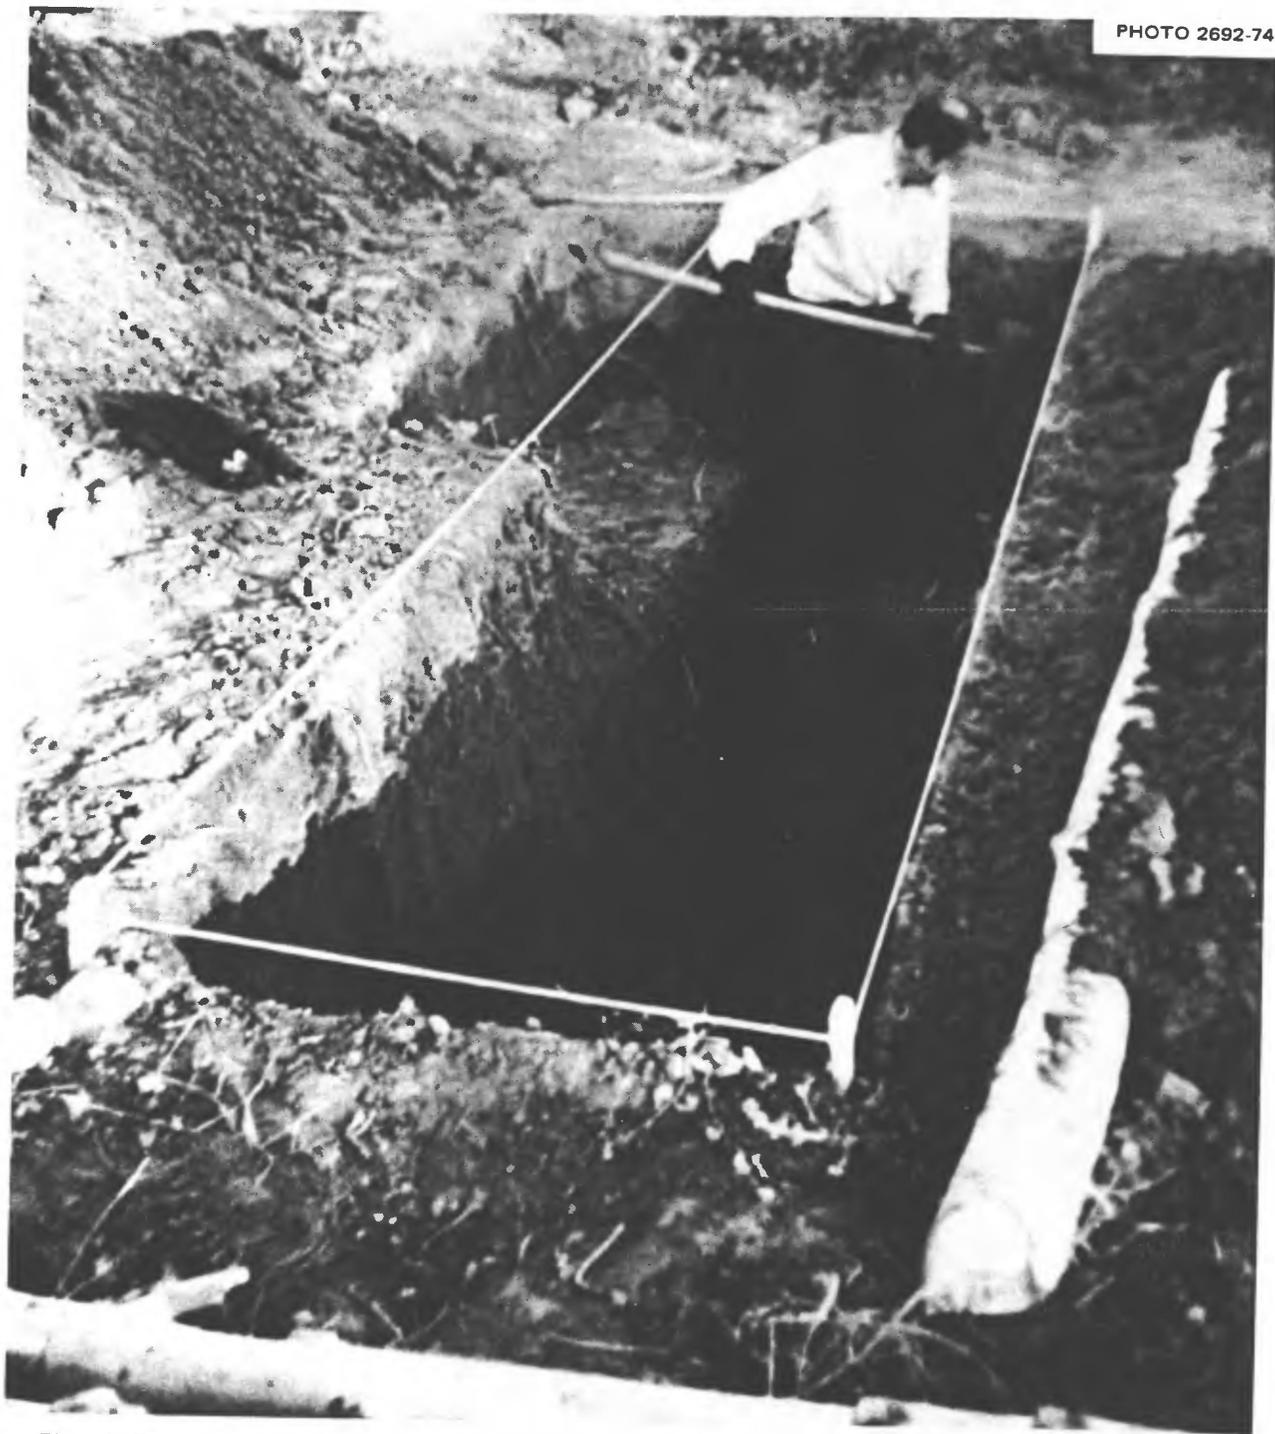
Fig. 4.4. Expanding the shelter room to its full specified width of  $3\frac{1}{2}$  feet, and to its  $4\frac{1}{2}$ -ft depth. This intelligent man made unnecessary work for himself by not following the instructions to cut a  $3\frac{1}{2}$ -ft stick, and then use it repeatedly to be sure the trench was being dug full width.

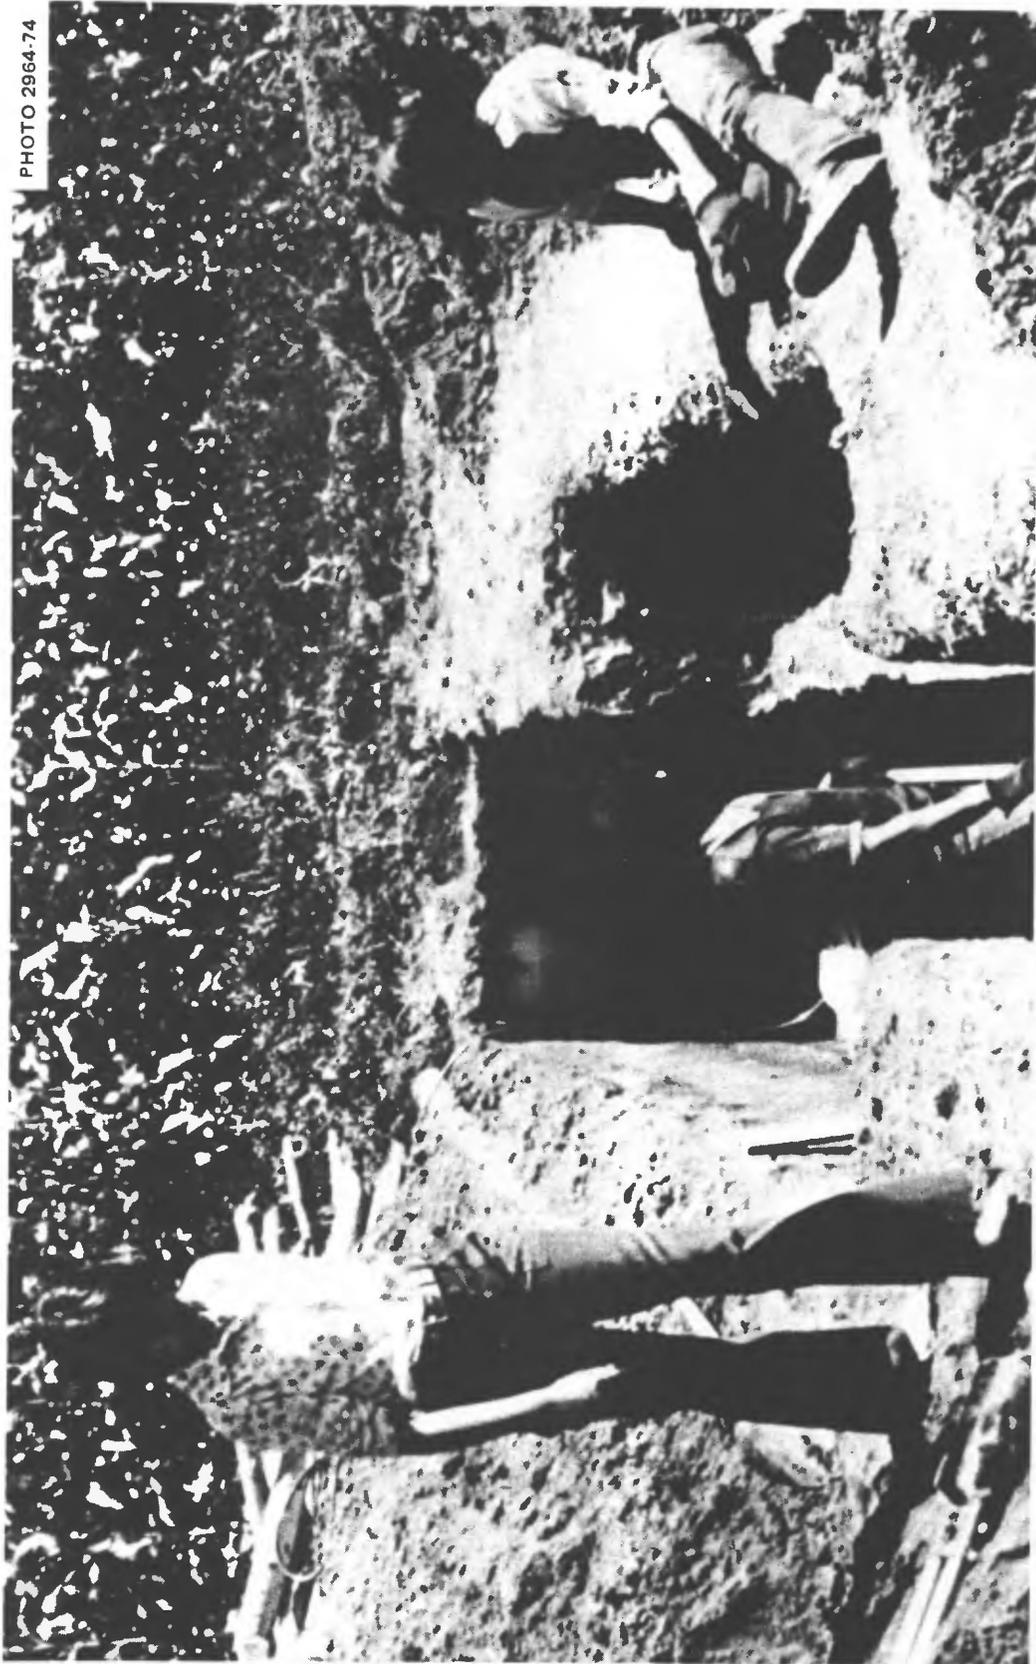
Fig. 4.5. The small ledgelike excavation on the side of the main trench was dug by Kearny to provide himself with a place to sleep and to observe the shelter-occupancy test. This sleeping ledge was 2 x 8 ft, providing a height to the log roof of only 2 ft. After Kearny got a sore neck from turning around periodically on this sleeping ledge, with only a 24-in. ceiling, during the 77 hours of shelter occupancy, he concluded that such sleeping ledges should be dug to provide a 30-in. ceiling.

The entry trench, 22 in. wide and 48 in. deep, is shown in the foreground. When this photo was taken, the 22 x 24 x 60 in. trench for the air exhaust-emergency exit had not yet been dug at the far end of the main trench. This main trench was 3½ ft wide, 4½ ft deep, and 16½ ft long.

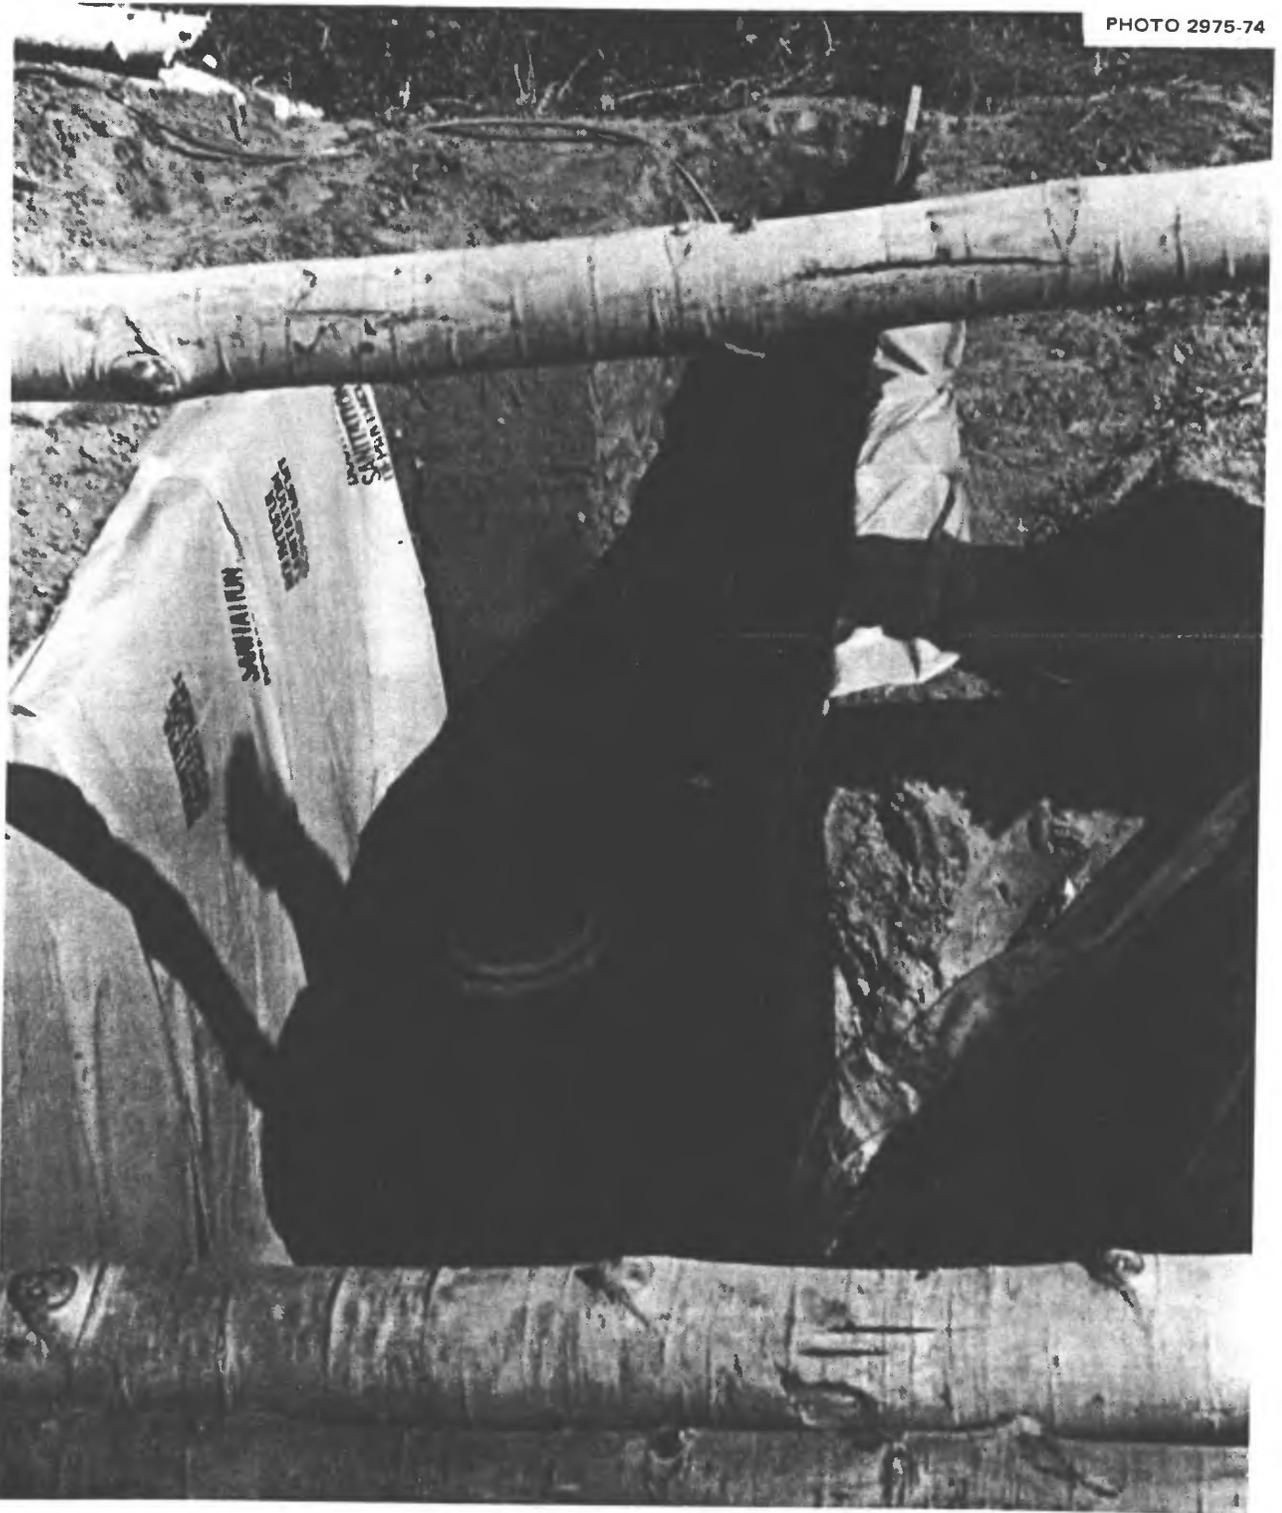
Fig. 4.6. Covering the main trench with 9-ft aspen logs. These logs were 4 to 6 in. in diameter at their small ends – thus being stronger than necessary to support the planned 3 ft of earth cover.

The uncovered narrow trench in the background is for the 22 × 24 × 60 in. ventilation duct-emergency exit. Note the plastic wall coverings, made of split-open garbage bags.
