ORNL-5039  
UC-41-Health and Safety

HEALTH PHYSICS DIVISION  
EMERGENCY TECHNOLOGY SECTION

EXPEDIENT SHELTER CONSTRUCTION AND  
OCCUPANCY EXPERIMENTS

Cresson H. Kearny

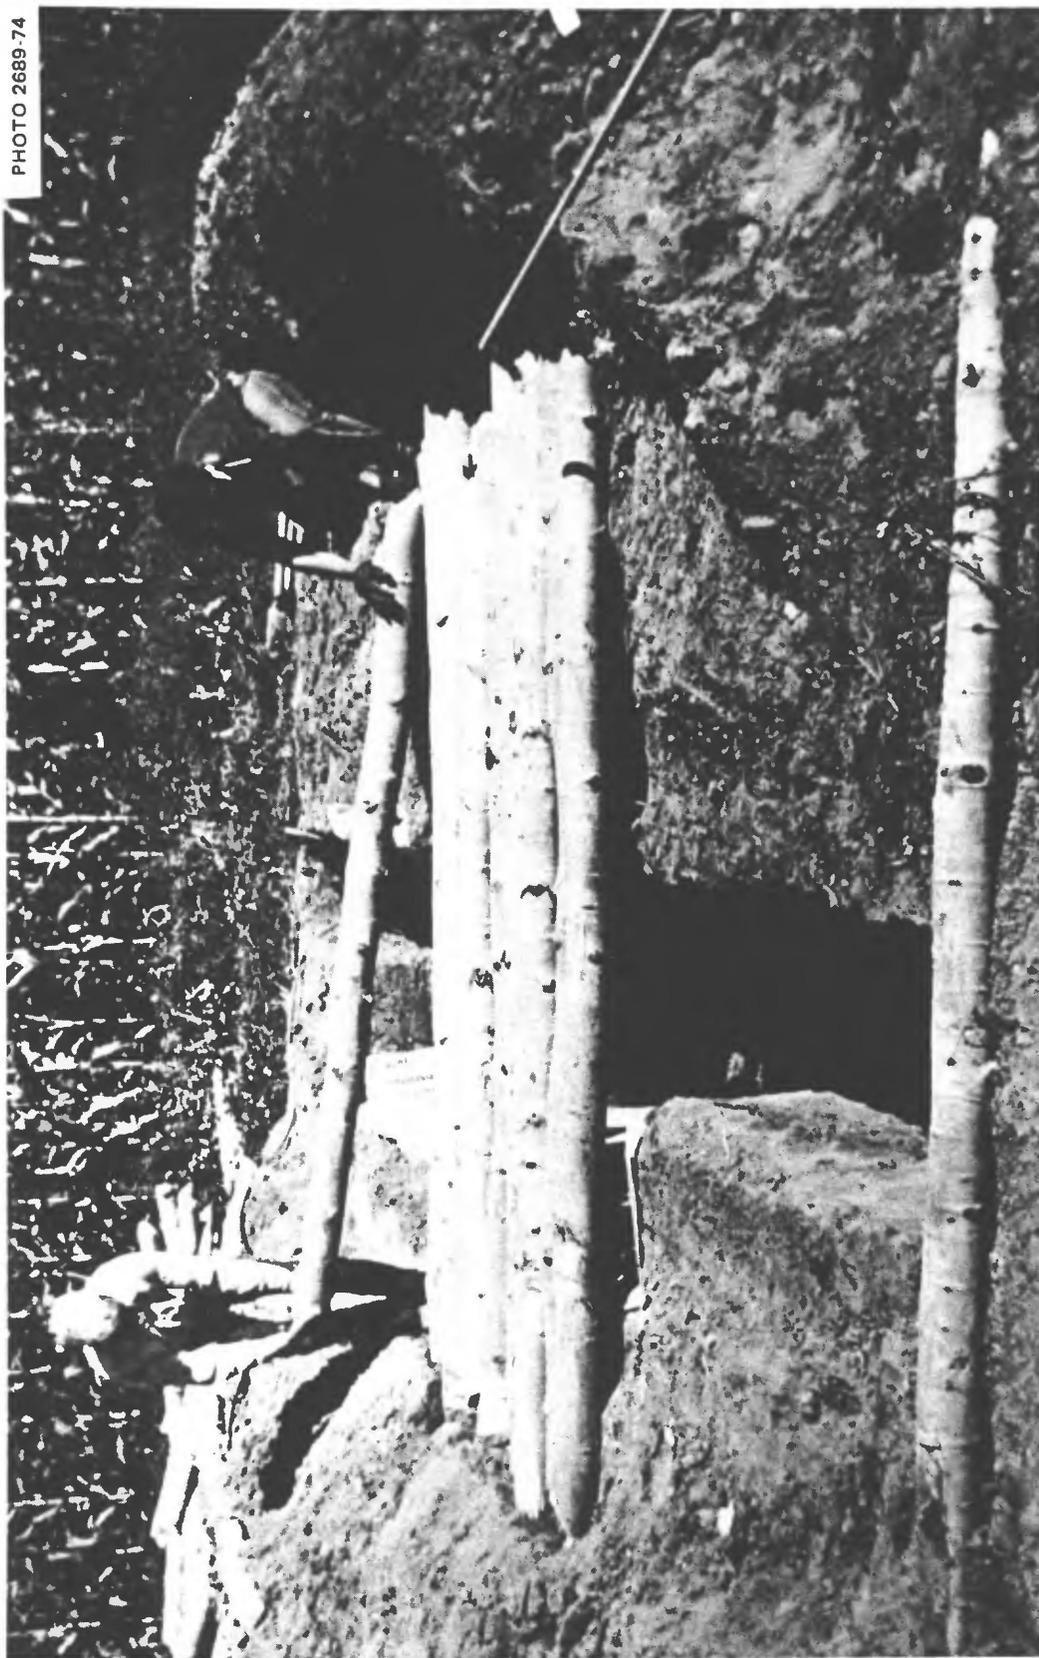
Fig. 4.7. Placing the 9-ft roof logs, all 2 ft off center, over the 3 1/2-ft-wide main trench. A shelter in firm earth such as this, with 9-ft roofing logs positioned 2 ft off center, would enable the builders to widen their shelter to a 5 1/2- or 6-ft width and to deepen it to standing height. If their home and community were destroyed, the family could live in such a rainproof dugout for months, if necessary, while minimizing their radiation doses and being more comfortable, in cold weather, than if living in a tent or shack.

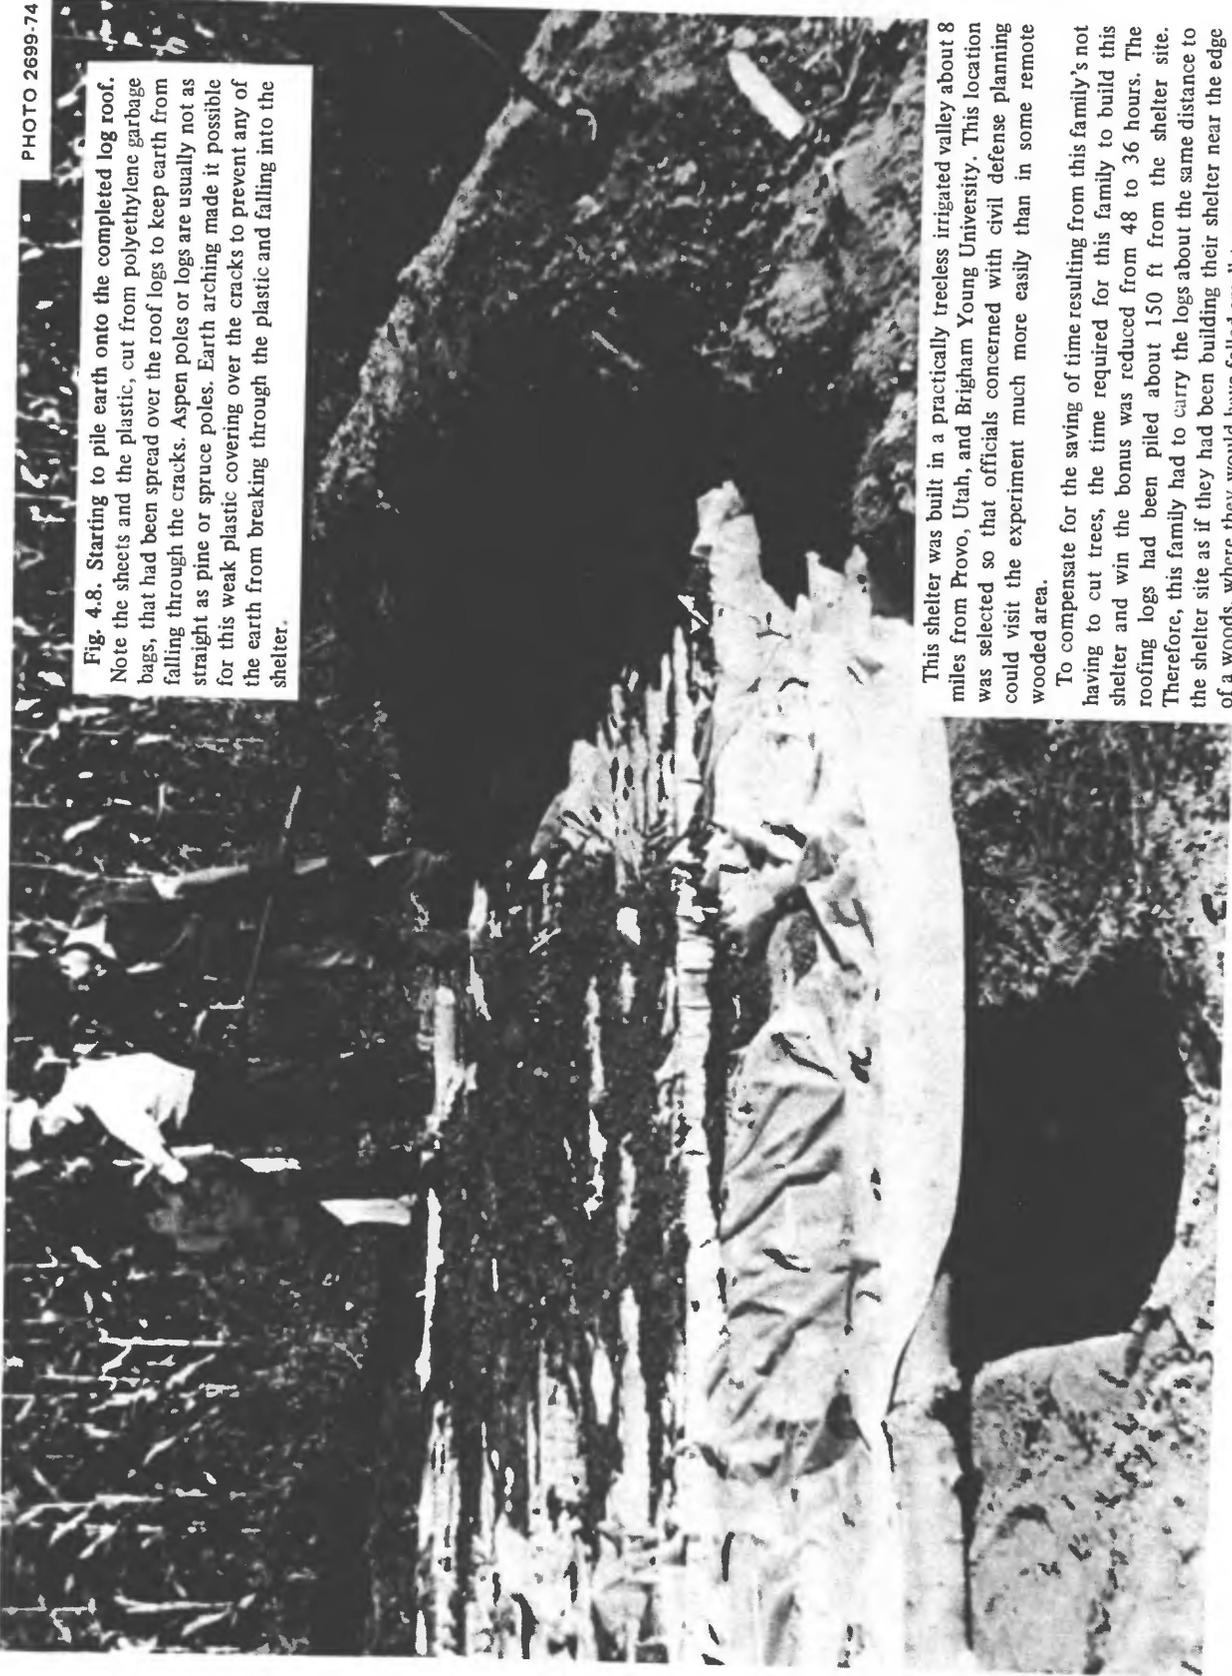
**Fig. 4.8. Starting to pile earth onto the completed log roof.** Note the sheets and the plastic, cut from polyethylene garbage bags, that had been spread over the roof logs to keep earth from falling through the cracks. Aspen poles or logs are usually not as straight as pine or spruce poles. Earth arching made it possible for this weak plastic covering over the cracks to prevent any of the earth from breaking through the plastic and falling into the shelter.

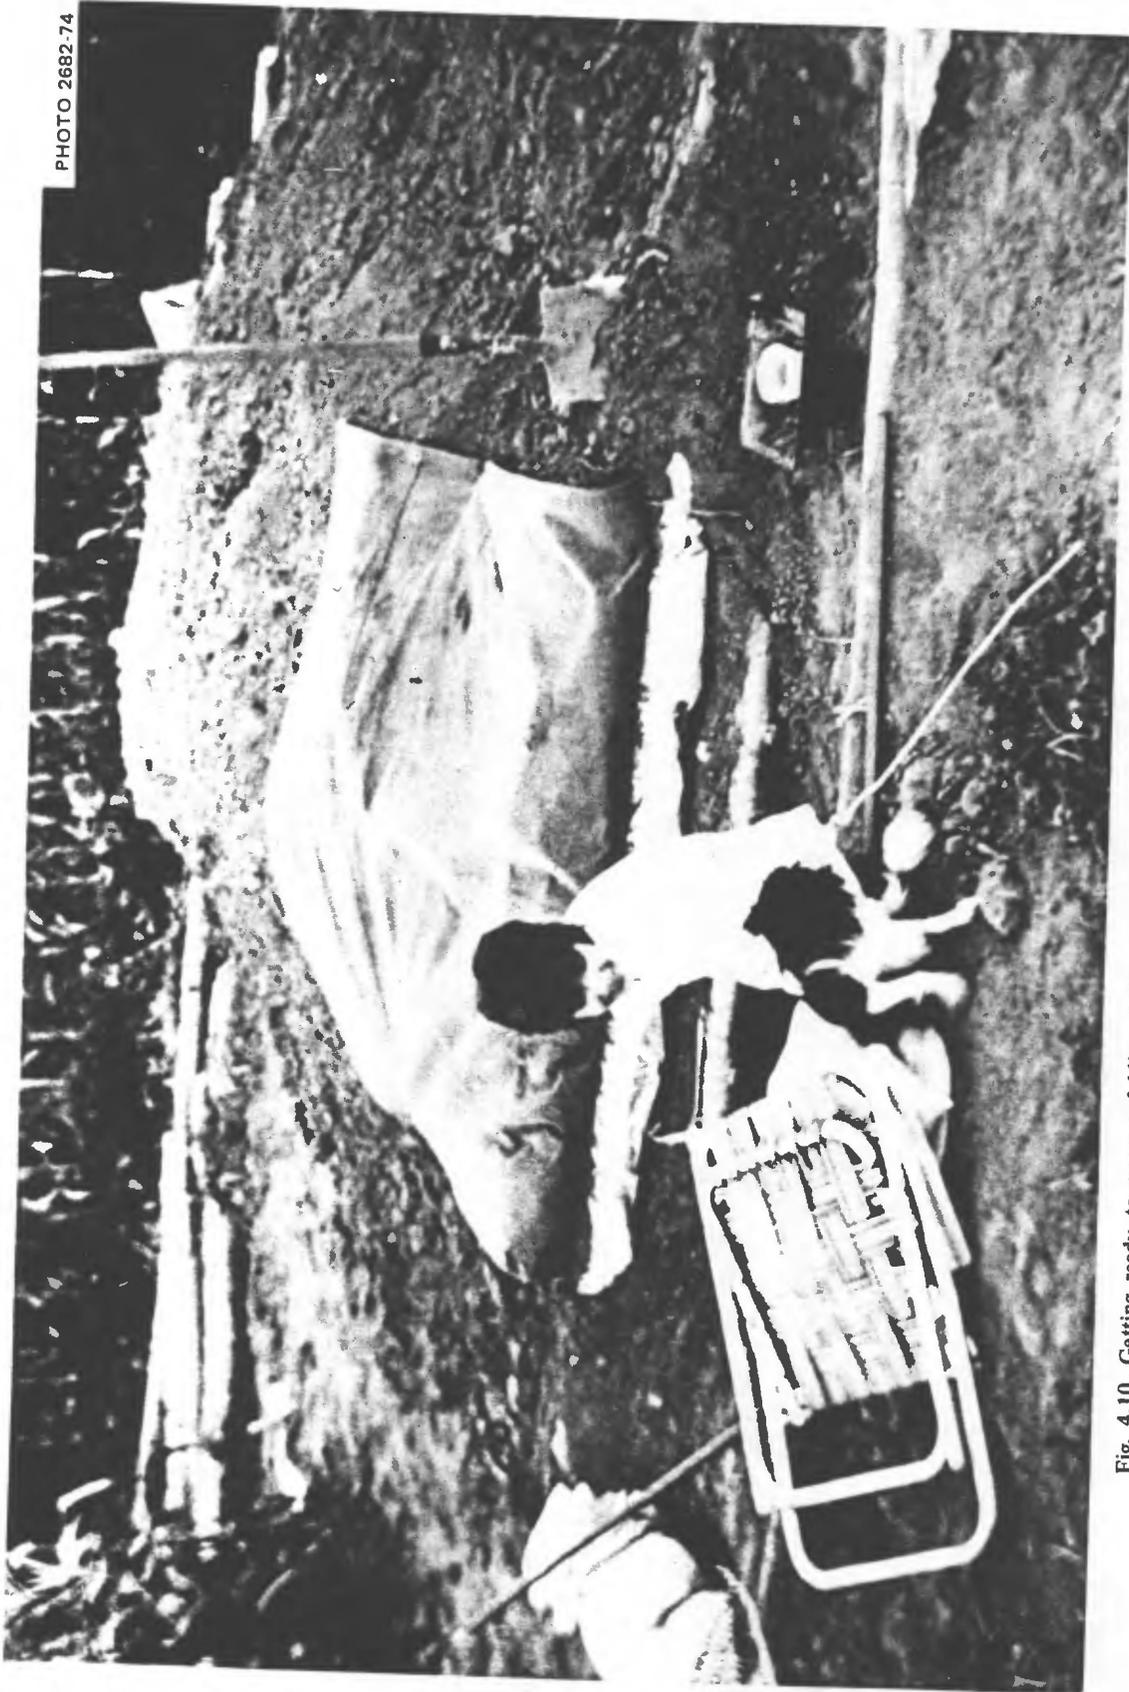
Fig. 4.10. Getting ready to carry a folding chair and the family dog into the shelter. The worst problem that this family anticipated, while living for at least 72 hours in this small expedient shelter, was the possibility of the 4-year-old son becoming so nervous or harassed that he would want out. Therefore, they brought along his dog and some of his smaller toys. Note the canvas tarp, with one of its edges secured to the outermost roof log, ready to be erected as a canopy over the 22 x 24 in. entry hole.

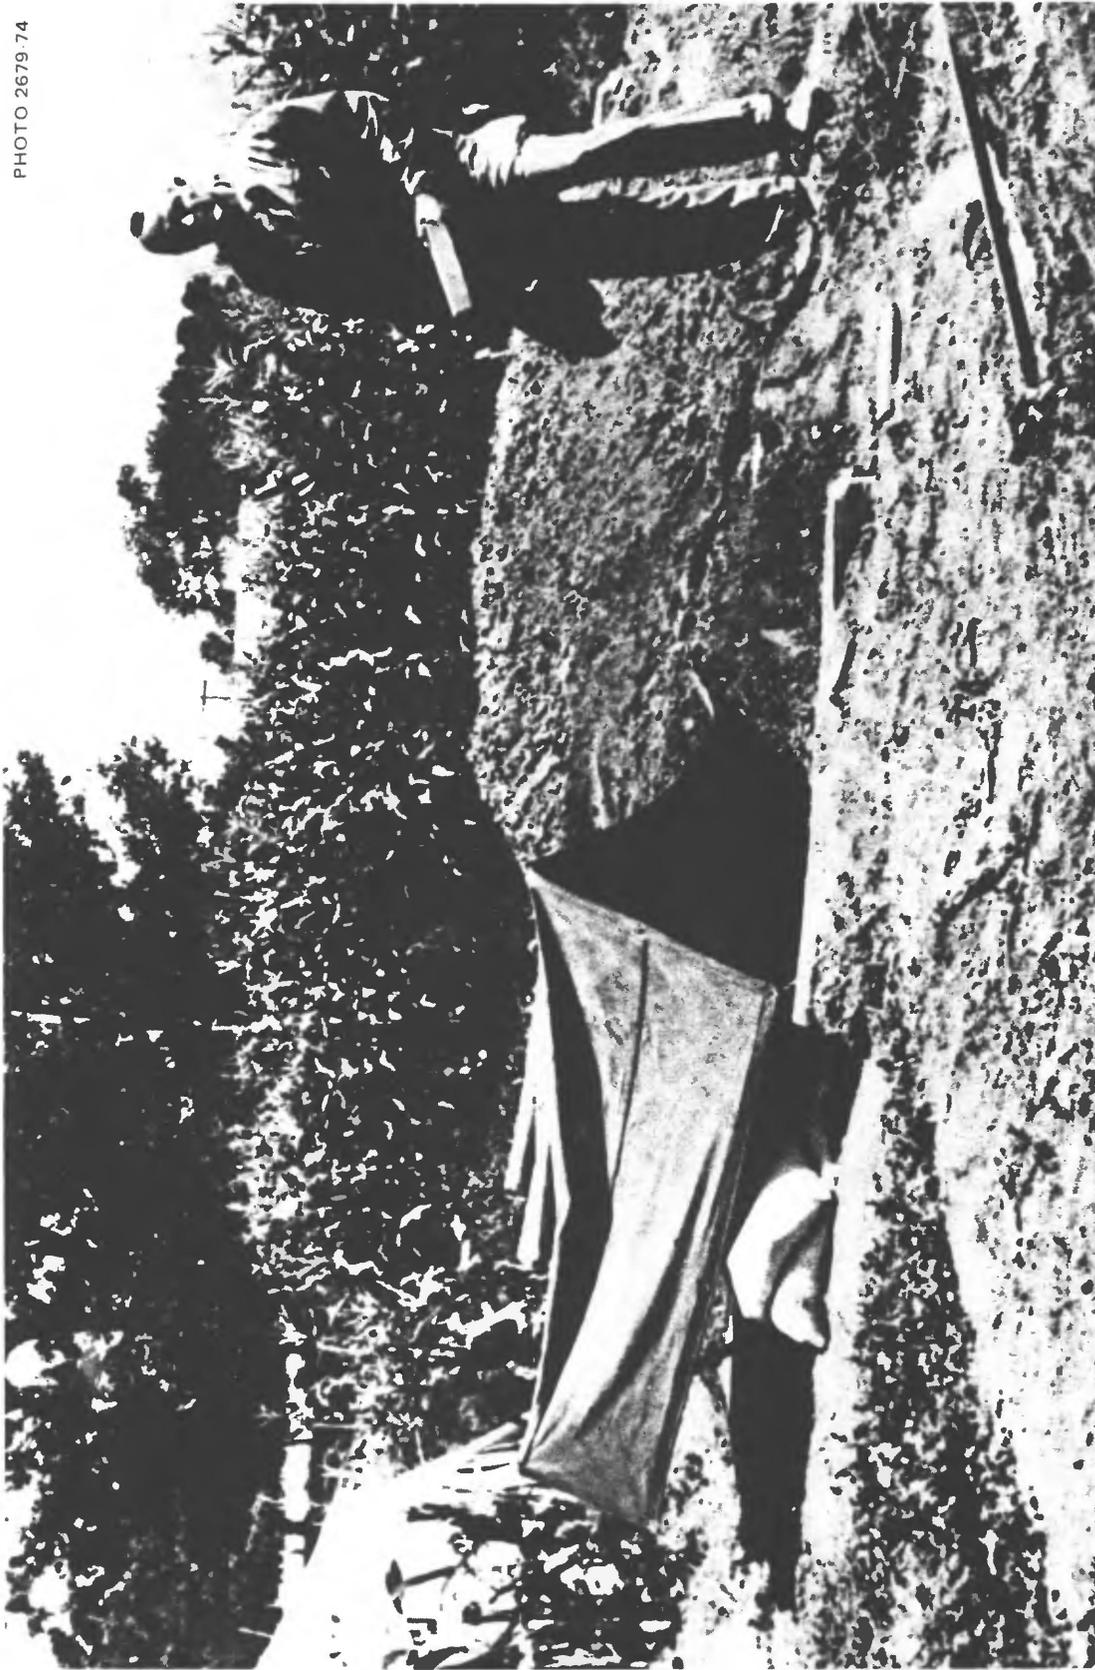
Fig. 4.11. Outside the completed shelter, with the family of six - and their dog - inside. Thirty-two and one-half hours elapsed from the time this family received an Evacuation Check List and the shelter-building instructions at their home in Bountiful, to the hour they completed their shelter near Spanish Fork and began the continuous occupancy test.

The small plastic canopy over the air-duct-emergency exit at the rear of the shelter is obscured by the mounded earth and the standing man. Window screens, one over each opening, kept out mosquitoes, numerous in this irrigated area.

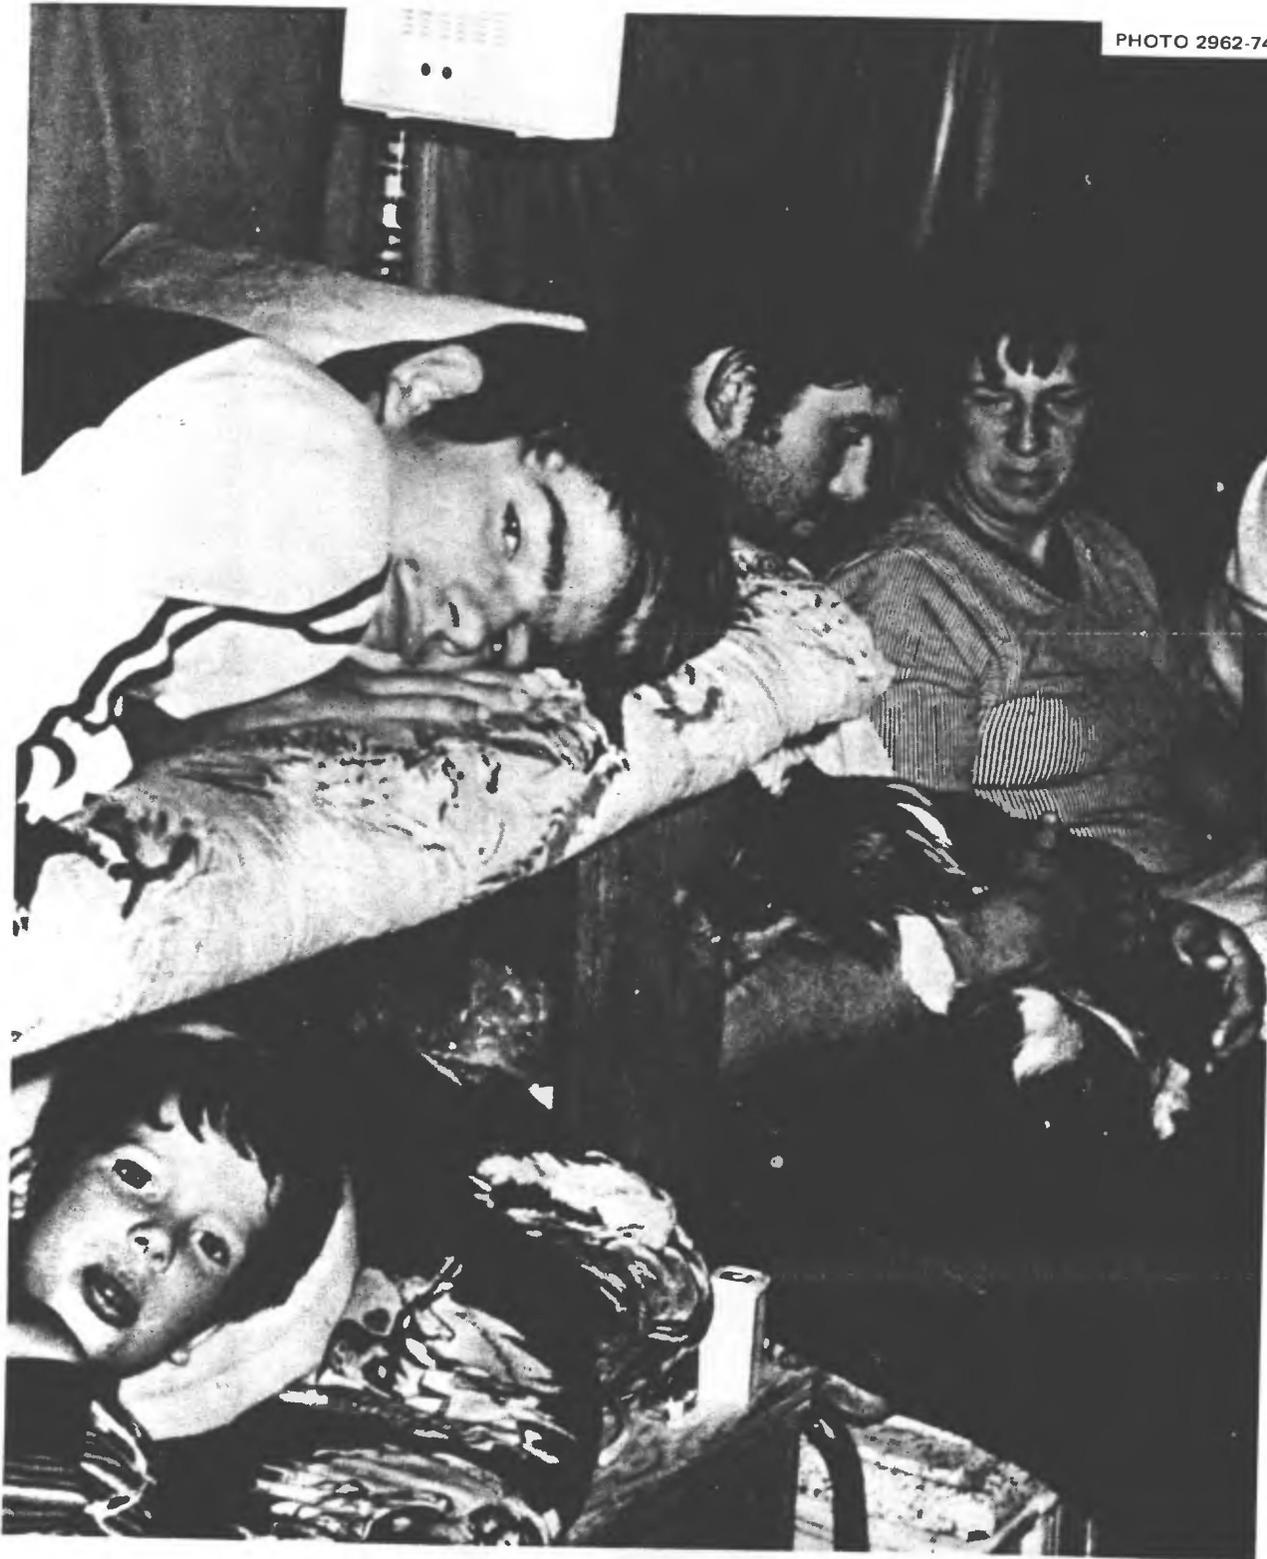
Fig. 4.12. Inside the completed shelter, showing the double-deck bunk, 21 in. wide and 6 ft long, in the 42-in.-wide shelter room. Most of the time two of the six shelter occupants slept or rested on the two bunks, while the remaining four sat in the four chairs along one wall. The walls were covered with 1-mil polyethylene sheets cut from garbage bags. This plastic was also placed under the shag rug on the floor, to keep the damp earth from dampening the rug.

Note the suspended transistor radio. Reception is good in all types of expedient shelters tested to date.

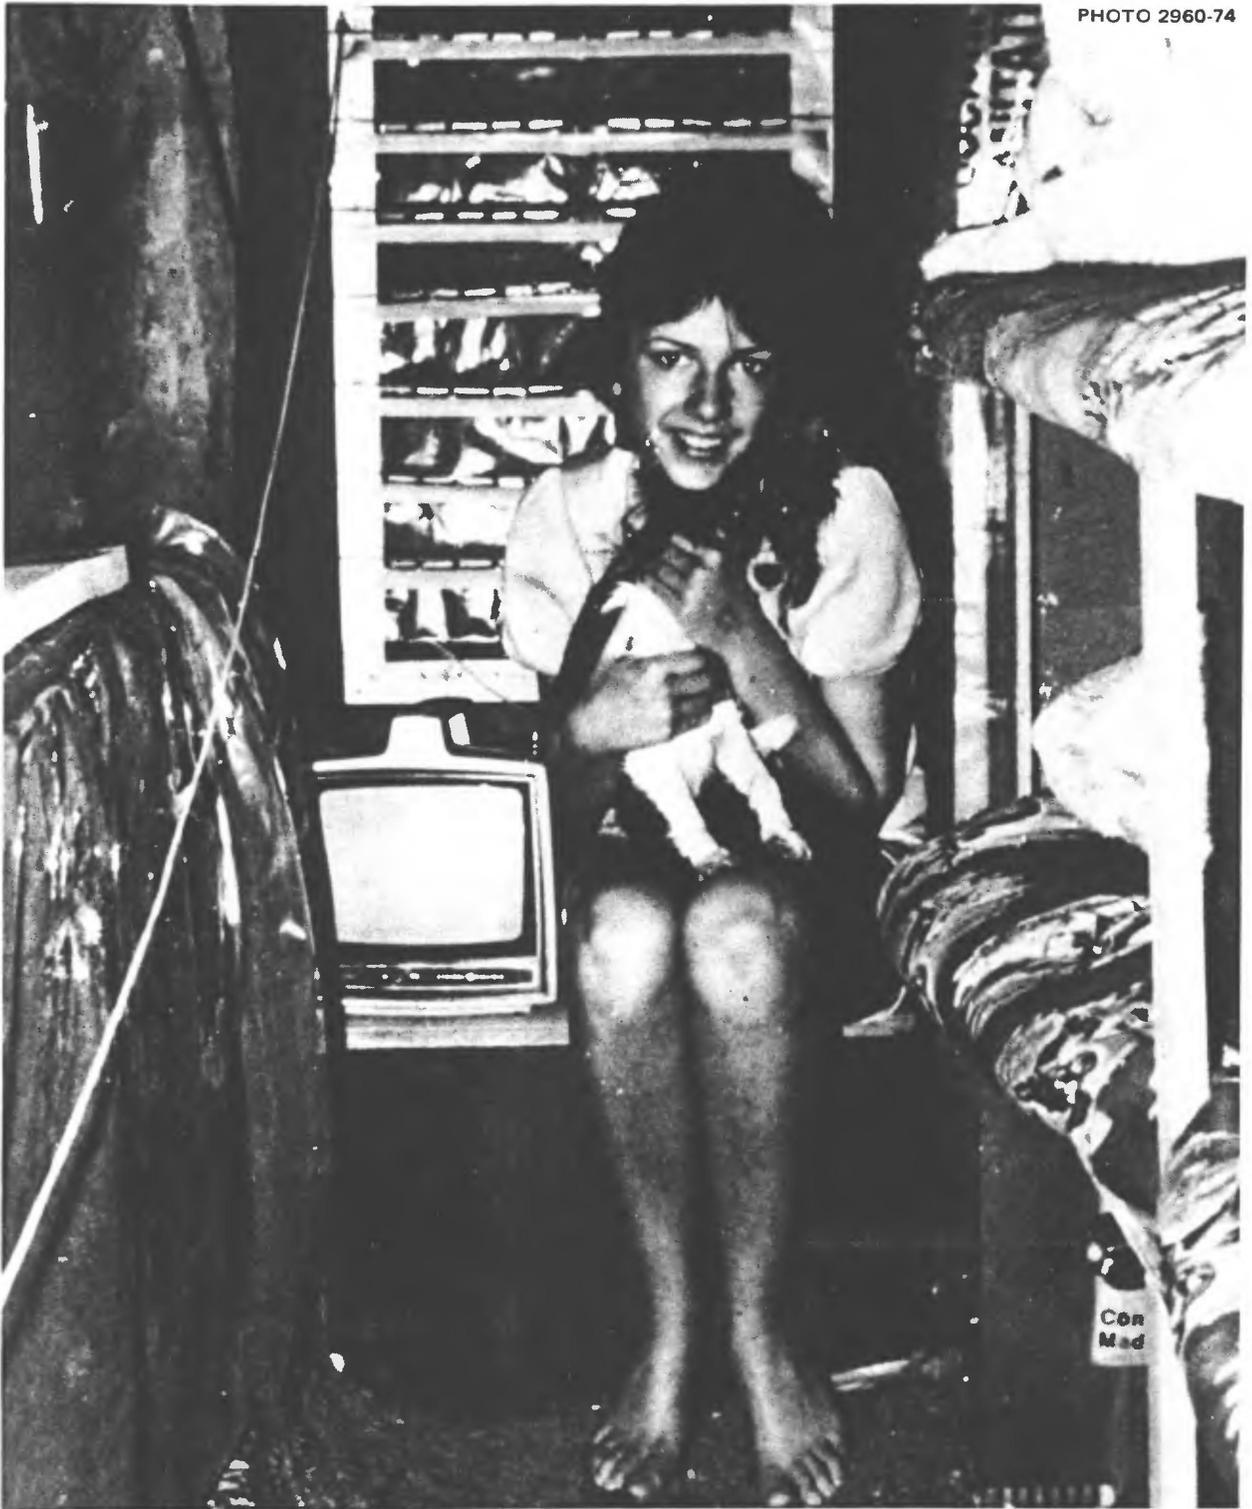
PHOTO 2959-74

Fig. 4.13. The *essential* shelter-ventilating pump, a homemade KAP 20 in. wide  $\times$  36 in. high. This KAP, which swung on two cabinet hinges, was operated by pulling on its pull cord. The pull cord was attached to the left side of the KAP frame, about 9 in. below its hinges. The pull cord was connected to the opposite end of the shelter, to enable anyone in the shelter to pump fresh air through the shelter without moving to another location.

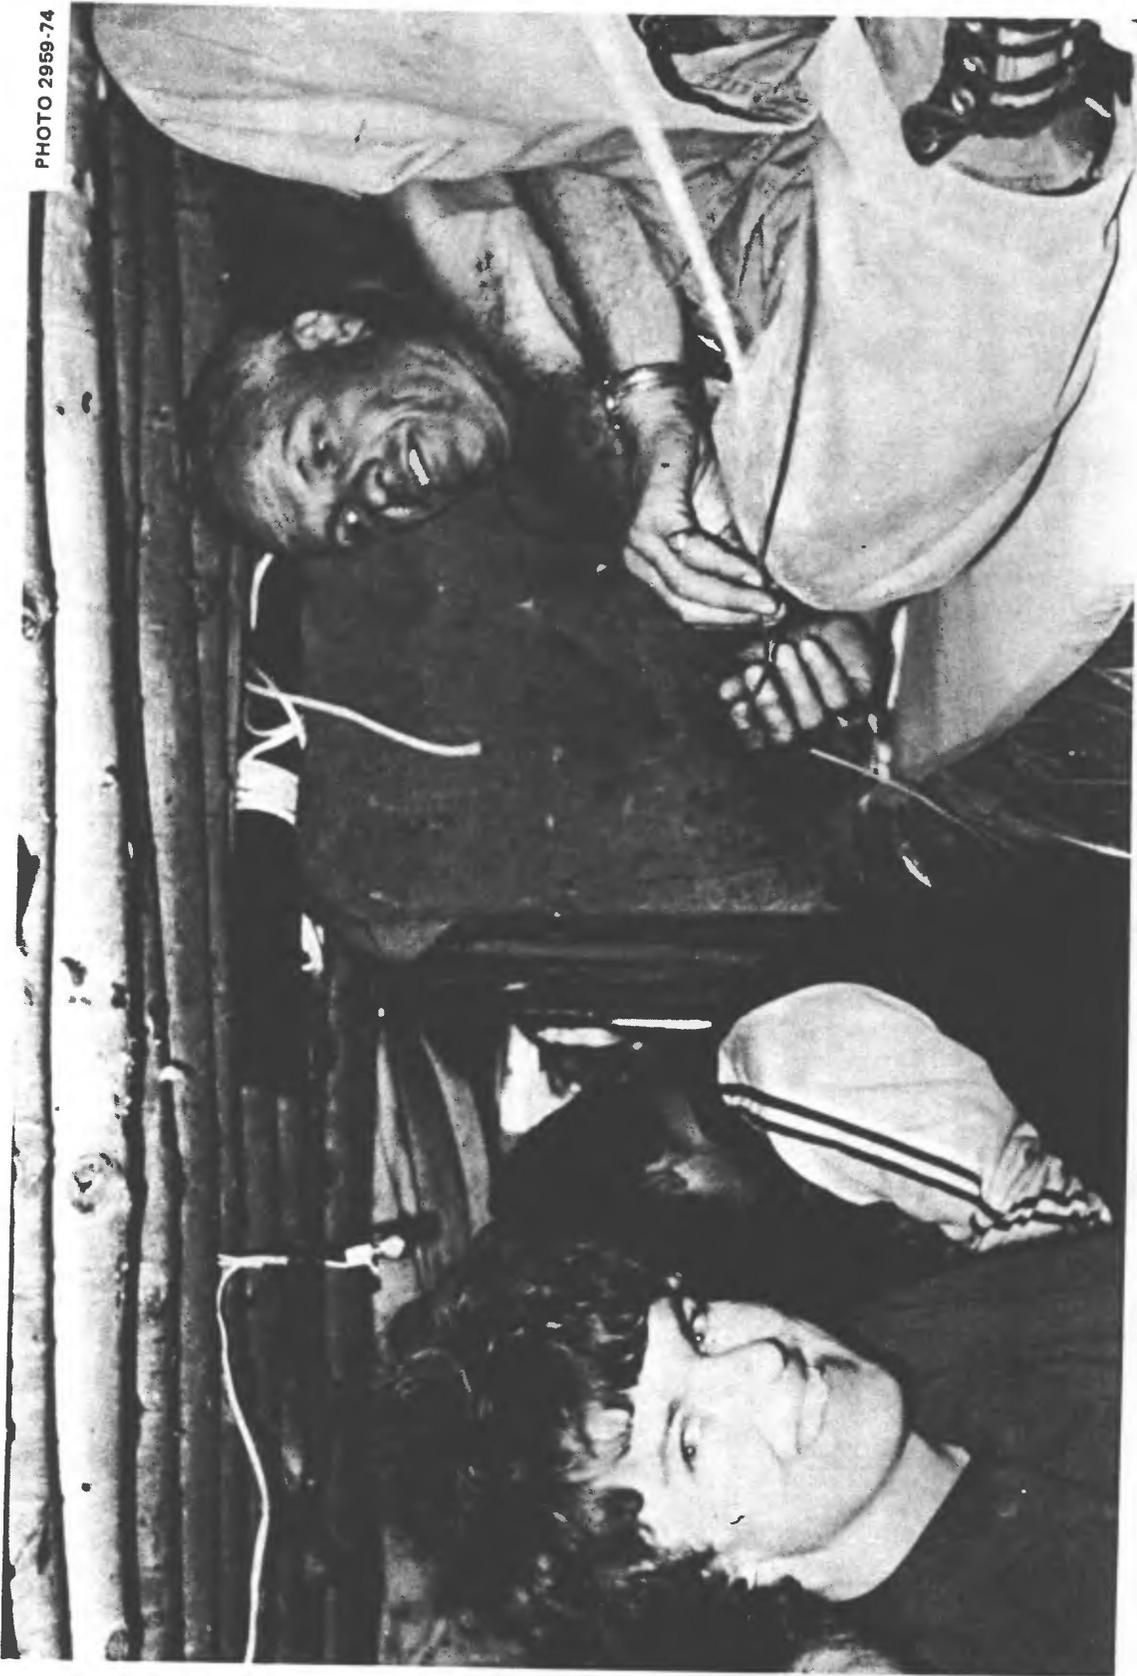
**Fig. 4.14.** Kearny, on his sleeping ledge, pulling the pull cord of the homemade KAP, to demonstrate to Dian Thomas, in the foreground, how a KAP forces an abundant flow of air through a crowded shelter.  
Only a few visitors, persons actively concerned with survival problems, were permitted to go inside the shelter, and only for brief periods. Dian Thomas works for the Mormon Church and teaches food storage, emergency cooking, etc., in many states.

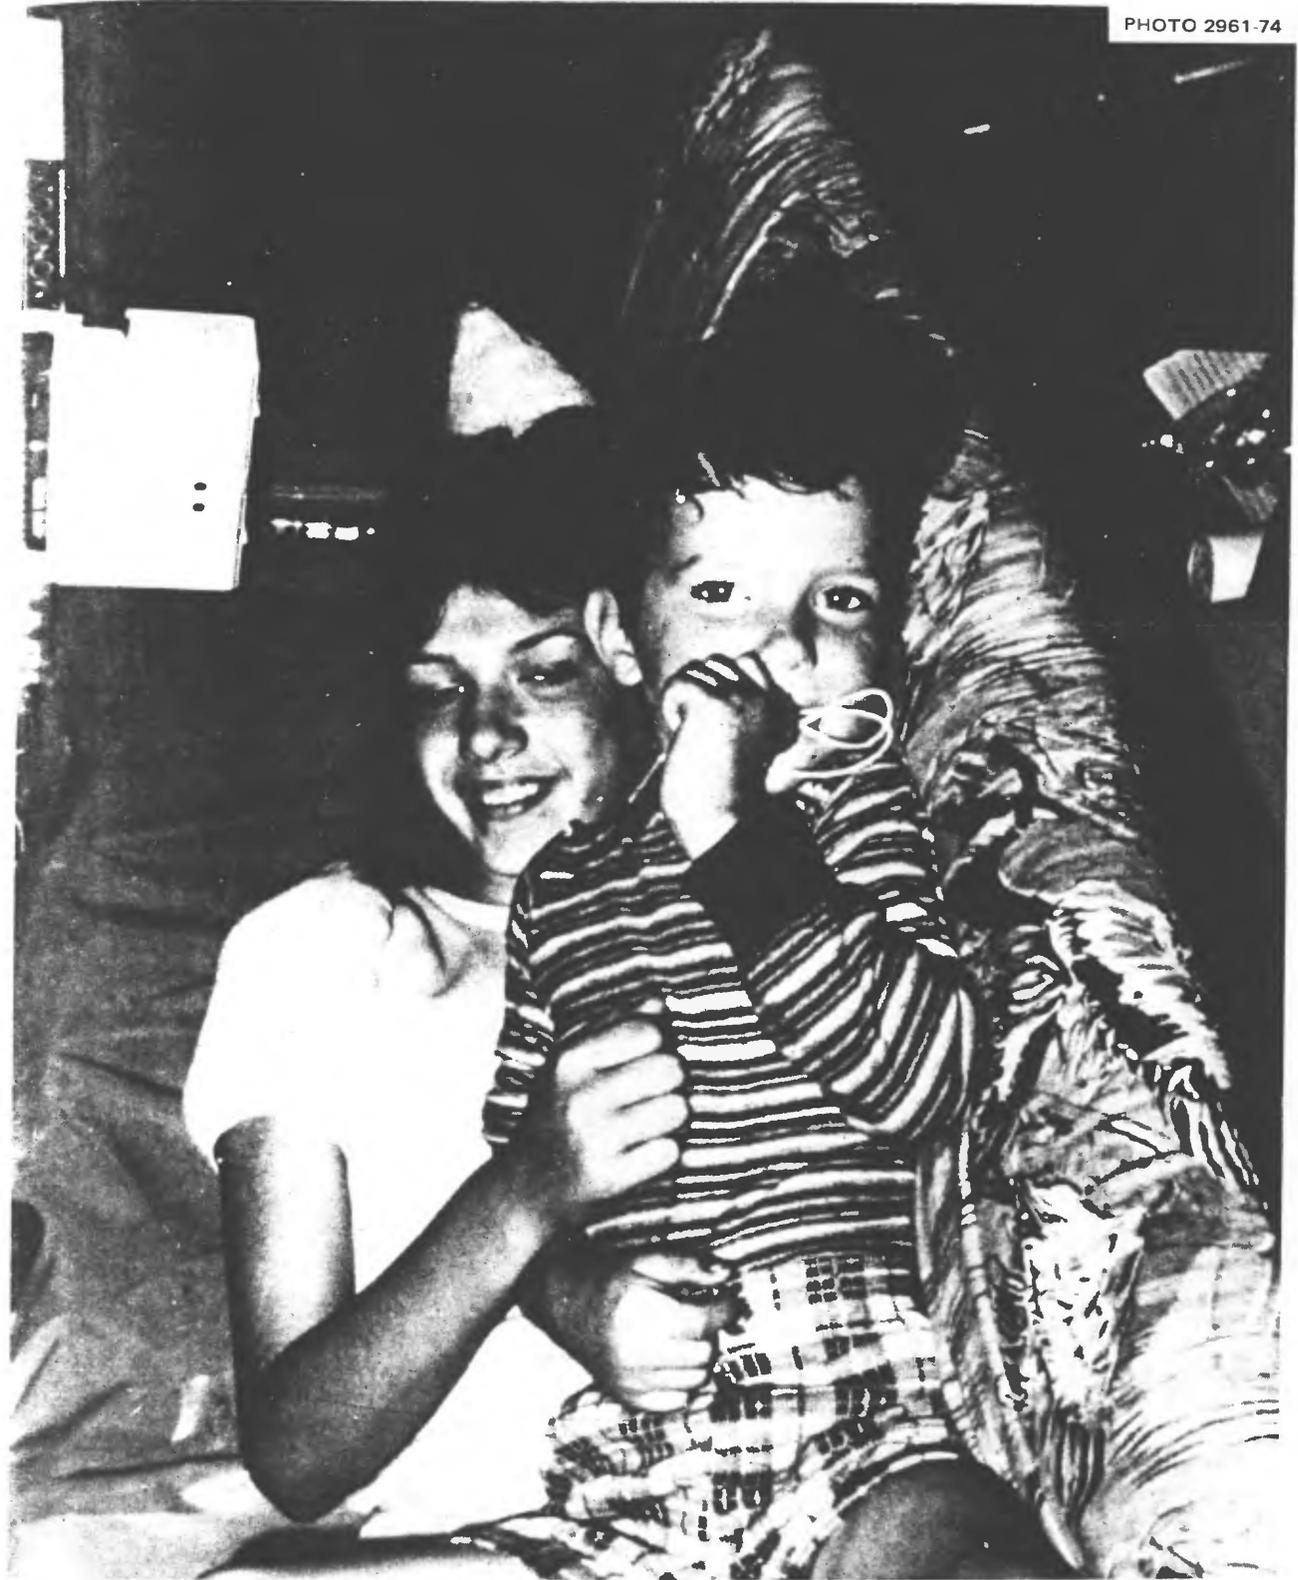
Fig. 4.15. The shared-bunk sleeping system proved to be a hardship in this small shelter. Even the two smallest children could not sleep together on a 21-in.-wide bunk. And when a 4-year-old boy is awake and very close to a person who is trying to sleep, going to sleep is difficult, especially in the daytime.

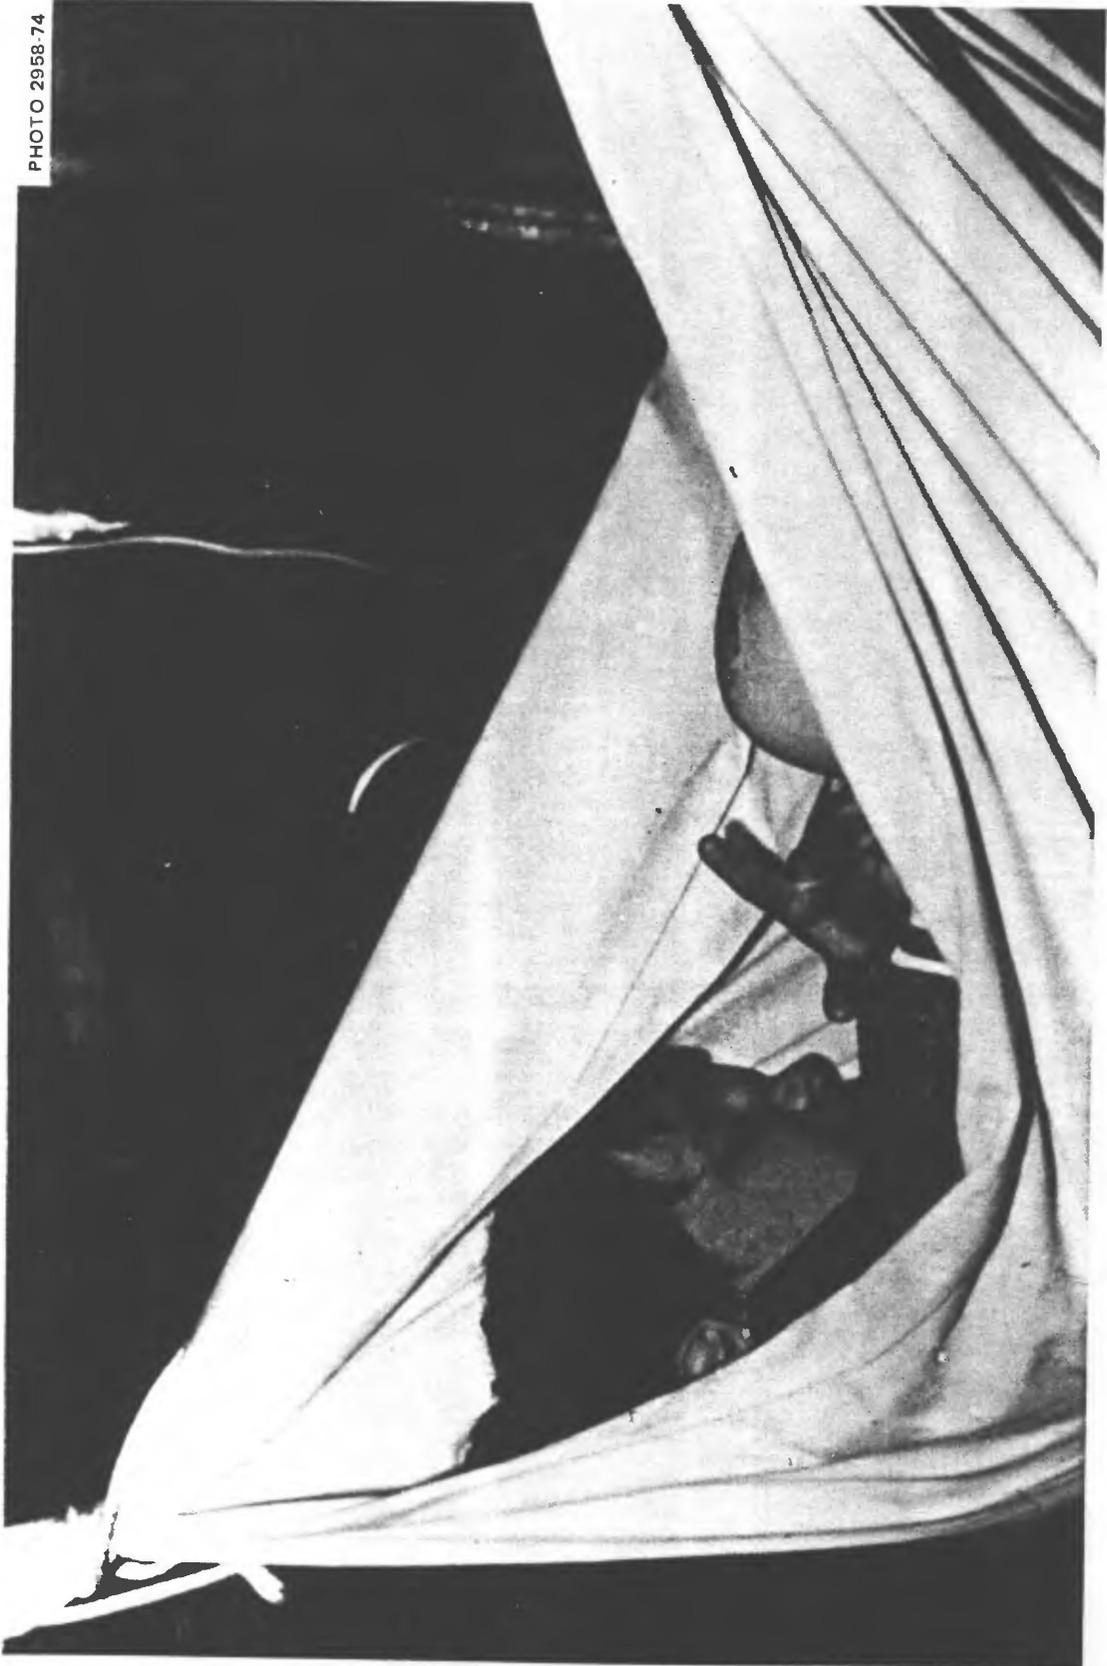
PHOTO 2958-74

**Fig. 4.16. Comfortably asleep on the fourth night, in an expedient Bedsheet-Hammock. At 1:30 AM on the fourth night (the hour at which this family won their bonus for occupying their shelter for 72 hours during which no person could emerge) this family had planned to leave the shelter, give three cheers, and sleep the rest of the night outside in their tent.**

However, before the fourth night Kearny had shown them how to improvise boatlike, comfortable Bedsheet-Hammocks and how to suspend them from the roof logs. So on the fourth night all six were sleeping so comfortably (three in hammocks, two in the double-deck bunk, and one on the rug-covered floor) that they did not awake at 1:30 AM and elert soundly until sunrise.

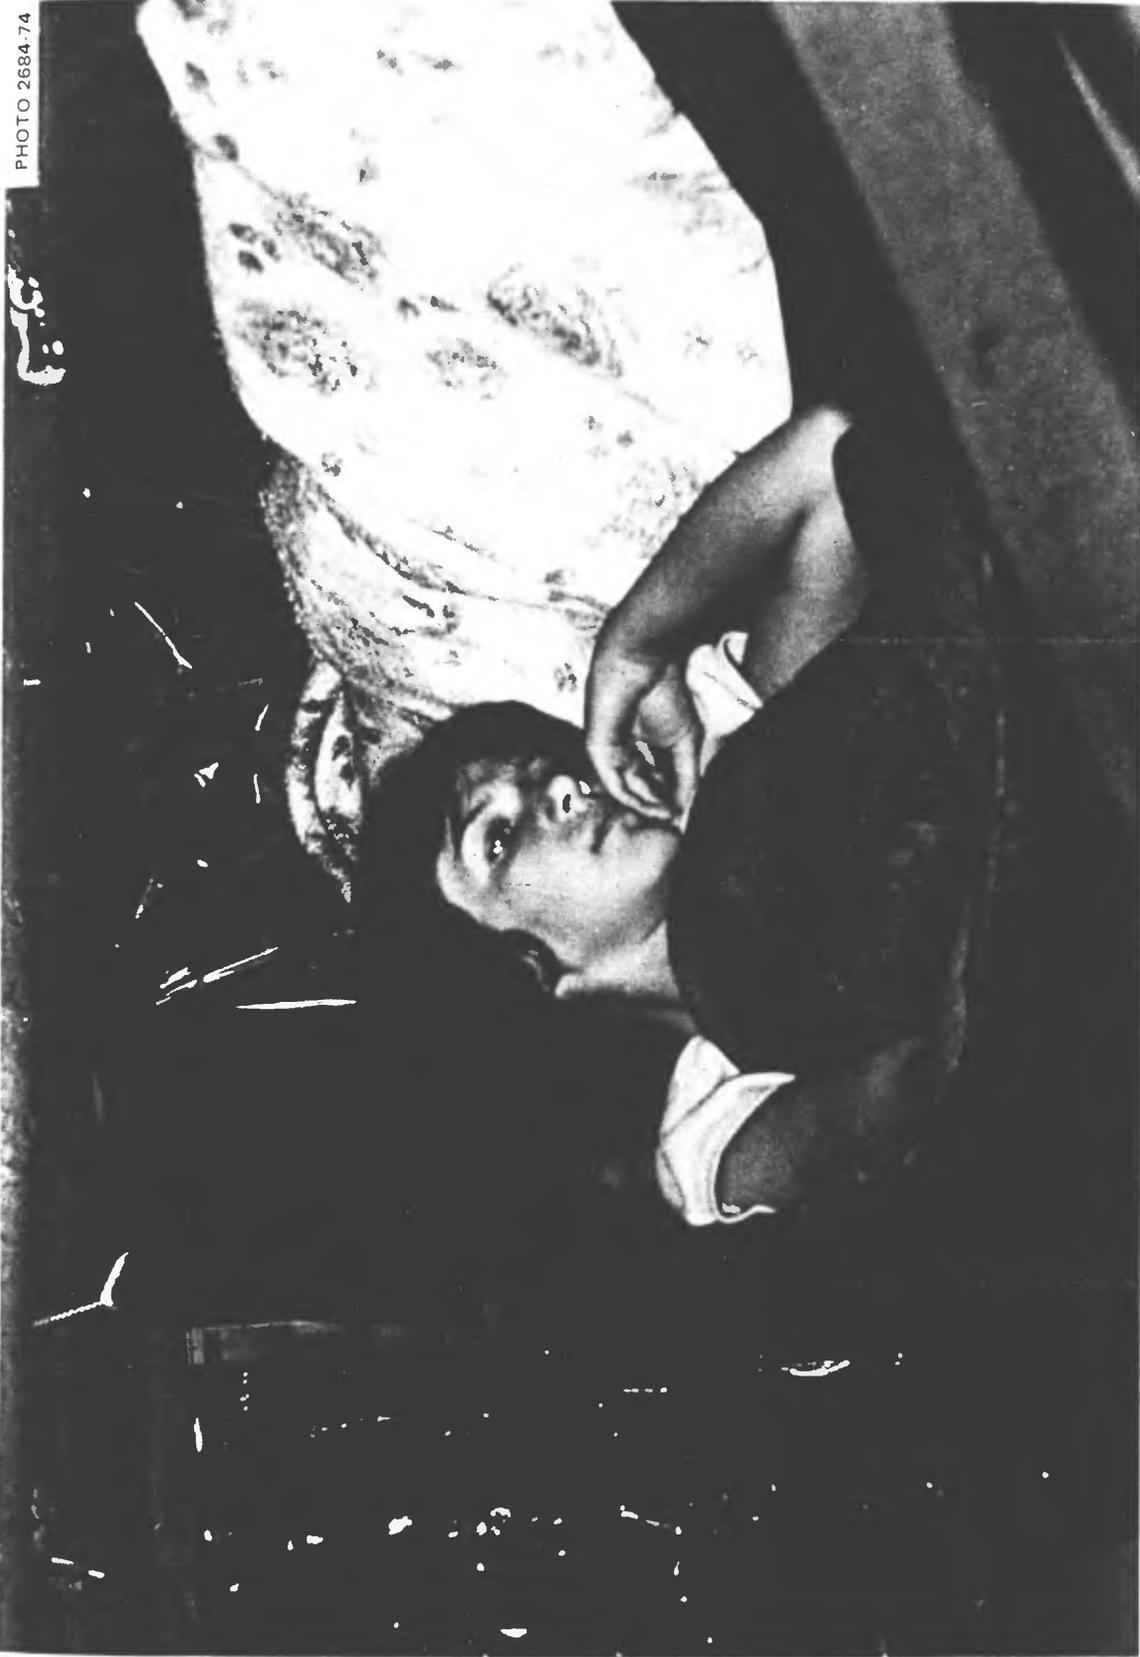
PHOTO 2684-74

**Fig. 4.17.** Sleeping under a flowered blanket on a bunk, and resting in a hammock during the chill of a desert night. In the early morning hours, outside temperatures as low as  $45^{\circ}\text{F}$  were recorded, with effective temperatures as low as  $ET\ 66.5^{\circ}\text{F}$  inside. The occupants wished they had brought more blankets, since they used their sleeping bags for mattresses.

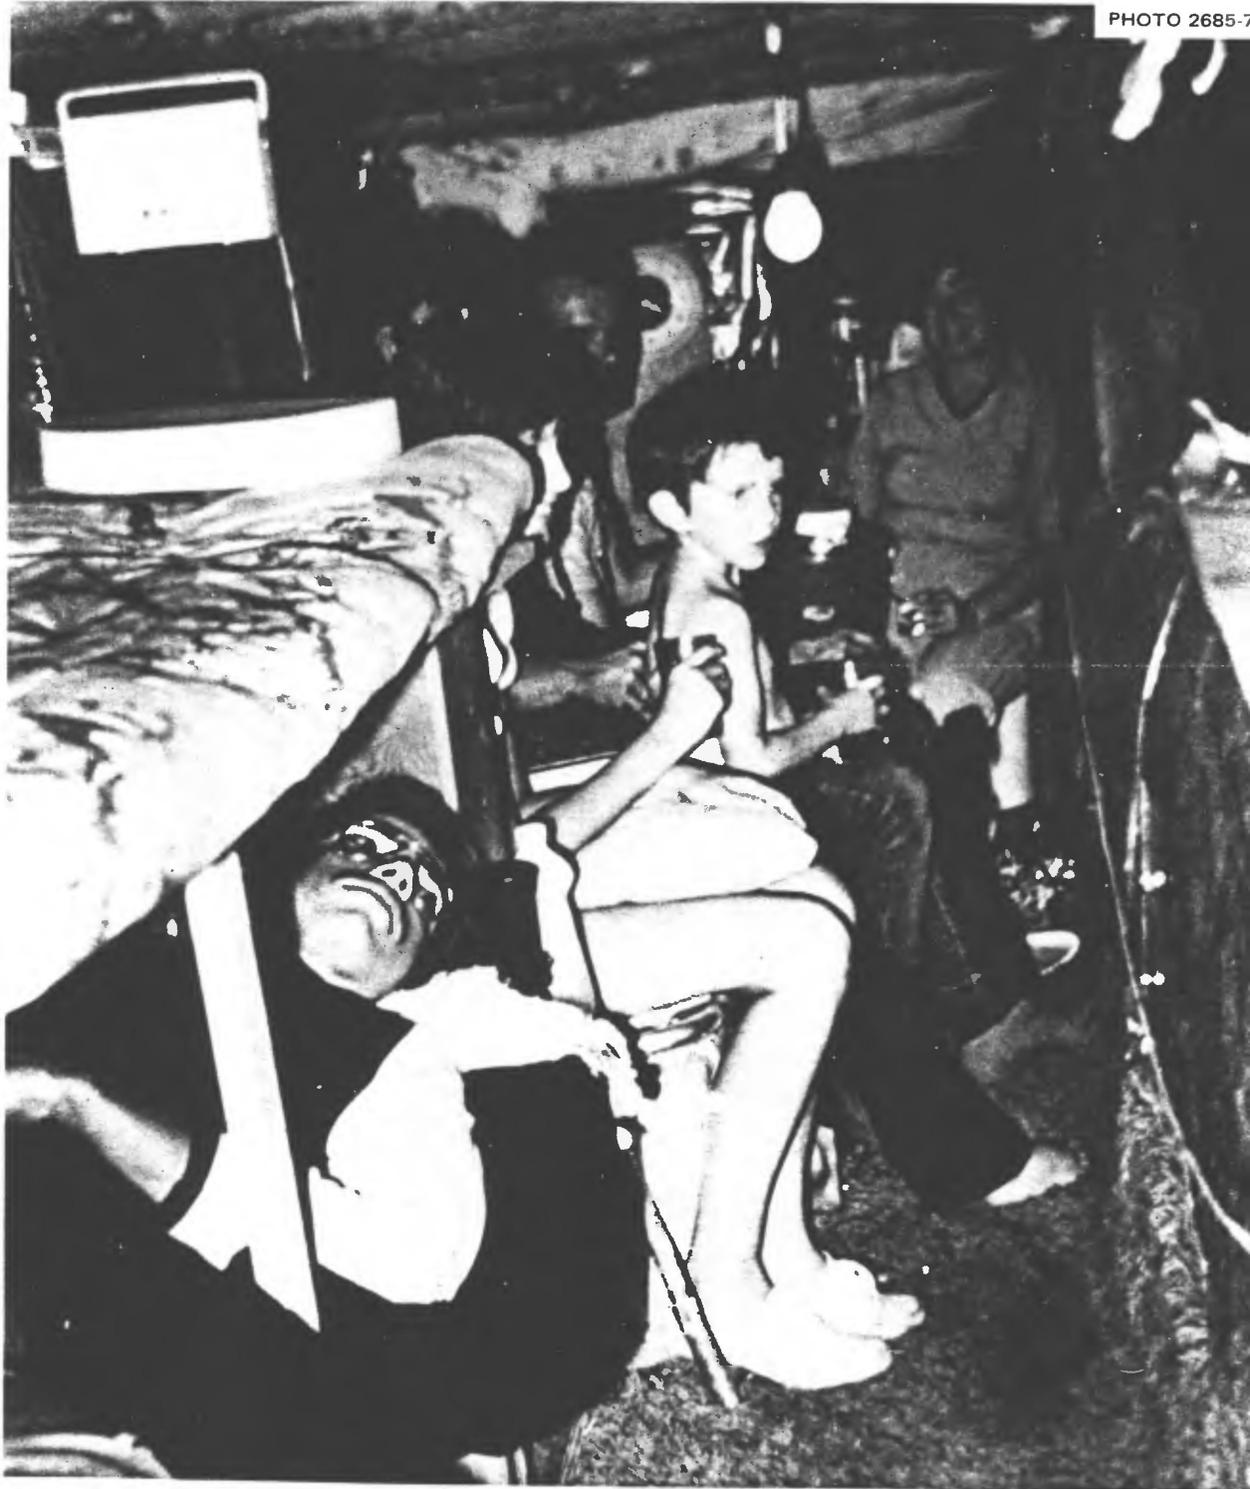
Fig. 4.18. Enjoying the occasional luxury of bright shelter illumination from a 25-watt bulb. A homemade manual generator and an extra car battery supplied electricity. The battery could have been recharged efficiently with this generator, if it had not had some faulty cells. Furthermore, both the original small 12-volt bulb and a spare bulb of this family's standard auto trouble light (operated off a 12-volt car battery) blew out while being used to provide light. Work progressed on most of two nights, before the shelter was completed at 1:30 AM on the second night. As a result, when the shelter-occupancy test started, this family was already using their spare flashlight batteries, and these batteries no longer gave a bright light.
