ORNL-5039  
UC-41-Health and Safety

HEALTH PHYSICS DIVISION  
EMERGENCY TECHNOLOGY SECTION

EXPEDIENT SHELTER CONSTRUCTION AND  
OCCUPANCY EXPERIMENTS

Cresson H. Kearny

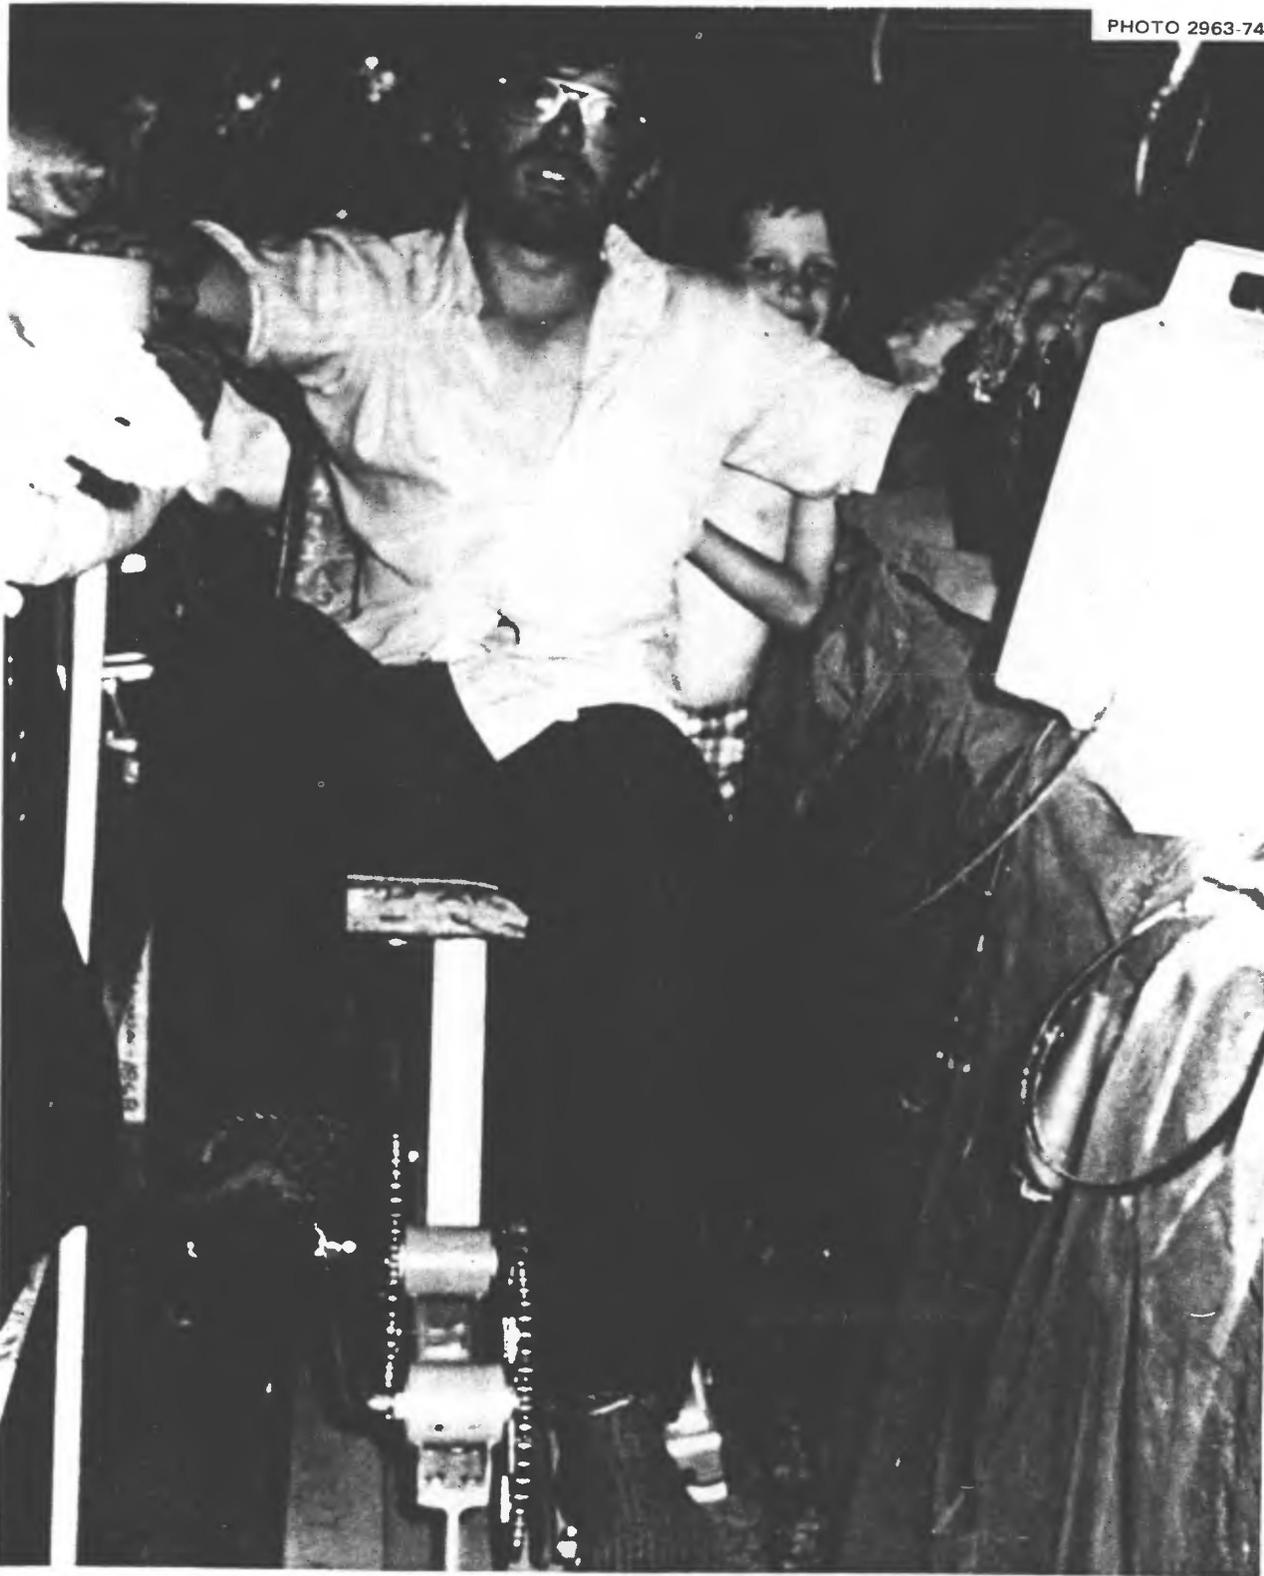
Fig. 4.20. The 18-year-old son getting good exercise by peddling his father's homemade generator to operate their portable TV set. Several years ago the father made this manually powered generator, which uses the sprockets and chains of two bicycles, mounted on a steel frame, to rotate the alternator from a car. The alternator is mounted on a bracket. Only a few minutes were required to remove the alternator and attach it securely to the bracket.

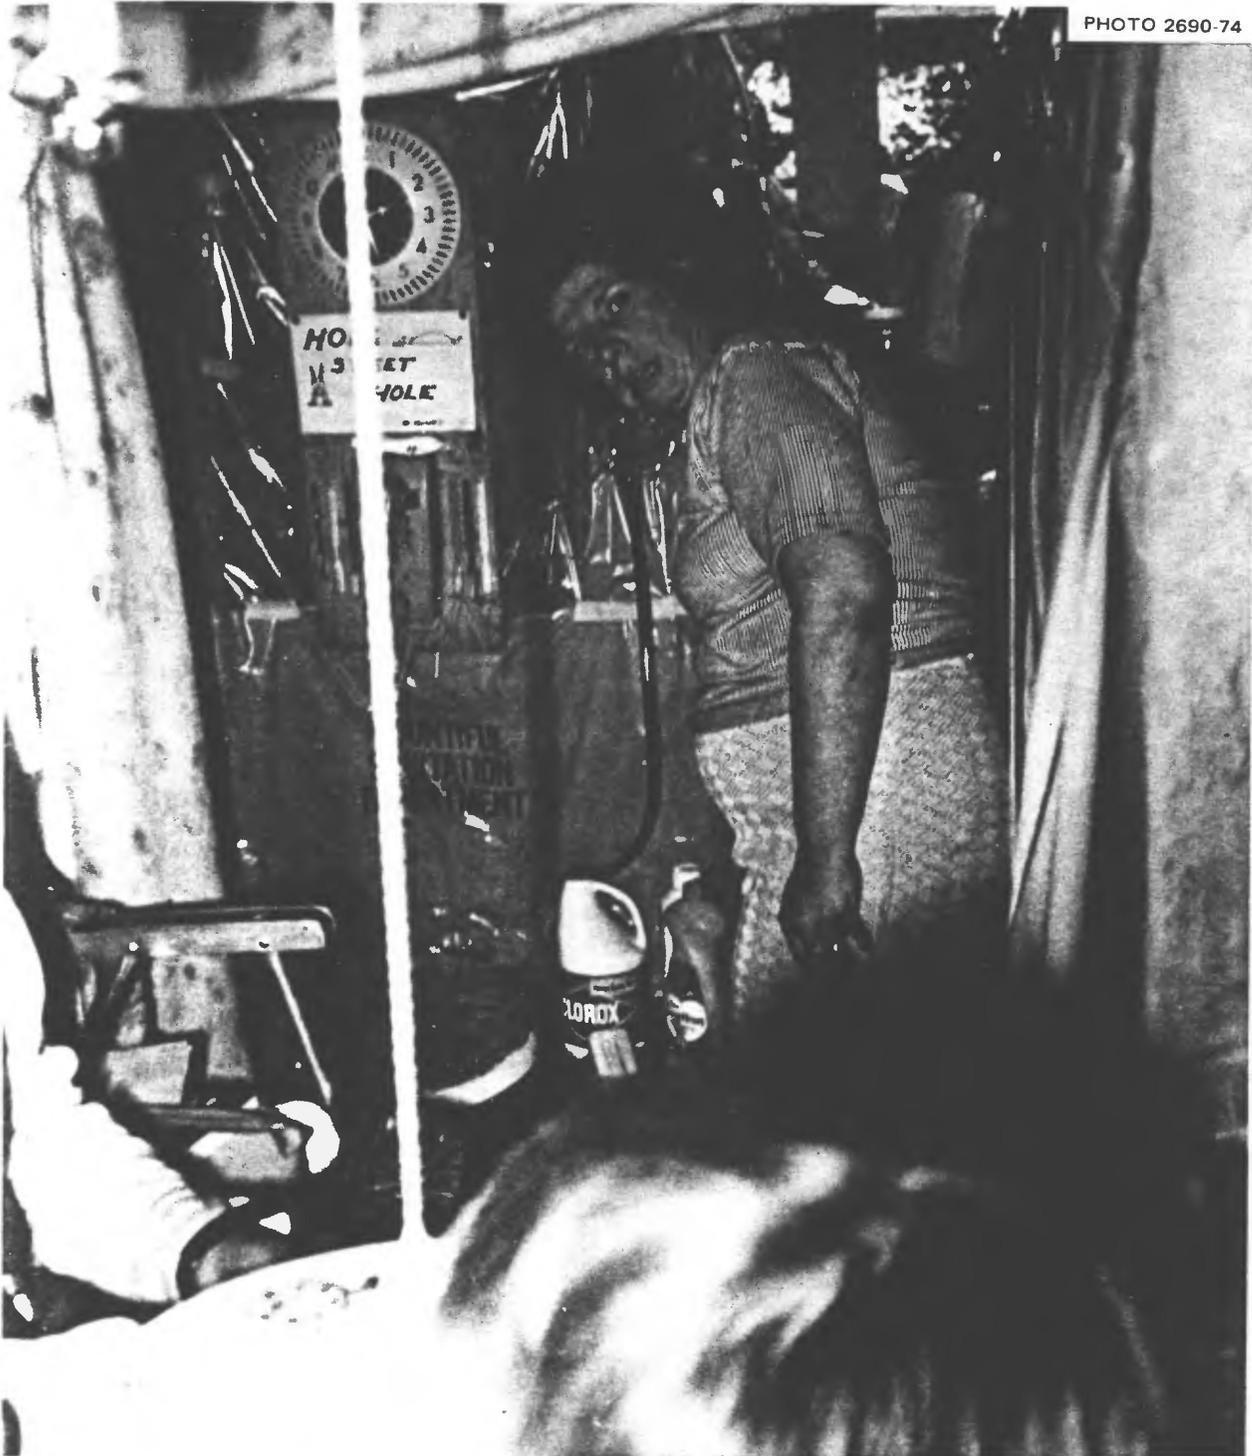
Fig. 4.23. The mother standing in the 18-in.-deep stand-up hole next to the toilet. Note the air-duct-emergency exit, shown above the mother's shoulders, with a piece of toilet paper hanging from its roof to indicate air movement.

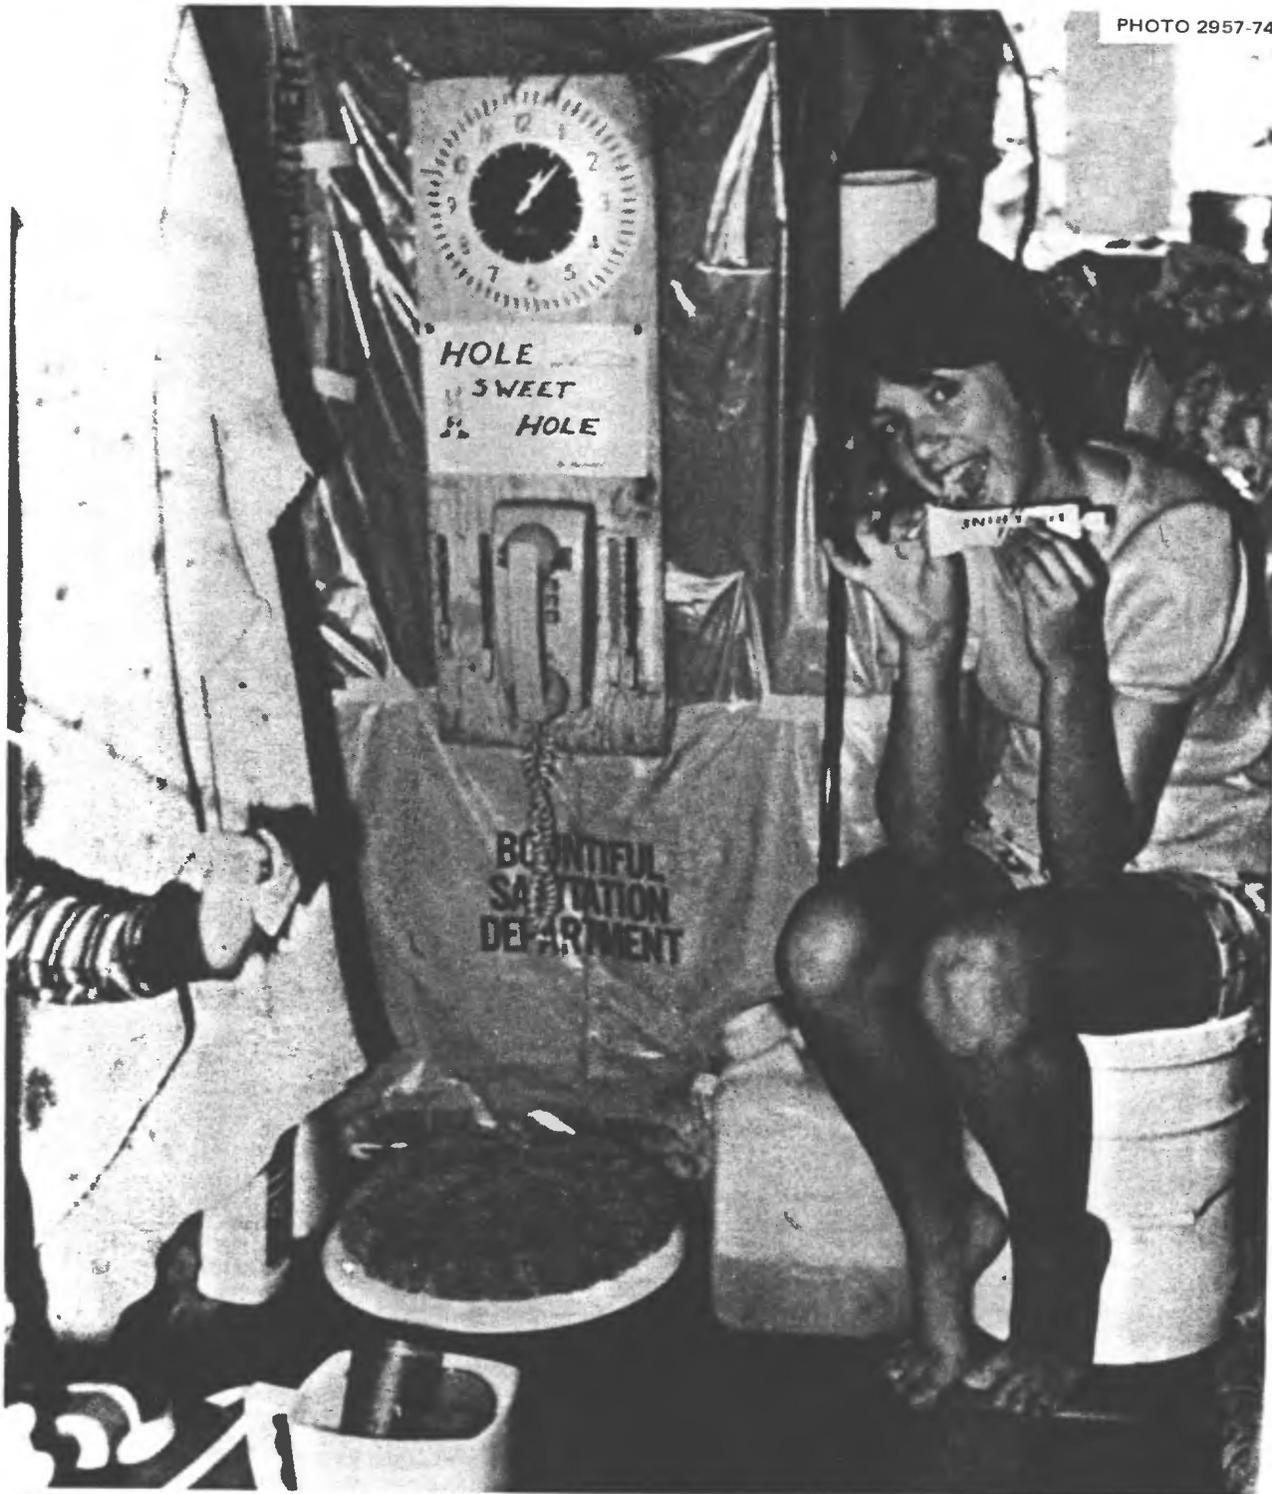
Fig. 4.24. The 13-year-old daughter brushing her teeth while sitting on a water container placed on the plywood threshold board. The stand-up hole, pictured just below the girl's toes on the edge of the threshold board, was also used by this family when taking their daily sponge bath.

The electric clock was powered by a flashlight battery. The telephone was brought along as a playful gag, to make nontechnical visitors think this family had all the conveniences of home in their 42-in.-wide shelter.

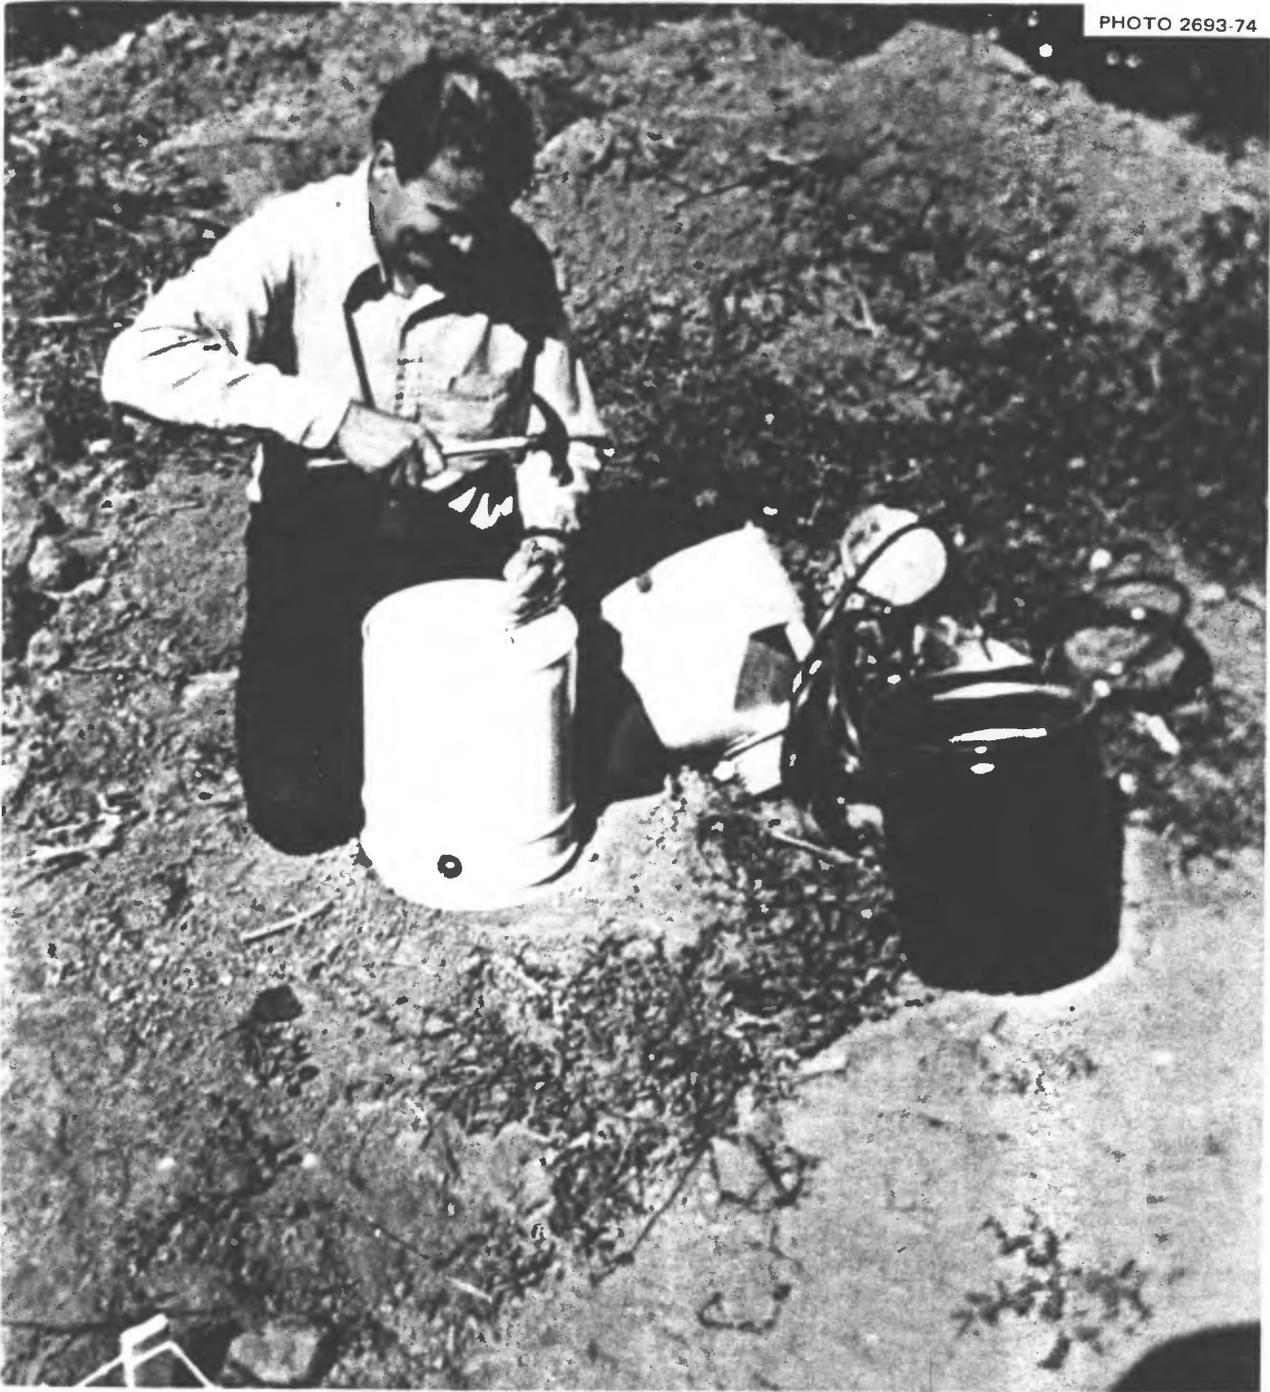
**Fig. 4.25.** The father starting work, with cold chisel and hammer, on his clever design of an odorless expedient toilet. In order to determine how long it would take to build and install this toilet under field conditions, he brought from his home the two 5-gallon cans, a 5-gallon plastic water jug (shown upside down), a garden hose, a complete toilet seat, an uncut piece of plywood, a tube, some cord, and freezer tape – all the materials needed to build this toilet.

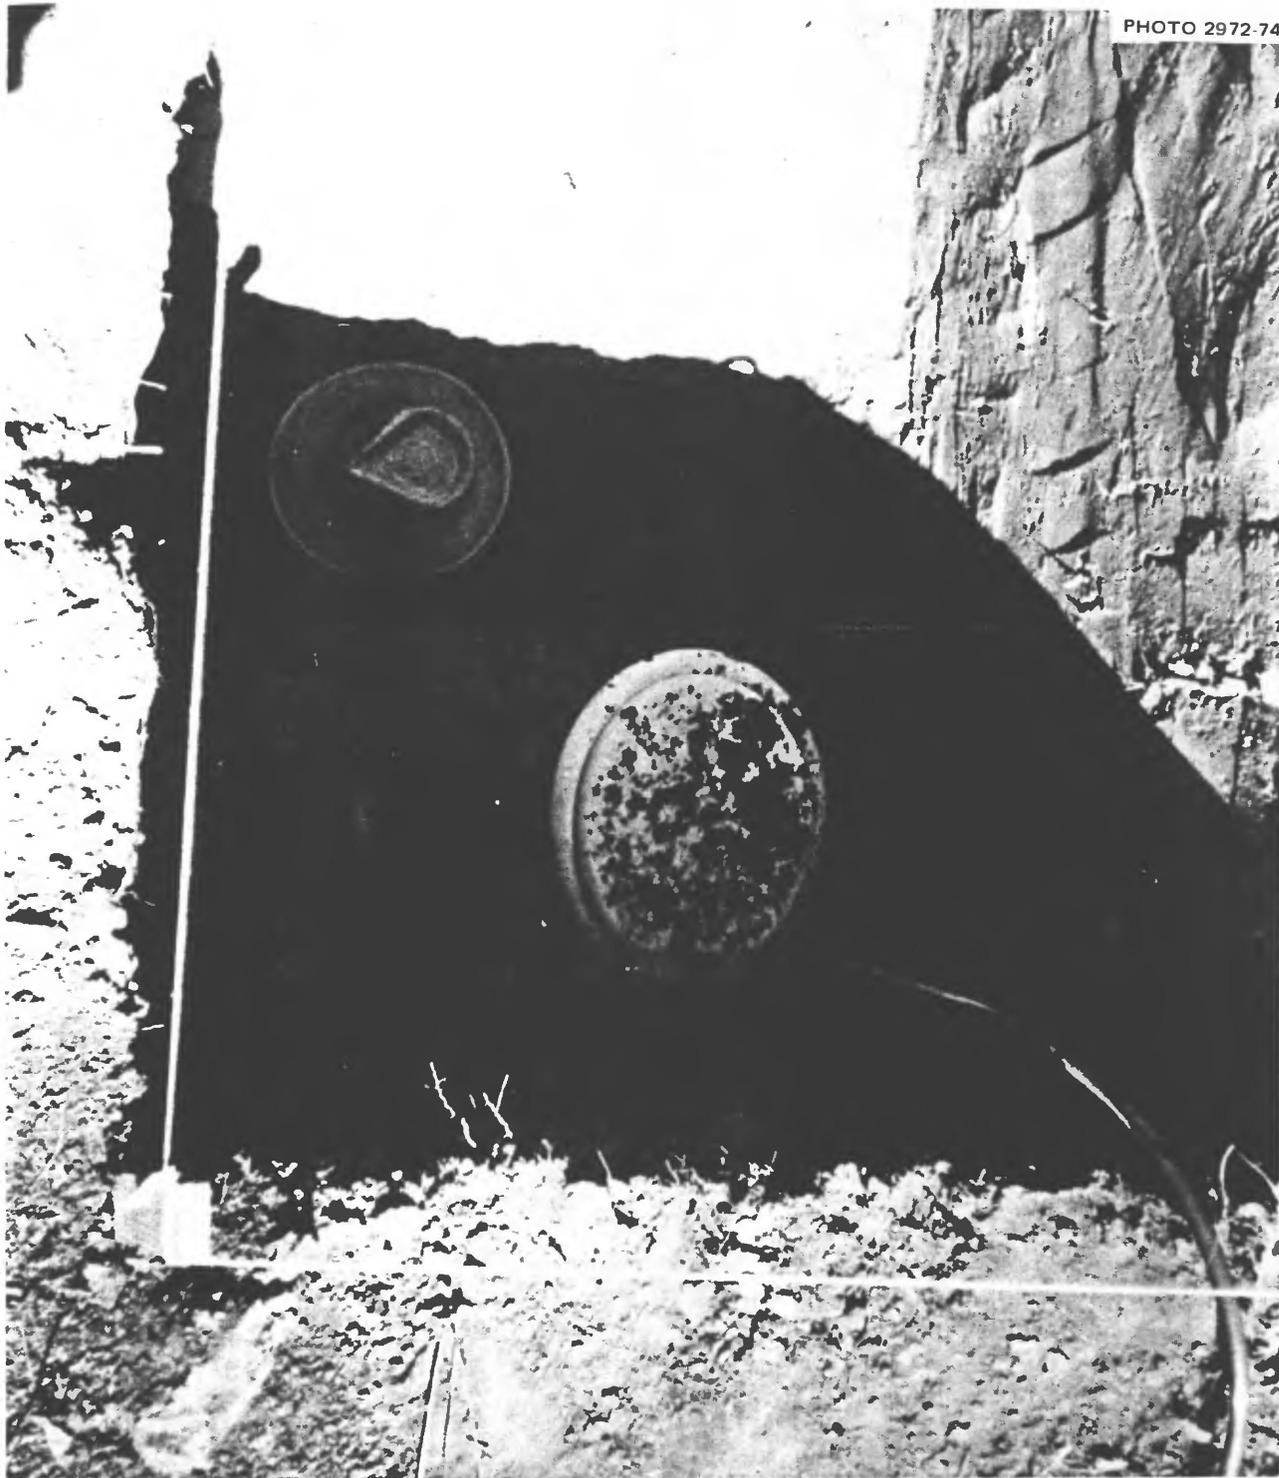
Fig. 4.29. View looking straight down on the installed toilet and its seat. The two assembled 5-gallon cans and the toilet bowl had been placed in a hole dug in the bottom of the shelter. A piece of  $\frac{1}{2}$ -in. plywood, in length equal to the 42-in. width of the shelter room and about 20 in. wide, served as the horizontal surface to which the toilet seat was attached. An appropriately sized, roughly elliptical hole had been cut in this plywood with a brace and bit and a cold chisel. The plywood base of the toilet was at floor level. Note the vent hose.

The 42-in.-wide threshold board is seen on the far edge of the stand-up hole. This and other threshold boards were installed on the edges of earth steps, and prevented the earth edges from being broken off, even after having been used for days.

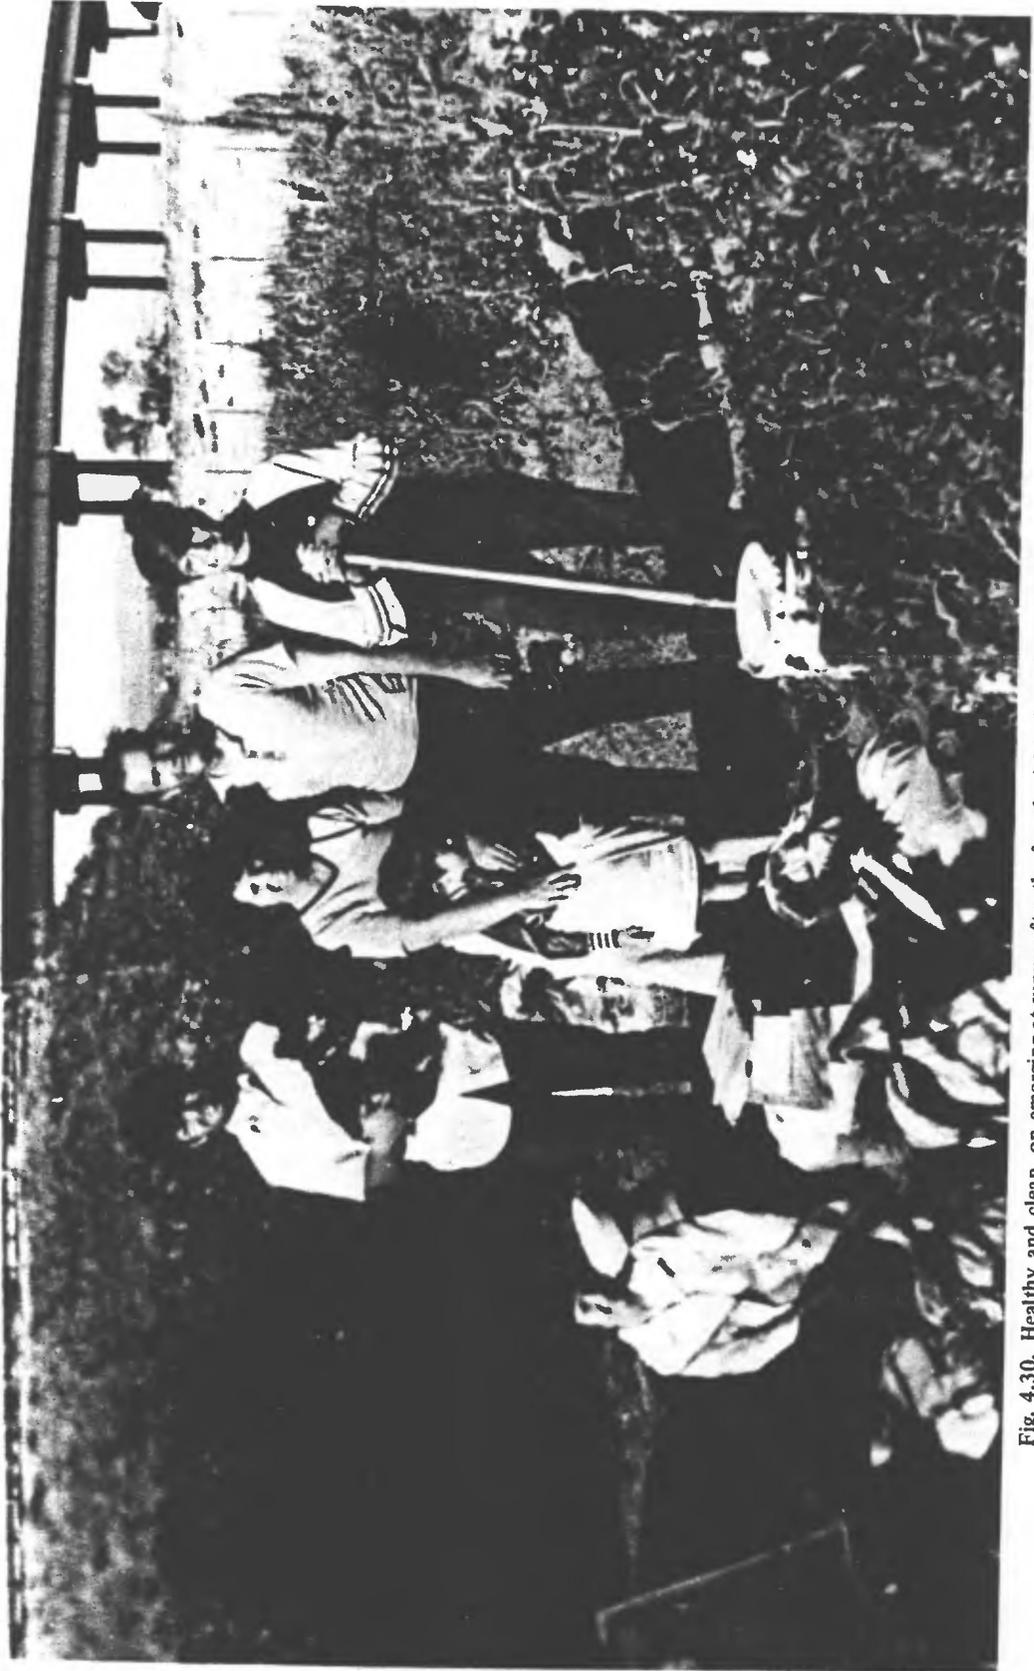
Fig. 4.30. Healthy and clean, on emerging at sunup after the fourth night of continuous shelter occupancy. The only member of this family that suffered during this test was the family dog, who, remarkably, held in everything for the 77 hours of shelter occupancy.

One of the two metal-framed window screens (that this family had carried from their home) is pictured on the left. These screens had been placed over the entrance hole and served well. Only a few of the many mosquitoes outside got into the shelter. The garbage bags, shown in the foreground, contained empty cans, waste paper, and other refuse accumulated during the shelter occupancy. These bags had been thrown outside from day to day. Behind the family are the screens.

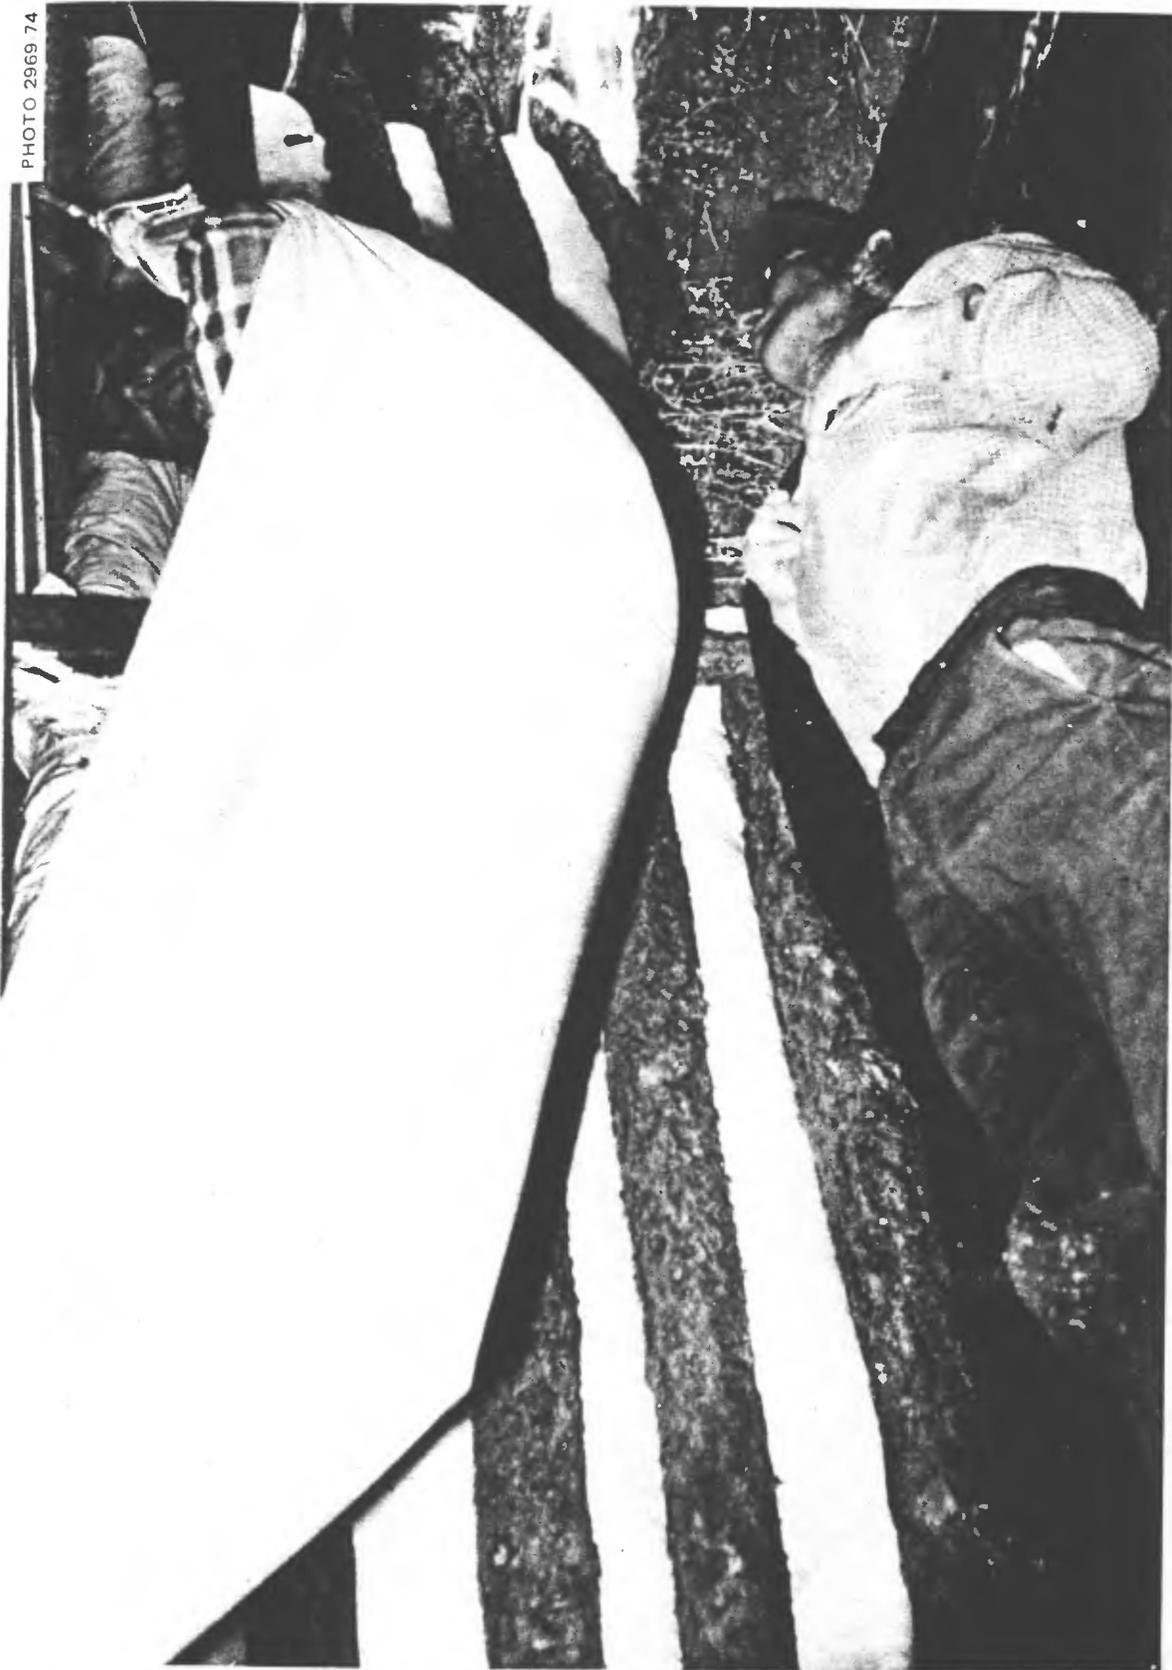
PHOTO 2969 74

Fig. 4.31. Using an expedient Bedsheet-Hammock, to enable two persons to sleep over the same floor space. Otherwise, only one person could sleep in this space in an Above-Ground Crib-Walled Shelter. The ceiling was only 40 in. above the floor.

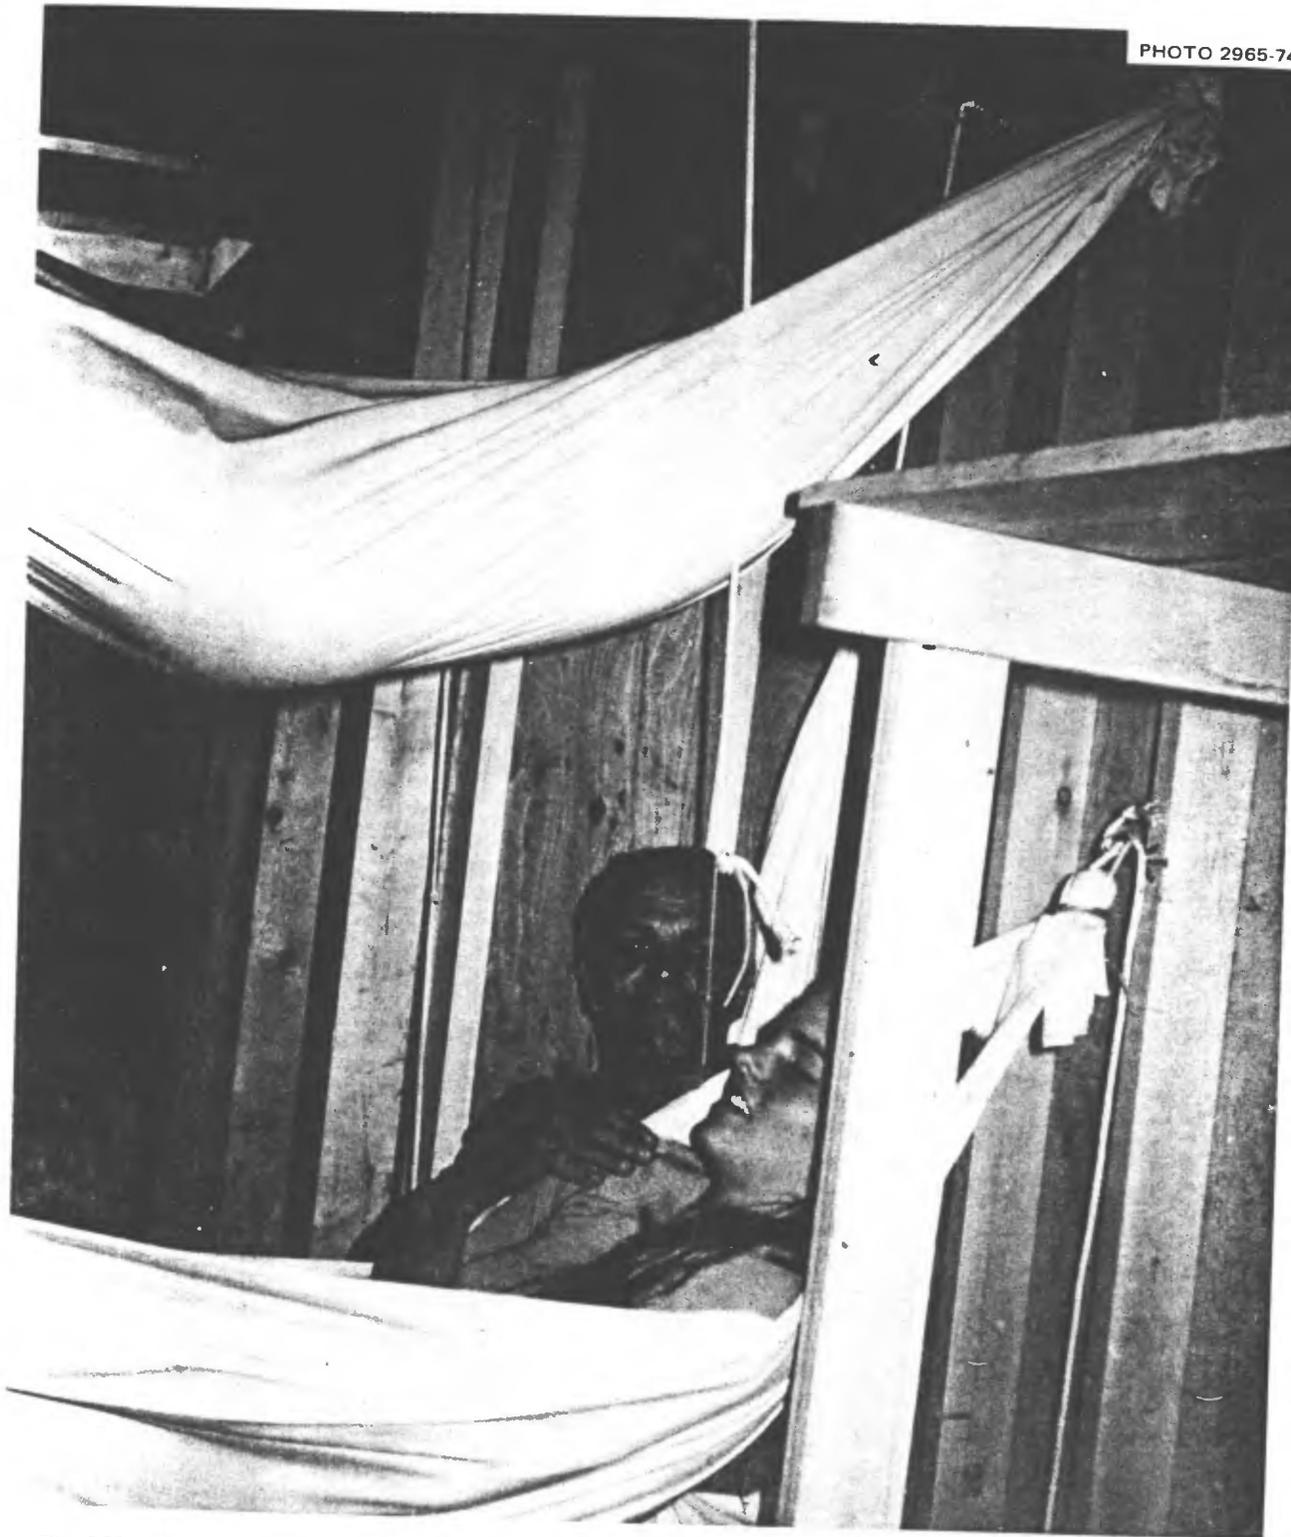
Fig. 4.32. Two Bedsheet Hammocks, one above the other, slung in the entrance end of a lumber version of a Russian-type Small-Pole Shelter. On the right is seen the end of one side of the typical Russian-style benches with overhead boardbunks. The Russian sitting-sleeping system is a "hot-bunk" system that enables only one-third of the occupants to lie down at the same time.

By using this new design of short, space-saving hammocks, all occupants can lie down and sleep at the same time – even in the austere stoop-in Log-Covered Trench Shelter. Furthermore, all occupants can sit comfortably together in suspended Bedsheet-Chairs, that they can quickly make from their Bedsheet Hammocks.

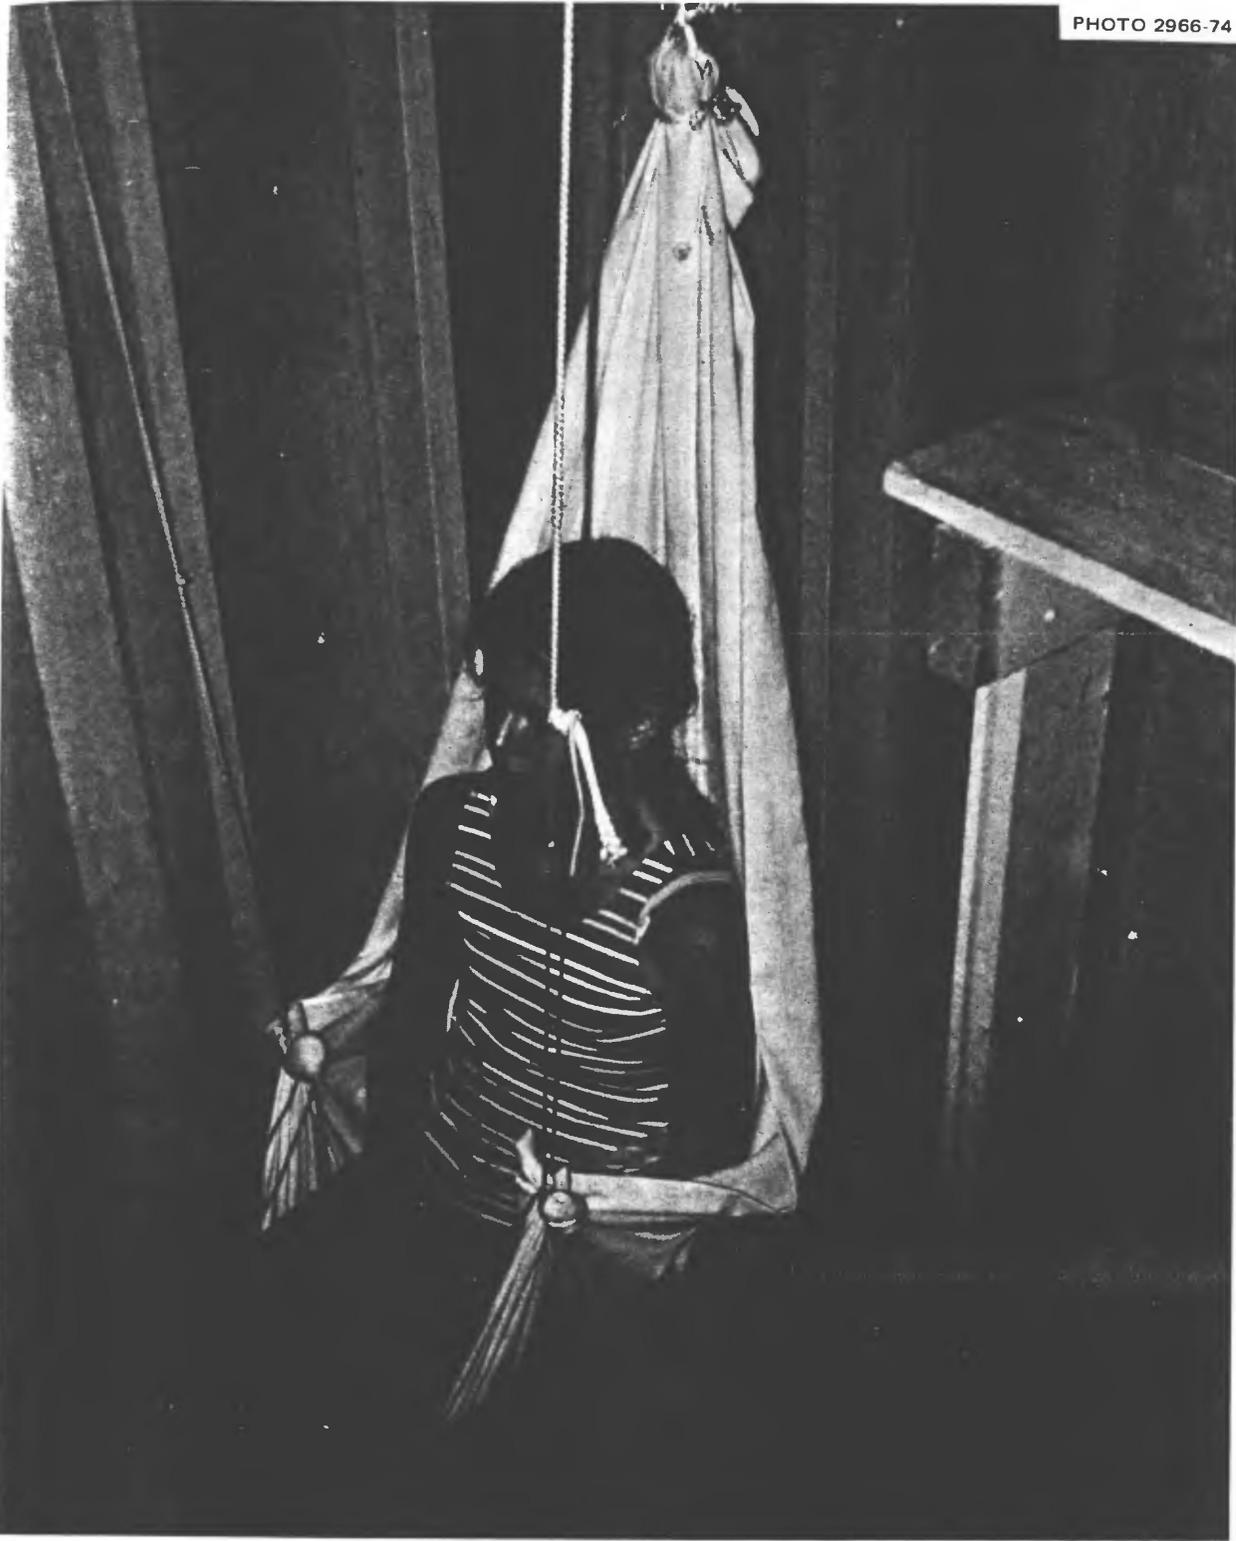
**Fig. 4.33.** Sitting comfortably in an expedient suspended Bedsheet-Chair, easily made by converting a Bedsheet-Hammock. This design was developed after the August 1974 shelter occupancy test.

Two stones, or lumps of earth, each about  $1\frac{1}{2}$  in. in diameter, are tied in the edges of a Bedsheet-Hammock, so that two cords (or strips of sheet serving as cords) can be securely connected as supports.

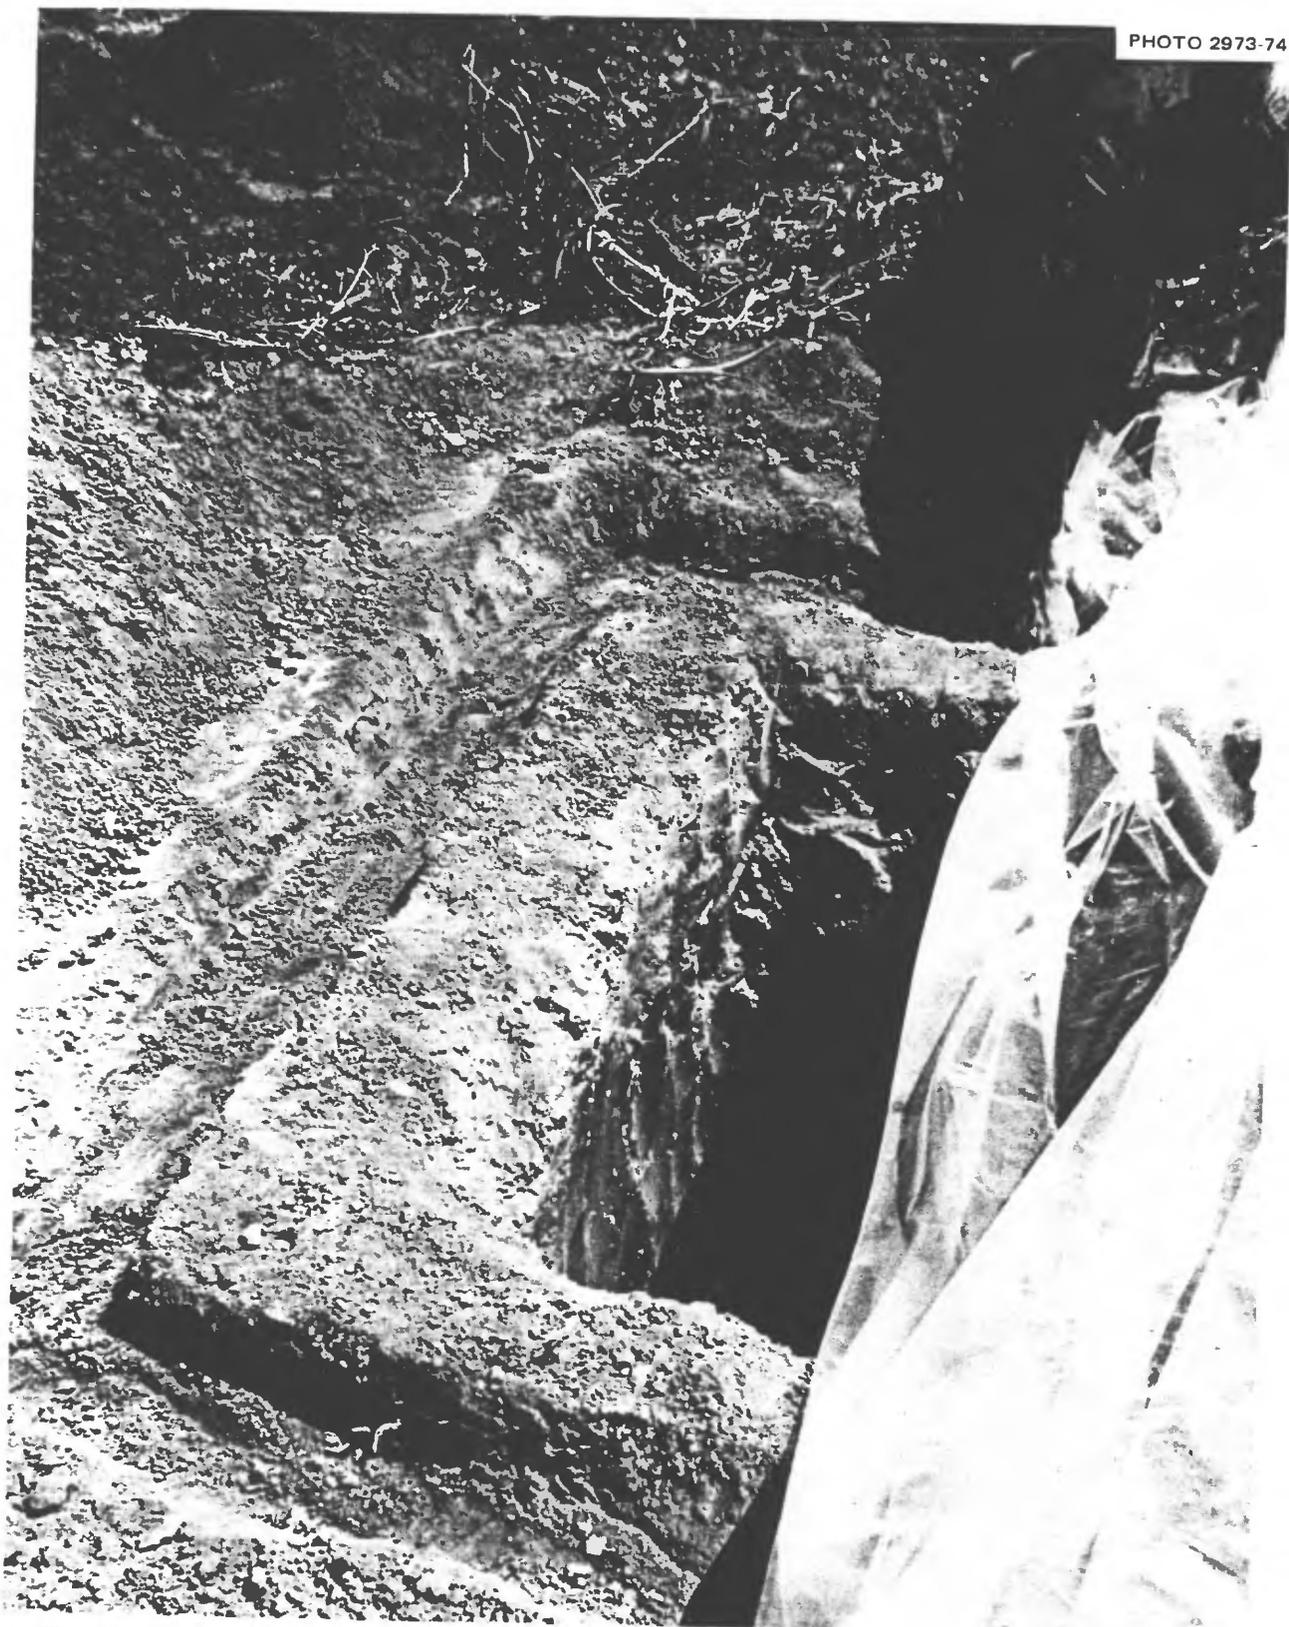
Fig. 4.34. Placing a sheet of 4-mil polyethylene in a 120-gallon water-storage pit. Unlike previous water-storage pits dug and tested by Kearny, this pit was not first lined with cloth or other material to keep sharp roots, etc., from puncturing the waterproofing plastic. All root ends were merely cut off with a knife. The edges of the plastic were folded into the small side trenches, and then held by packed earth. Six days after being filled, no leaks had developed.

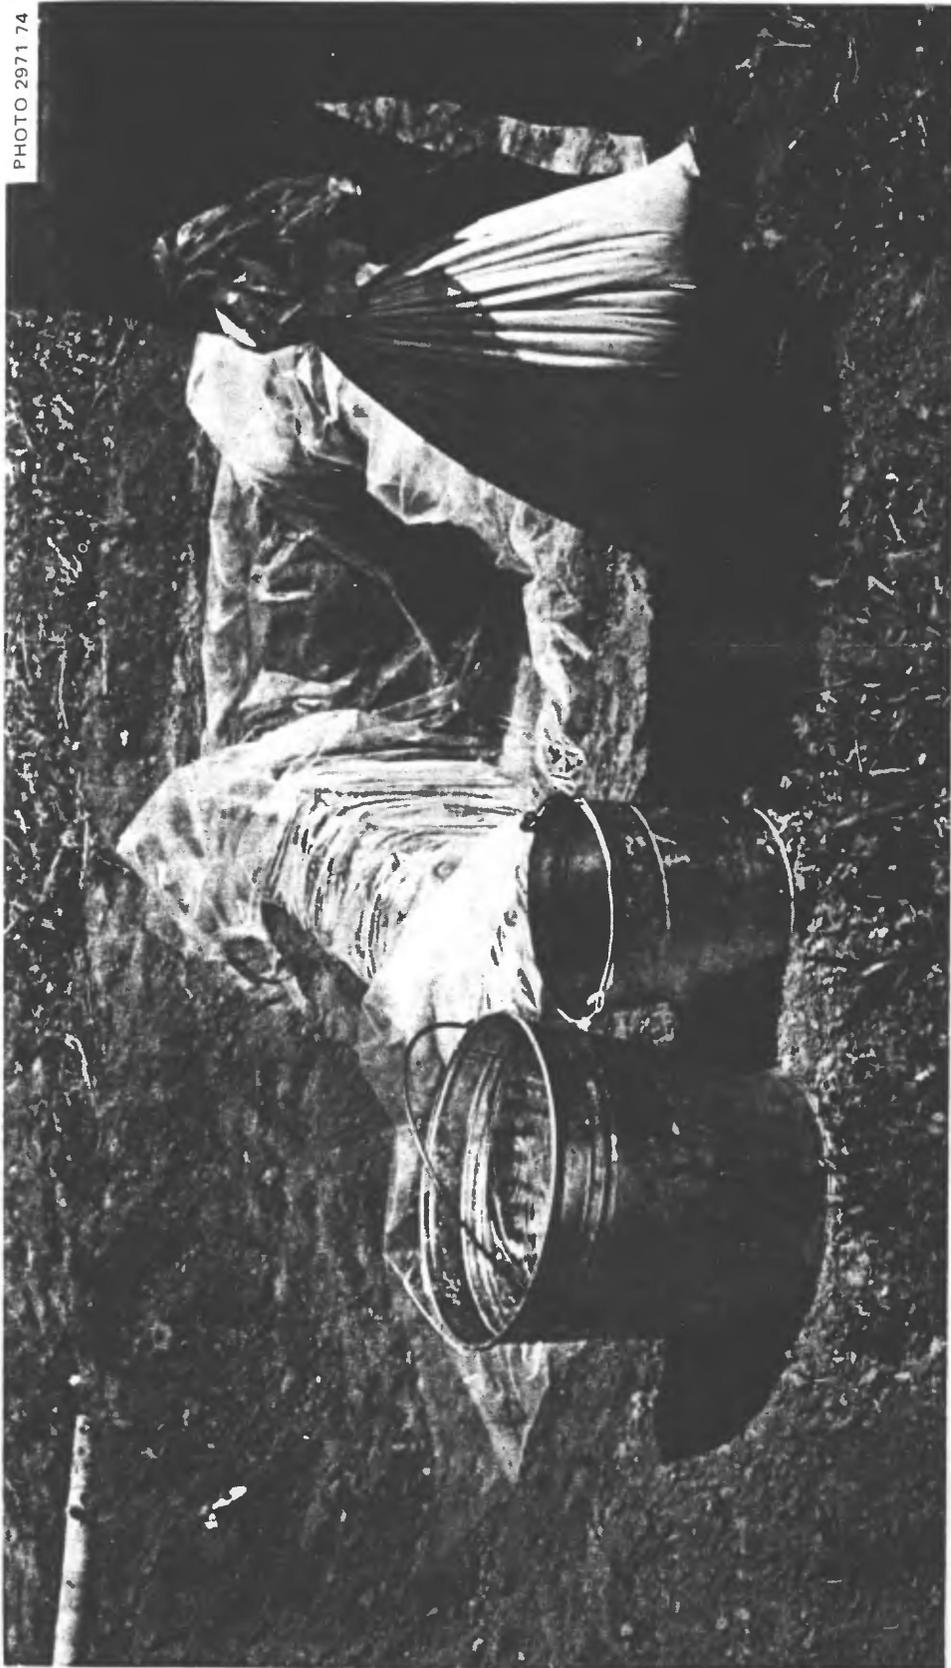
Fig. 4.35. The 120-gallon water storage pit of thin plastic being filled. This pit was later covered with boards, over which thin plastic was placed, and then earth was mounded over the boards, about 6 in. deep in the center. Next, a waterproof, outward-sloping "buried roof" of the plastic was laid on top of the mounded earth. Finally, about 4 in. of earth was mounded on top of the buried roof.

Water was readily carried to the pit inside an ordinary polyethylene trash bag, placed inside a smaller pillowcase. Thus the thin polyethylene bag did not have to carry the stresses, since the water merely pressed the thin waterproof bag against the cloth. By securing the mouth of such a lined water container so that the mouth remains above the level of the water, quite large volumes can be both carried and/or stored.

The stand-up hole also served for a place to take sponge baths, using water brought into the shelter by 40 ft of  $\frac{1}{2}$ -in.-diam. garden hose. This hose was used as a siphon to bring water from a 120-gallon, covered water-storage pit (Fig. 4.35).

Kearny dug this pit about 35 ft from the far end of the family's test shelter. The father used 40 ft of  $\frac{1}{2}$ -in.-diam. garden hose to make a syphon, so that, when the end of the hose inside the shelter was lowered, water ran from the pit into the shelter. Sometimes the hot Utah sun heated the water in the hose as hot as 125° F.
