ORNL-5039  
UC-41-Health and Safety

HEALTH PHYSICS DIVISION  
EMERGENCY TECHNOLOGY SECTION

EXPEDIENT SHELTER CONSTRUCTION AND  
OCCUPANCY EXPERIMENTS

Cresson H. Kearny

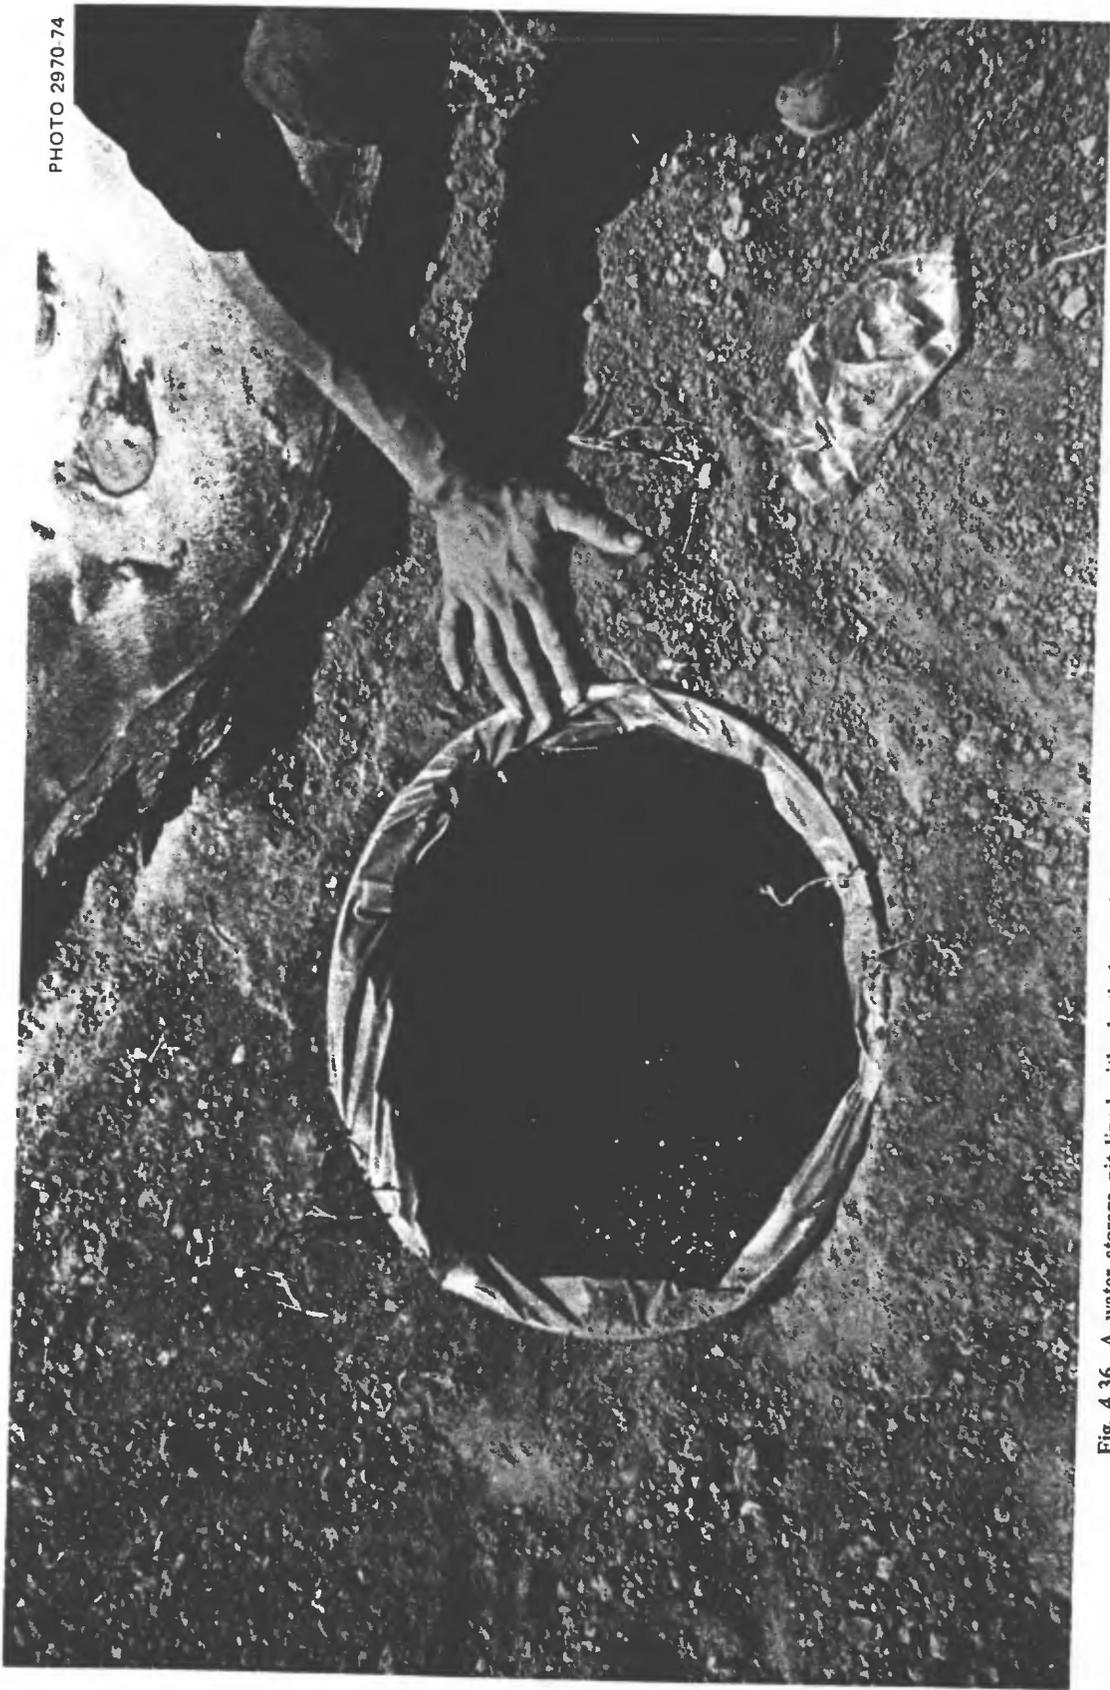
**Fig. 4.36. A water storage pit lined with plastic bags, photographed 6 days after having been filled and covered. None of the approximately 25 gallons of water in this pit had leaked through the two 30-gallon trash bags (each about 1/4 mils thick) placed one inside the other for a pit lining.**

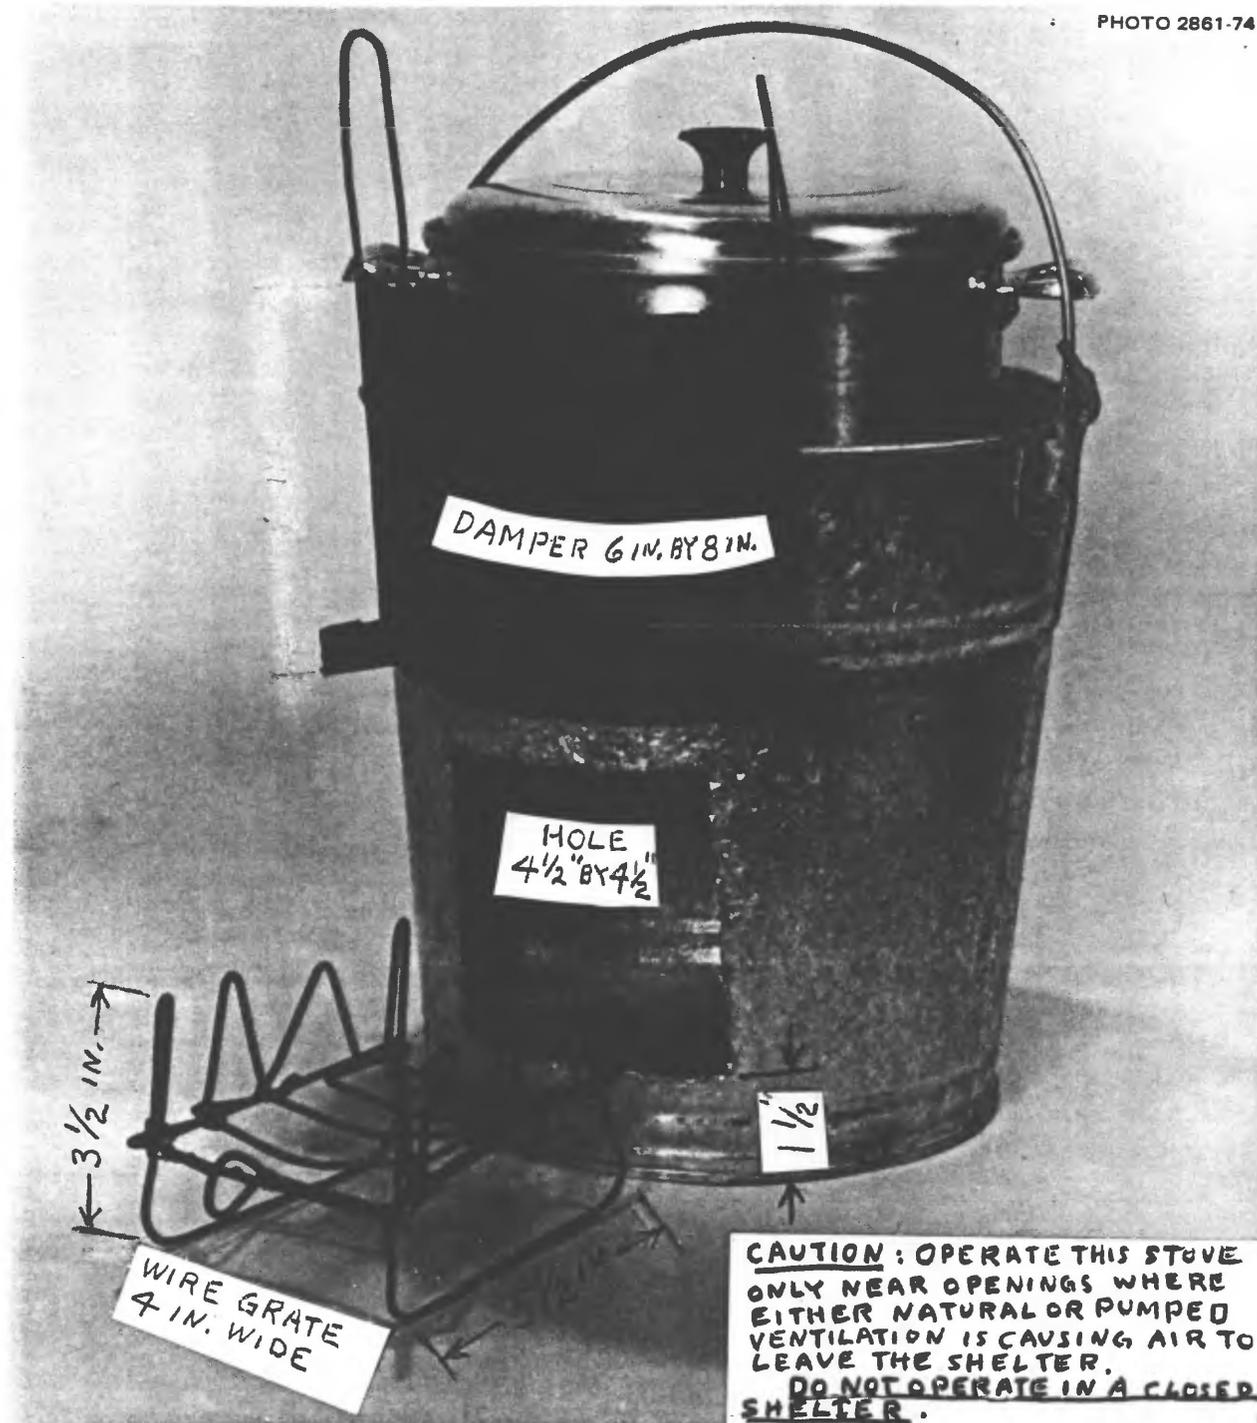
Fig. 4.37a. Expedient Bucket-Stove, made of a bucket, coat-hanger wire, about 2 ft of finer wire, and metal from an ordinary juice can. This is the most efficient expedient stove tested to date.

When this stove is used with a covered-lid pot having a diameter about 2 in. less than the diameter of the bucket (or large can) at the height of the bottom of the pot, 3 quarts of water can be raised from 60°F to boiling by burning only about 7 ounces of dry wood or paper.

If an expedient fireless cooker is also available, then 3 quarts of soaked beans, wheat, or tough meat can be cooked by burning only about half a pound of dry wood or paper.

Fig. 4.37b. Bucket-Stove, showing its adjustable sliding damper partly closed, and the two coat-hanger wires that serve as pot supports. The ends of these wires are bent over the top of the bucket to form protruding springs to center and secure the pot by pressing against its sides. Pieces of wood about  $\frac{1}{2} \times \frac{3}{4} \times 6$  in. are best.

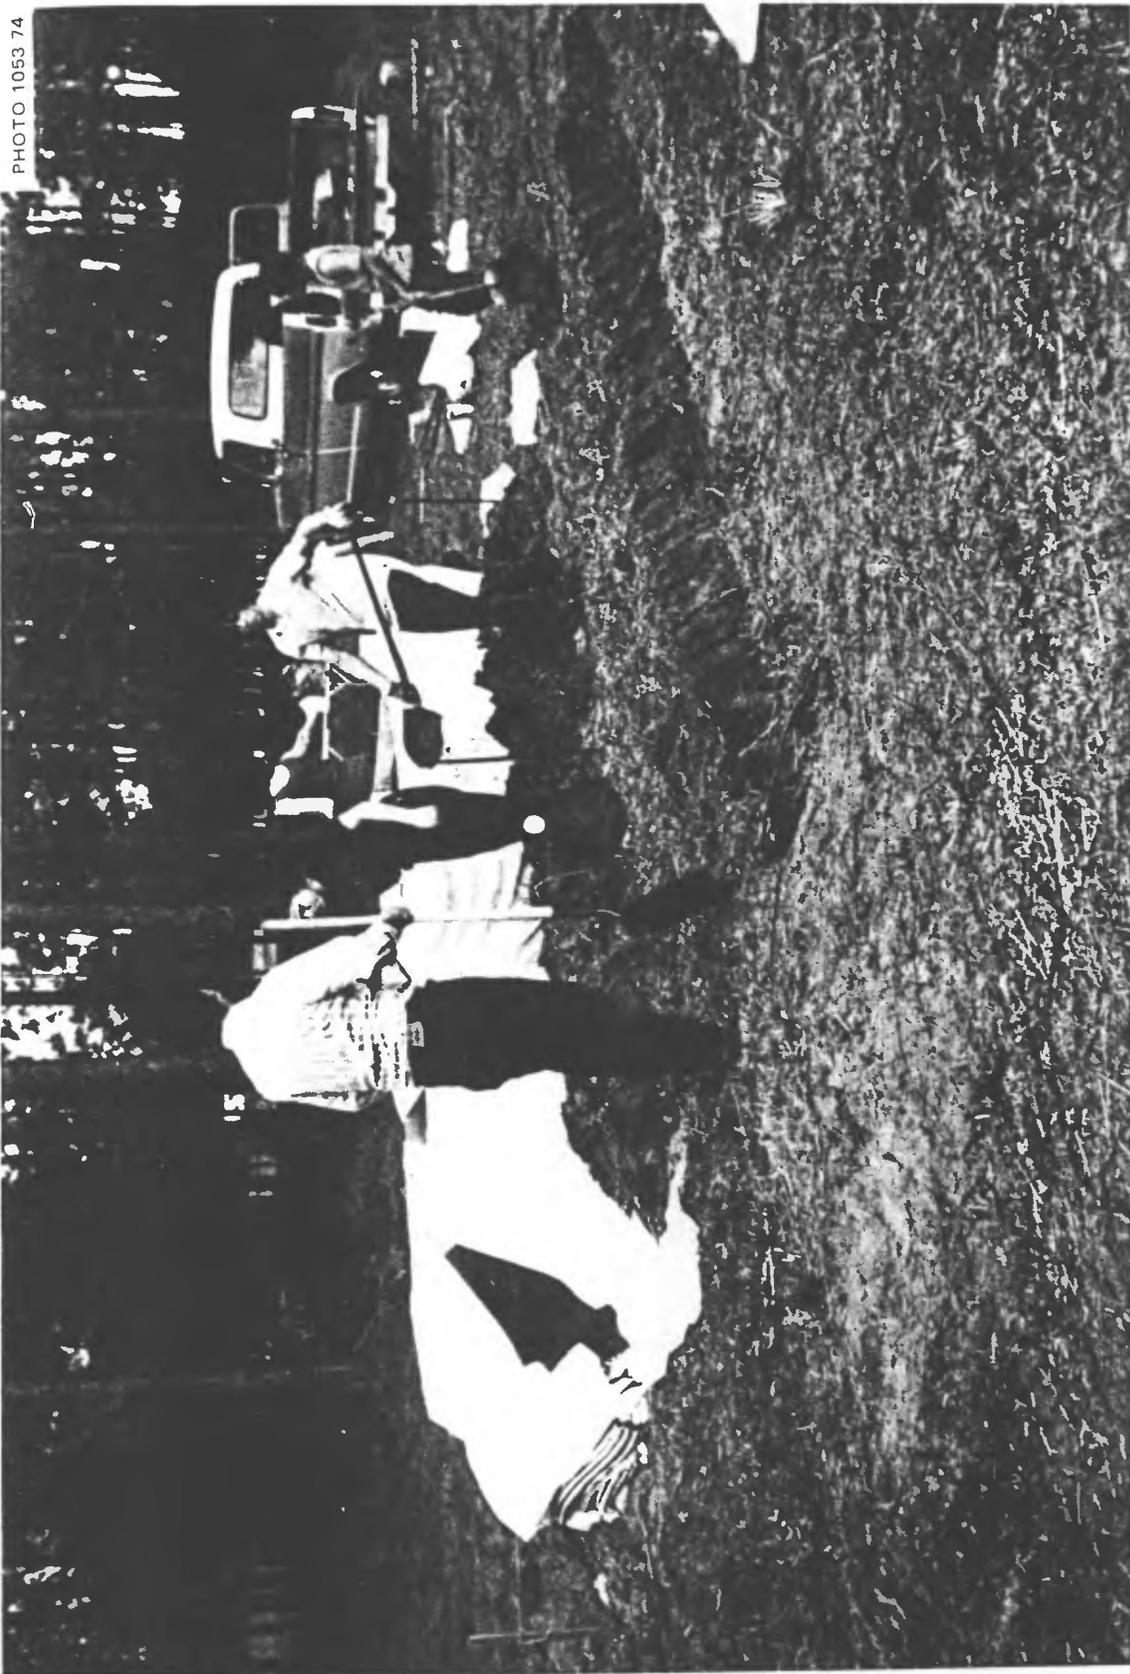
PHOTO 1053 74

Fig. 5.4. Starting to make the first roll by shoveling earth onto bed sheets that had been placed with 2 ft of their long sides on the ground, with the rest of the sheets temporarily draped over the doors used as forms. This sandy earth could be dug quite easily with shovels.

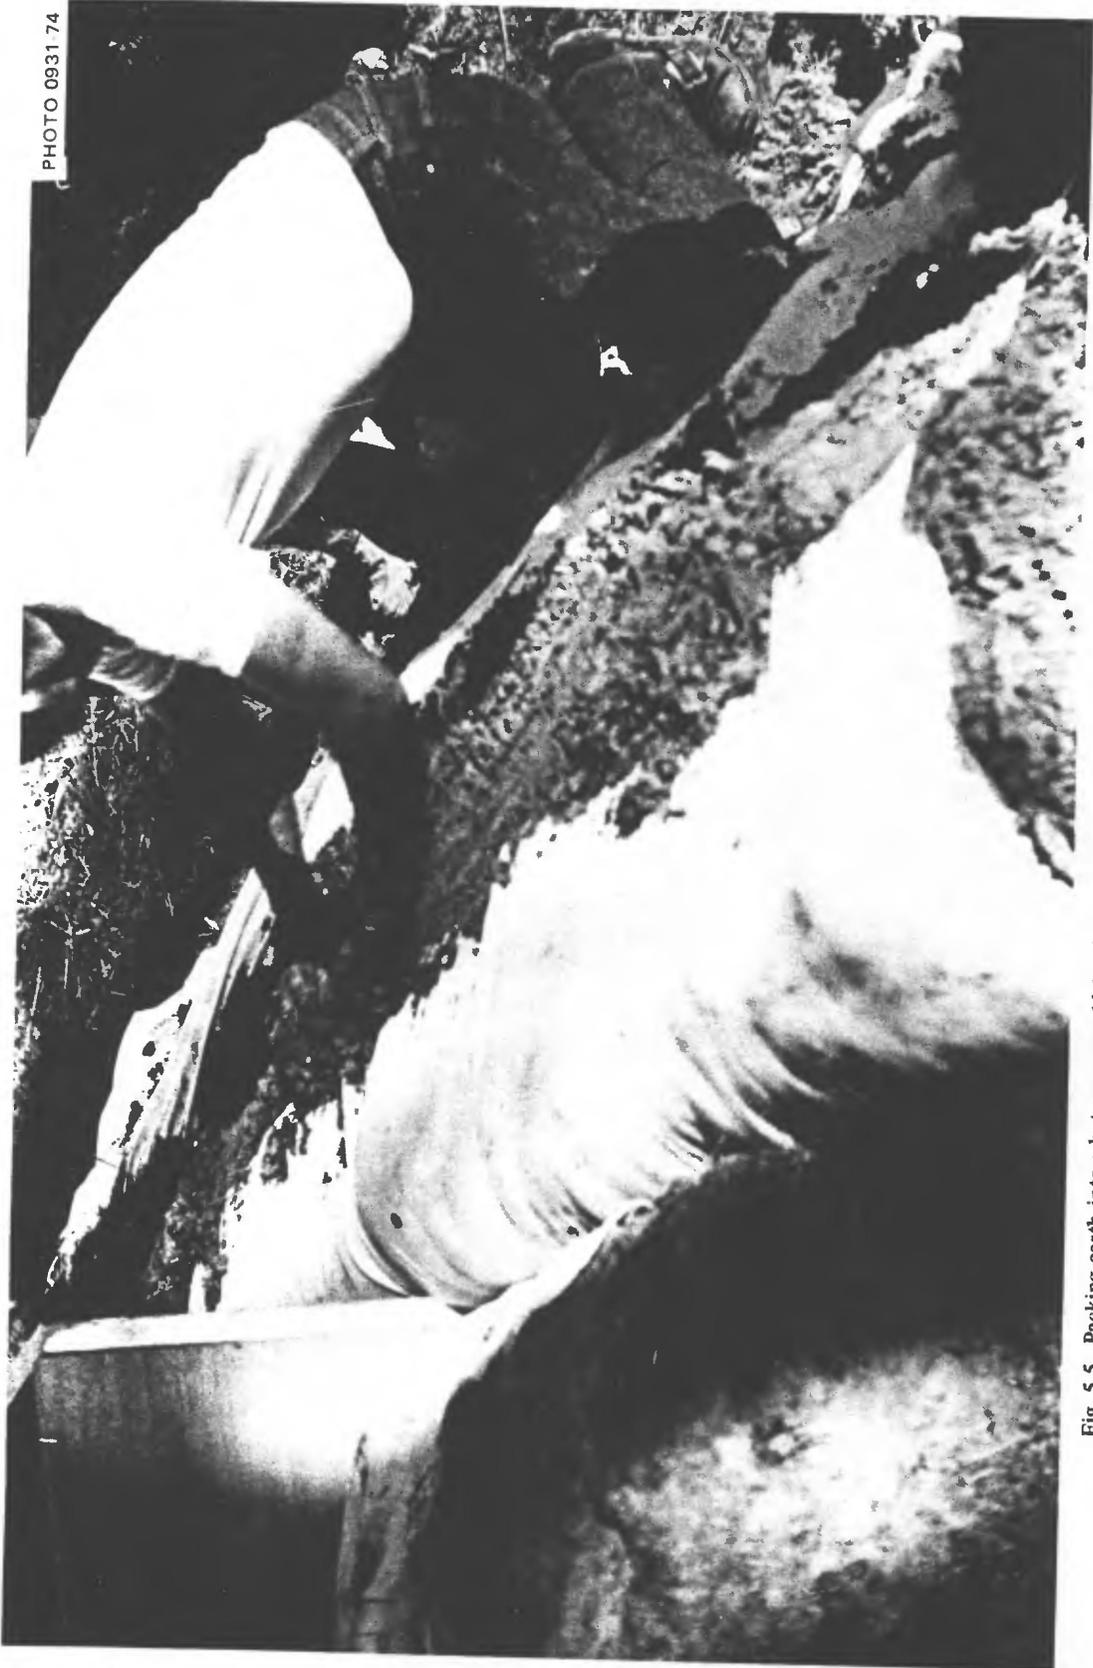
PHOTO 0931.74

Fig. 5.5. Packing earth into what soon would be the hook of a roll. This photo was taken after the upper, free part of the sheet had been pulled down and over the earth that had been piled on part of the sheet while part of it was supported by the form made of an interior door. A part of this sheet had been folded down into a shallow ditch dug in the mounded earth; this ditch was below the line of packed-in earth on which the father's hands are pressed.

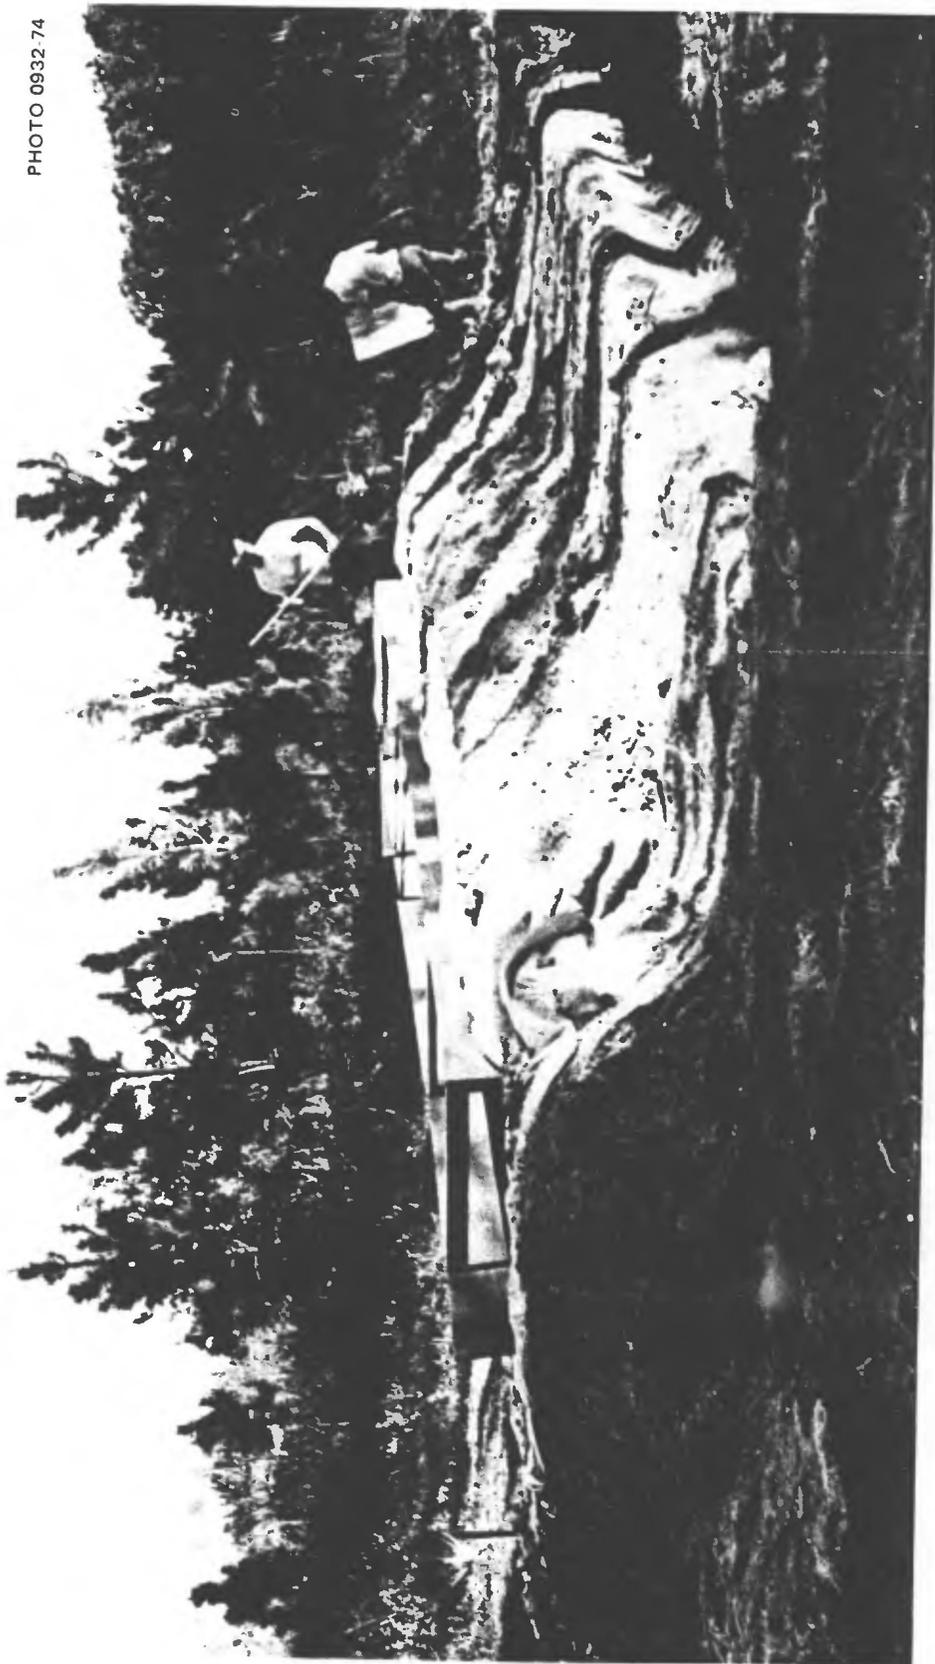
**Fig. 5.7.** One of the side walls, made of three rolls placed one on top of the other, pictured shortly before the door forms were removed.

Note the pits from which earth was excavated. Due to the high water table and underlying wet clay, these workers removed earth from only the uppermost 12 to 15 in.

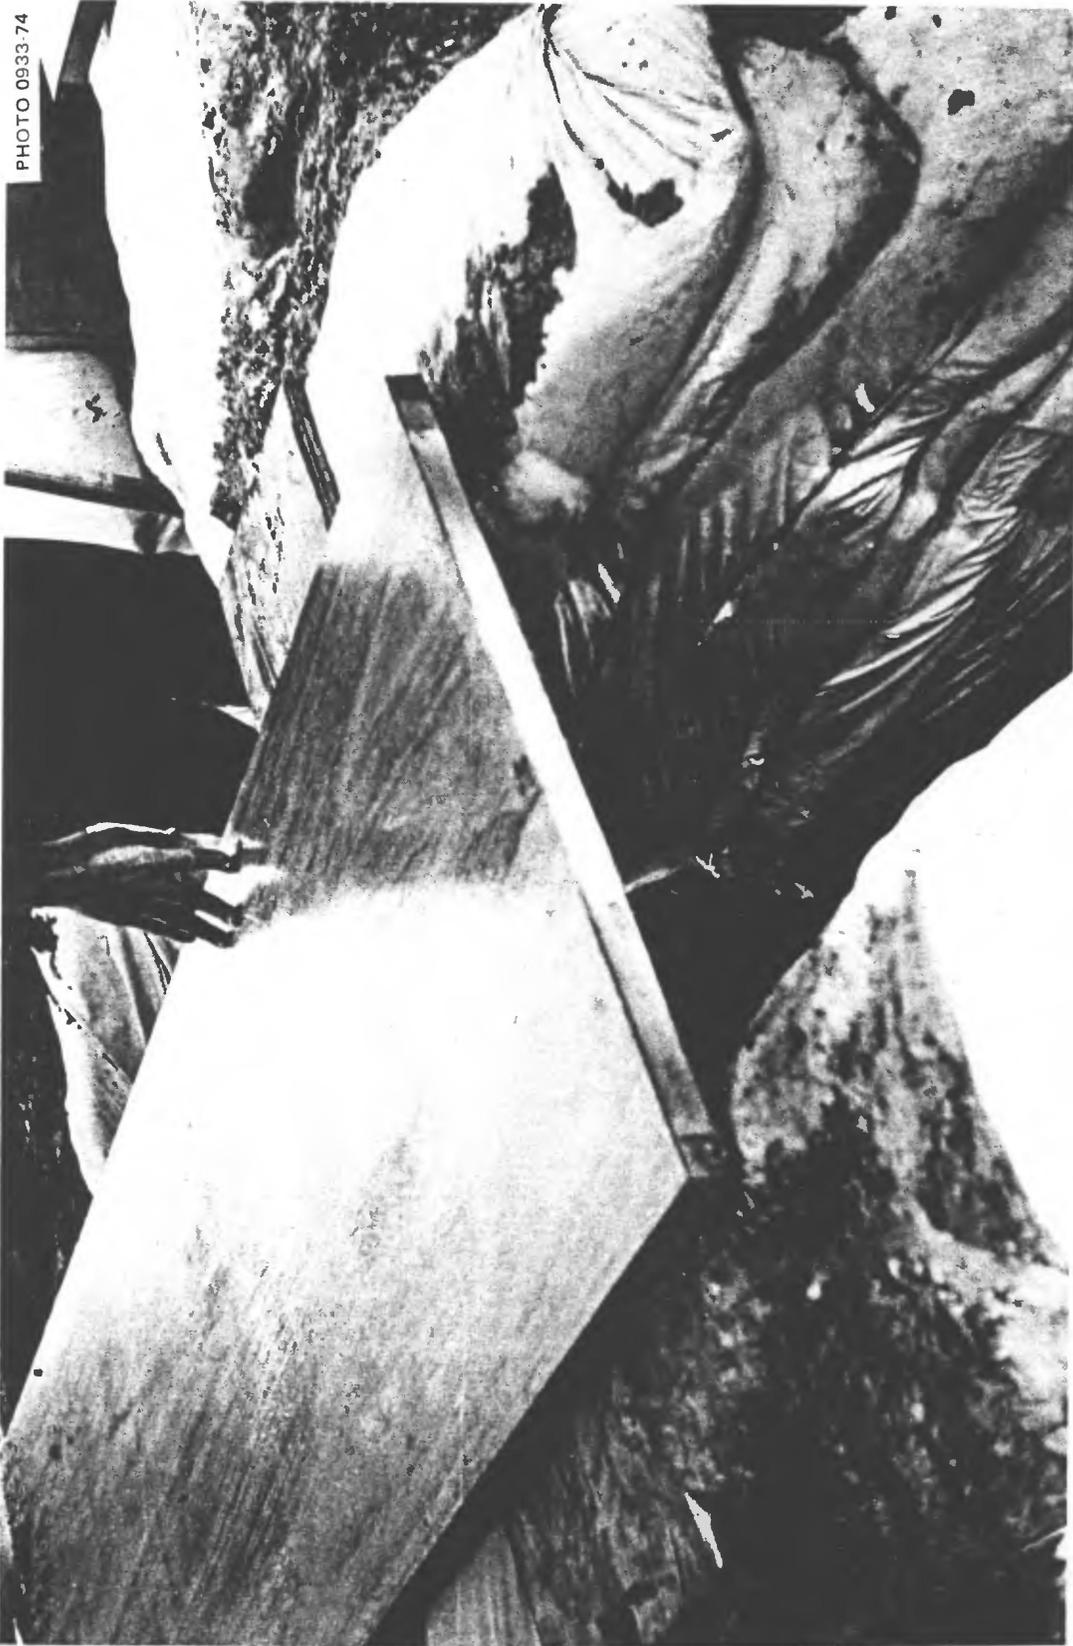
PHOTO 09333-74

Fig. 5.8. Placing an interior door over one end of the shelter and part of an entryway. The wall of this entryway consisted of 7 small rolls which were made by using pieces of sheets and other cloth, with the outer ends tucked in. The man was standing on the main part of the shelter, over which other doors were soon to be placed, all parallel to the pictured door.

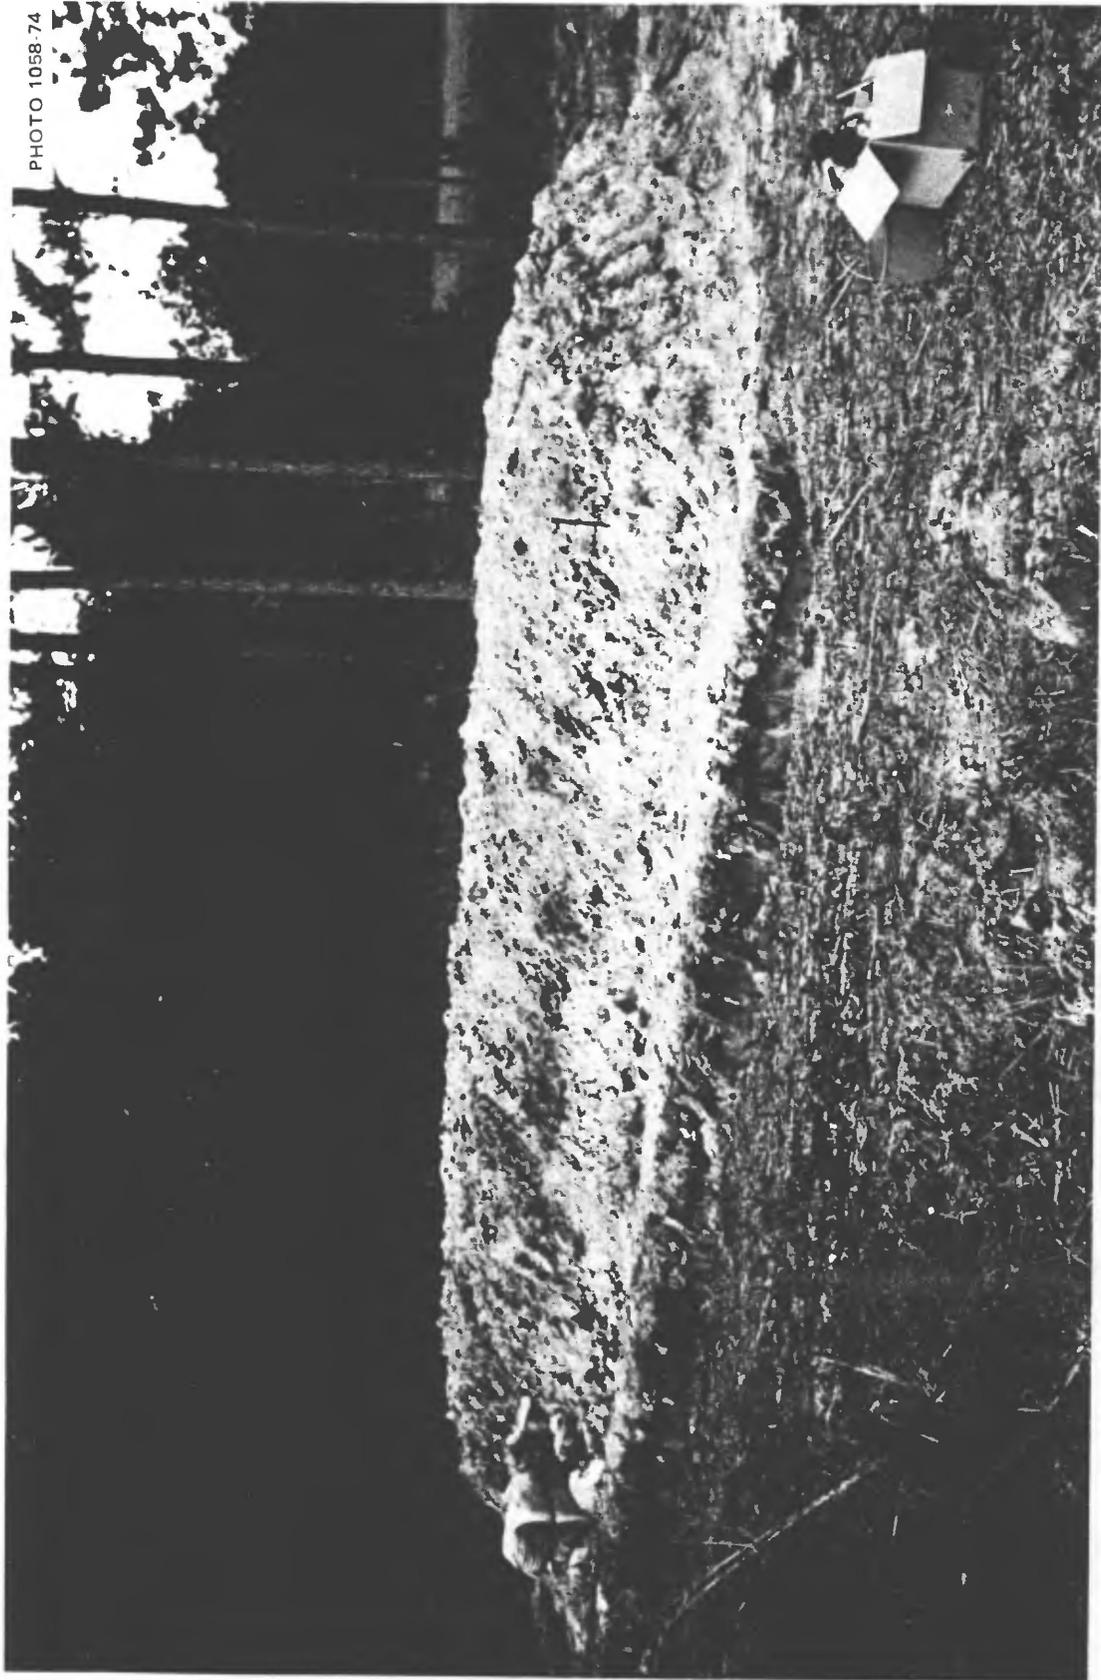
Fig. 5-9. The completed shelter, after a full 15 in. of heavy, wet, sandy earth had been piled on top of the roofing doors. These doors had all been painted or varnished with two coats, to simulate the interior doors from an average home. As an additional means to keep dampness from weakening the cardboard honeycomb inside these hollow-core doors, the walls made of earth-filled rolls were made about 3 in. higher on one side than on the other. Then waterproof materials (shower curtains, plastic film, and plastic clothes bags) were placed directly on these sloping doors. Finally, earth was piled 15 in. deep on top of these waterproof door coverings.

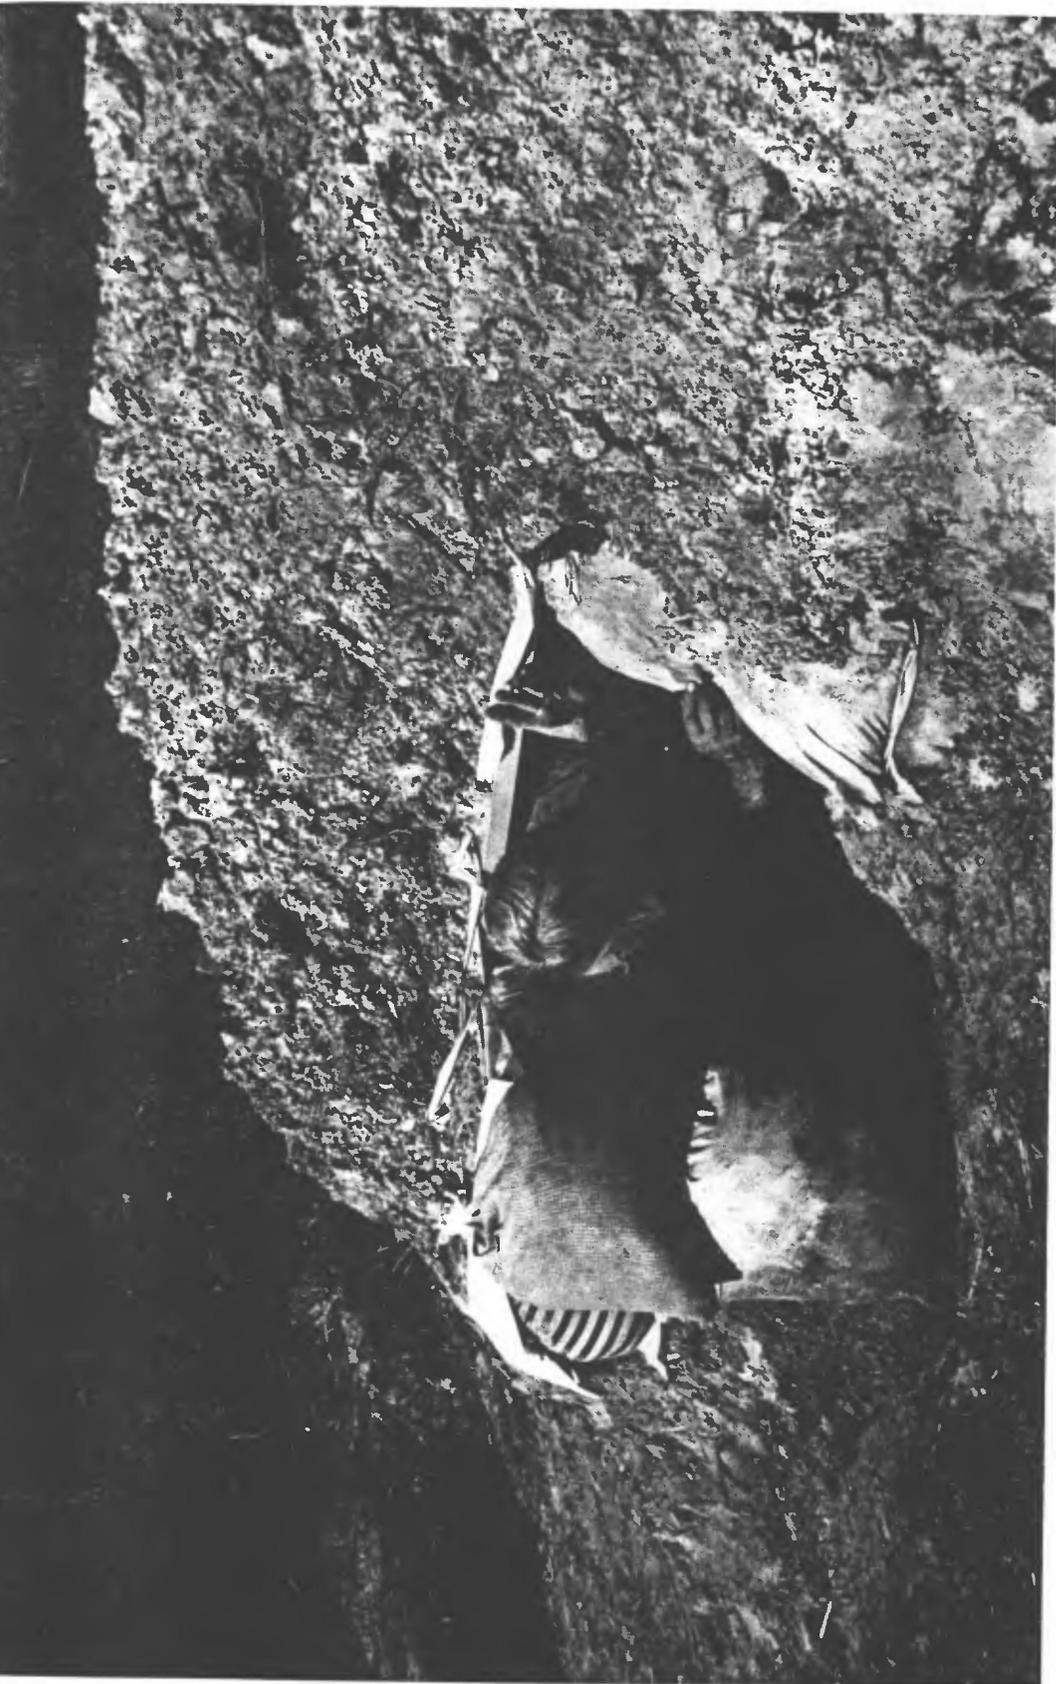
Fig. 5.10. A closeup view of the same entry pictured previously, showing the sandbags used to finish the ends of the entryway walls and to reduce radiation from fallout on the ground, which otherwise would enter the shelter. This shelter, like the other above-ground shelters designed for use in a hot, humid climate, had two entryways, facing in opposite directions, one at each end.

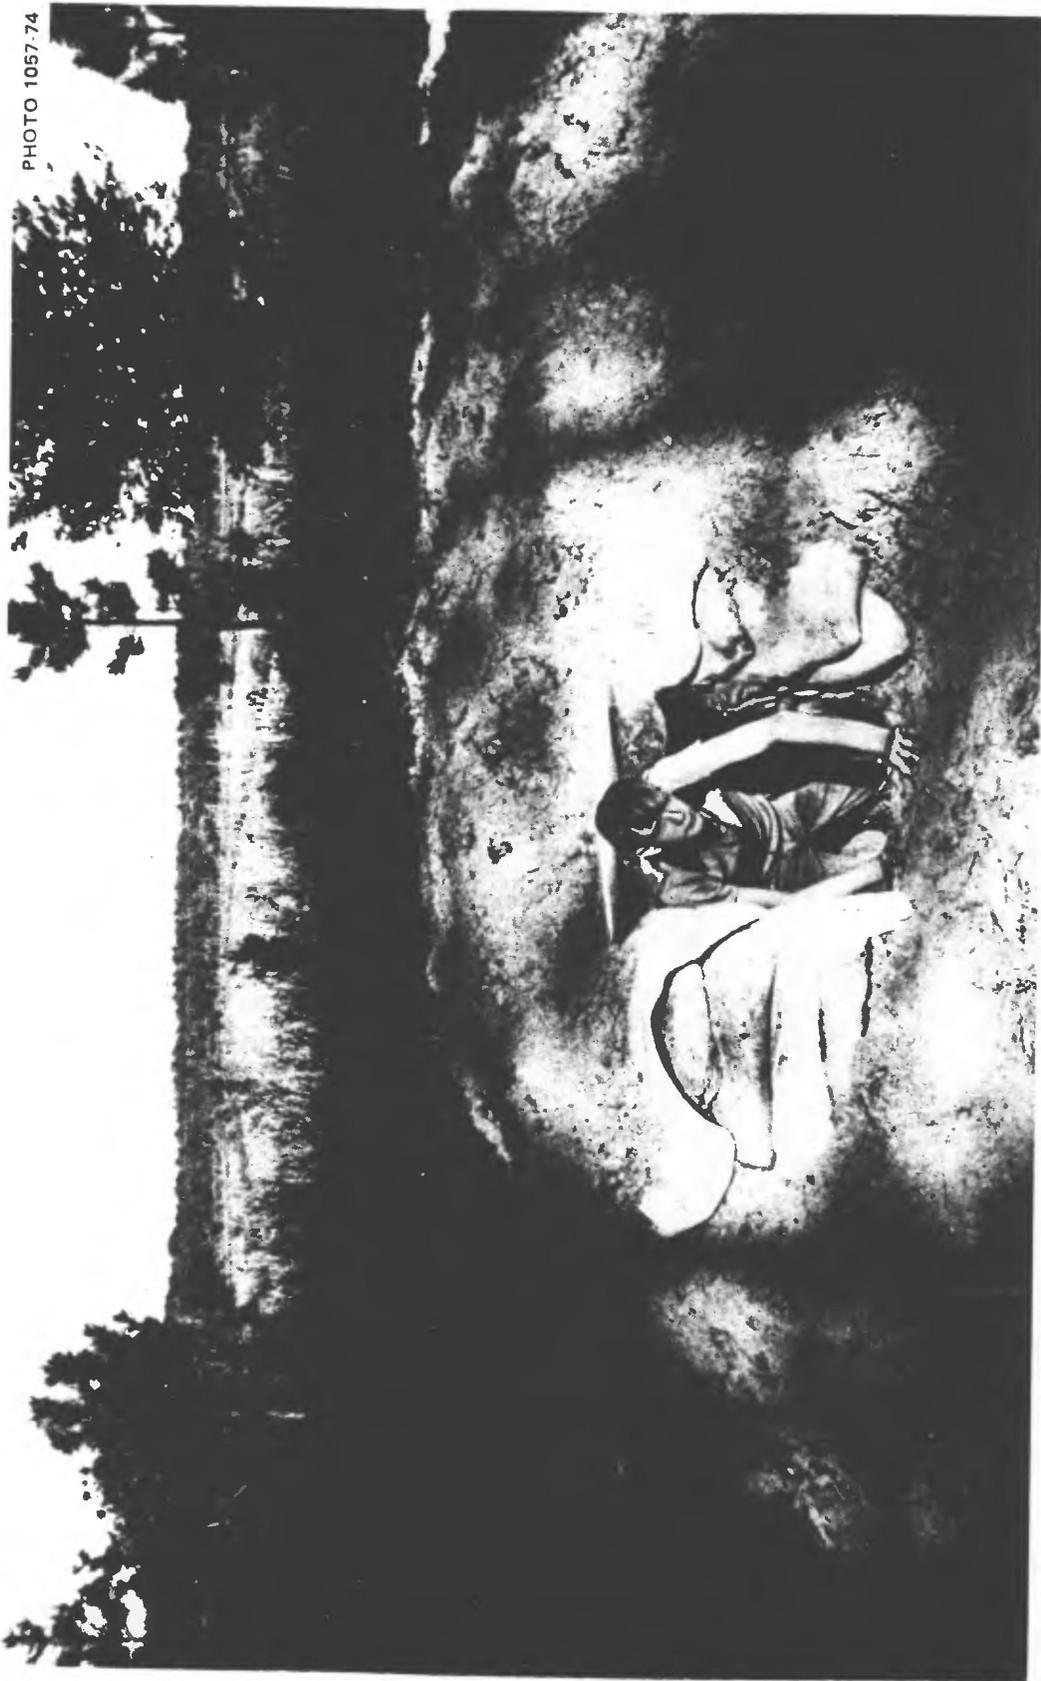
**Fig. 5.11. The other entryway of the same shelter.** In previous tests hollow-core interior doors used as previously described had supported at least this thick an earth covering for more than a month, during which extremely heavy rains had fallen.

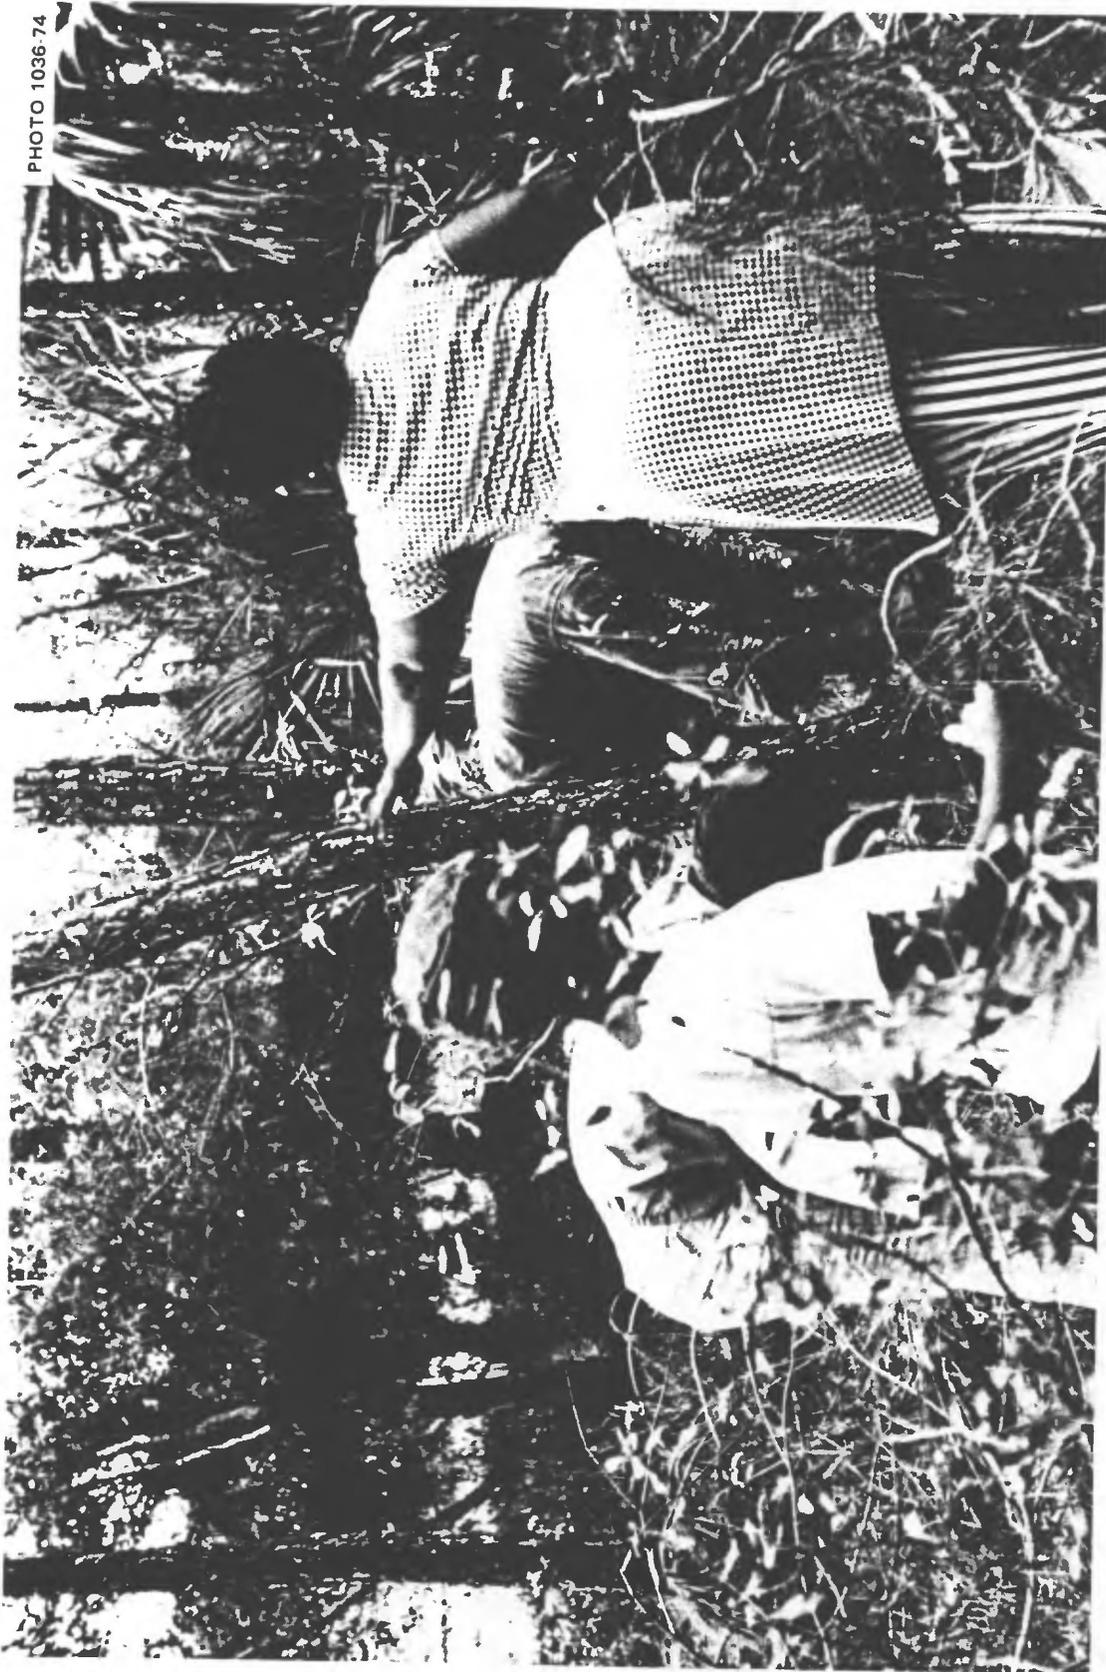
PHOTO 1036-74

Fig. 5.14. A Florida family cutting a small pine tree to build an above-ground Crib-Walled Shelter in Flagler County. This family had hard luck in that the months-long drought was broken by a 3-in., all-day rain lasting what would have been the first 12 hours of their shelter-building effort.

To fell trees, the father and his 16-year-old son used an old crosscut saw that they had sharpened before this experiment began officially.

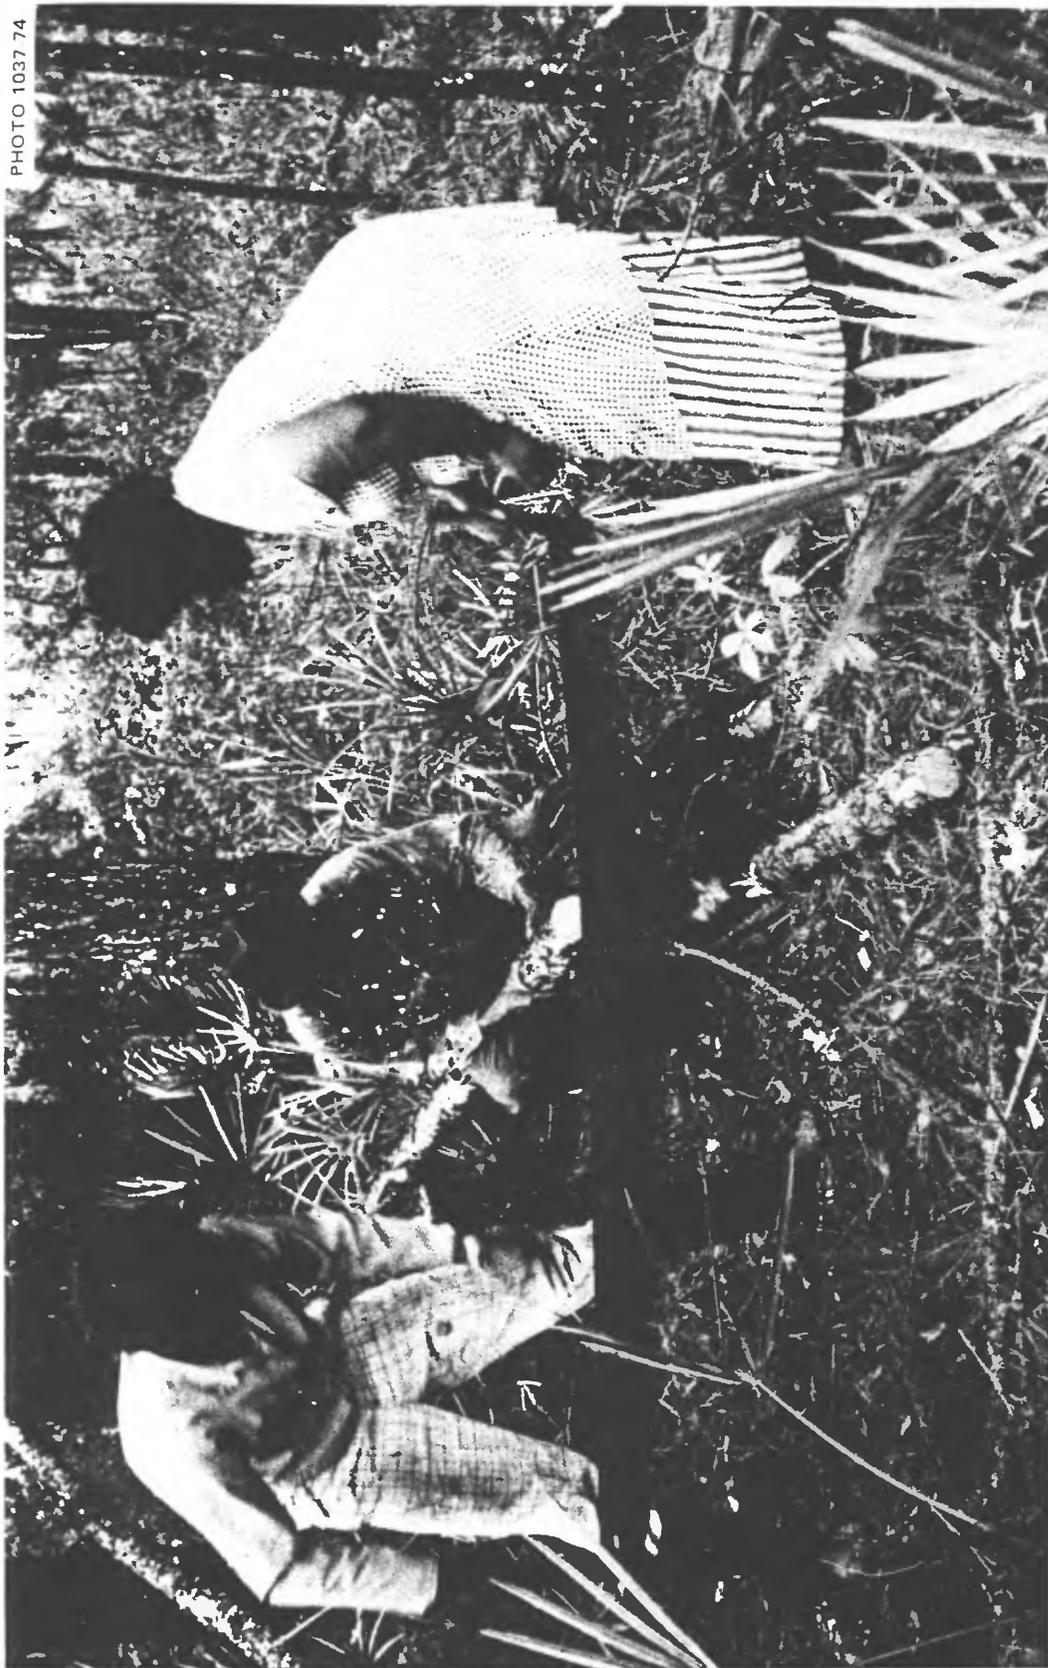
**Fig. 5.15.** Cutting a small felled tree into one of the specified lengths needed to build pole cribs. Later the cribs were lined with bed sheets and then filled with earth. Instead of following the instructions and pulling long poles to the shelter-building site, where they should have been cut to the desired lengths, this family chose to have the children carry small poles one at a time to the site.

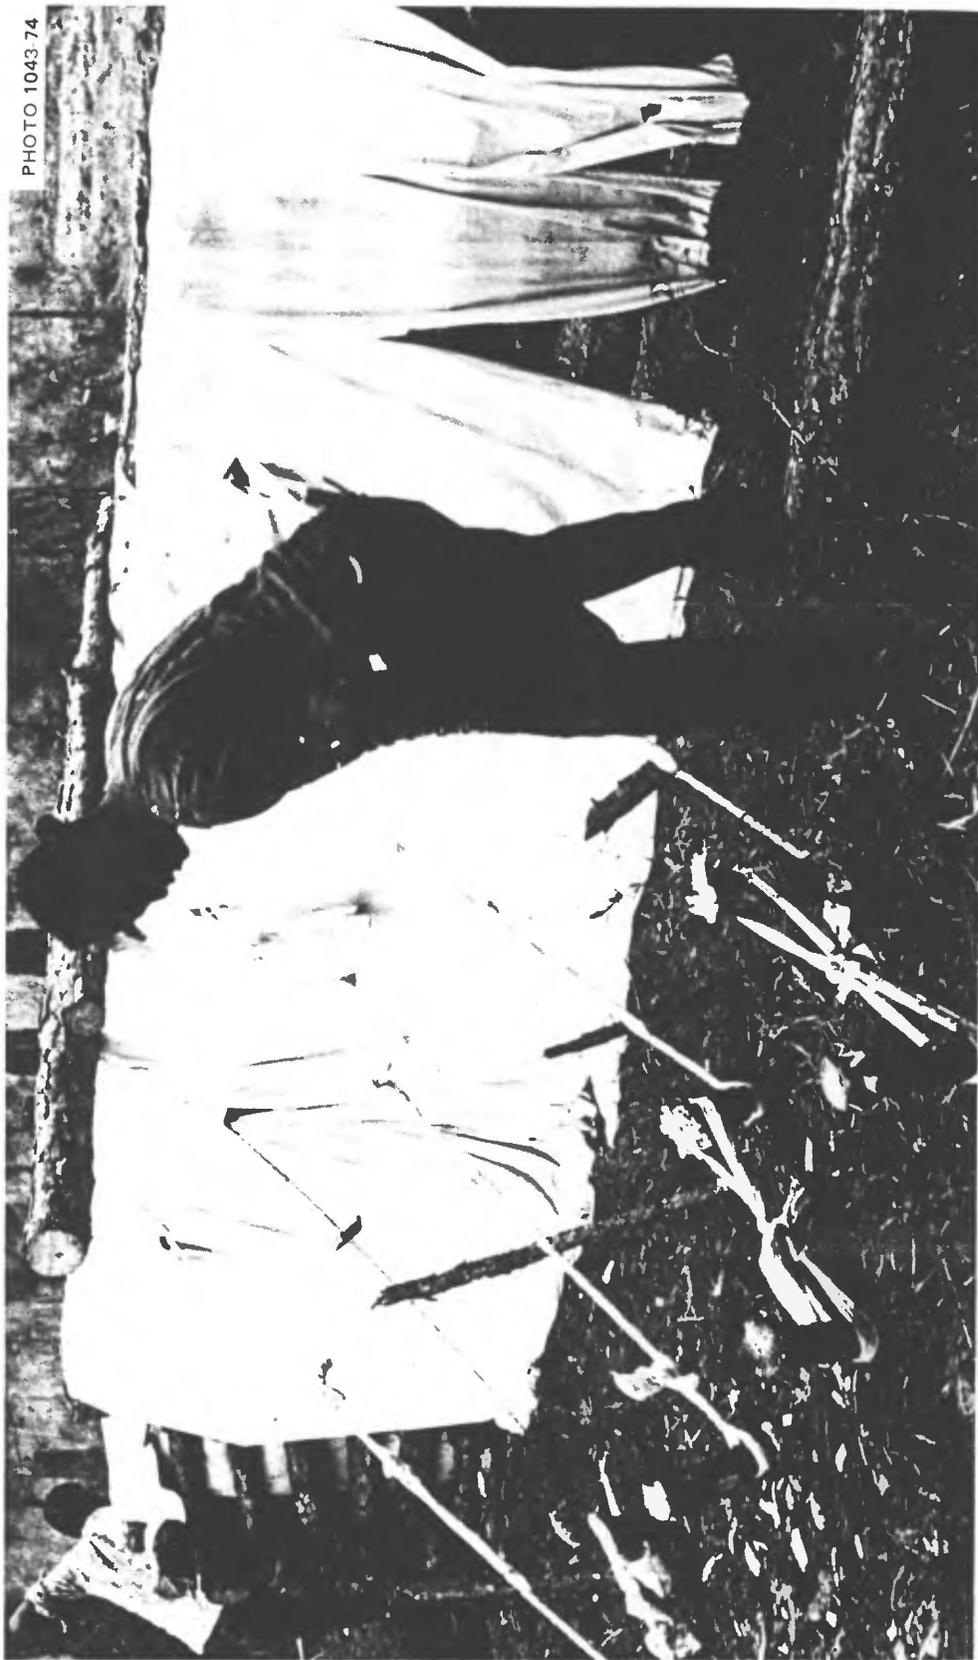
PHOTO 1043 74

Fig. 5.17. The outside of the spaced-pole walls of the shelter room, after it had been readied for mounding earth against it by guying vertical poles against the inside of this wall to stakes driven outside the wall. Note the guy ropes made of foot-wide strips of bed sheets, twisted and pulled tight by the twist-sticks near the inner line of stakes. These twist-sticks are kept from unwinding by being positioned so that their lower ends could be pressed against the ground. Later these guy ropes and sticks were completely covered by the earth mounded against this wall until the 2-ft-wide top layer was about 3 in. higher than the top of the spaced-pole wall. The bed sheets (with the help of earth arching) kept the earth from falling through the spaces between the poles.
