ORNL-5039  
UC-41-Health and Safety

HEALTH PHYSICS DIVISION  
EMERGENCY TECHNOLOGY SECTION

EXPEDIENT SHELTER CONSTRUCTION AND  
OCCUPANCY EXPERIMENTS

Cresson H. Kearny

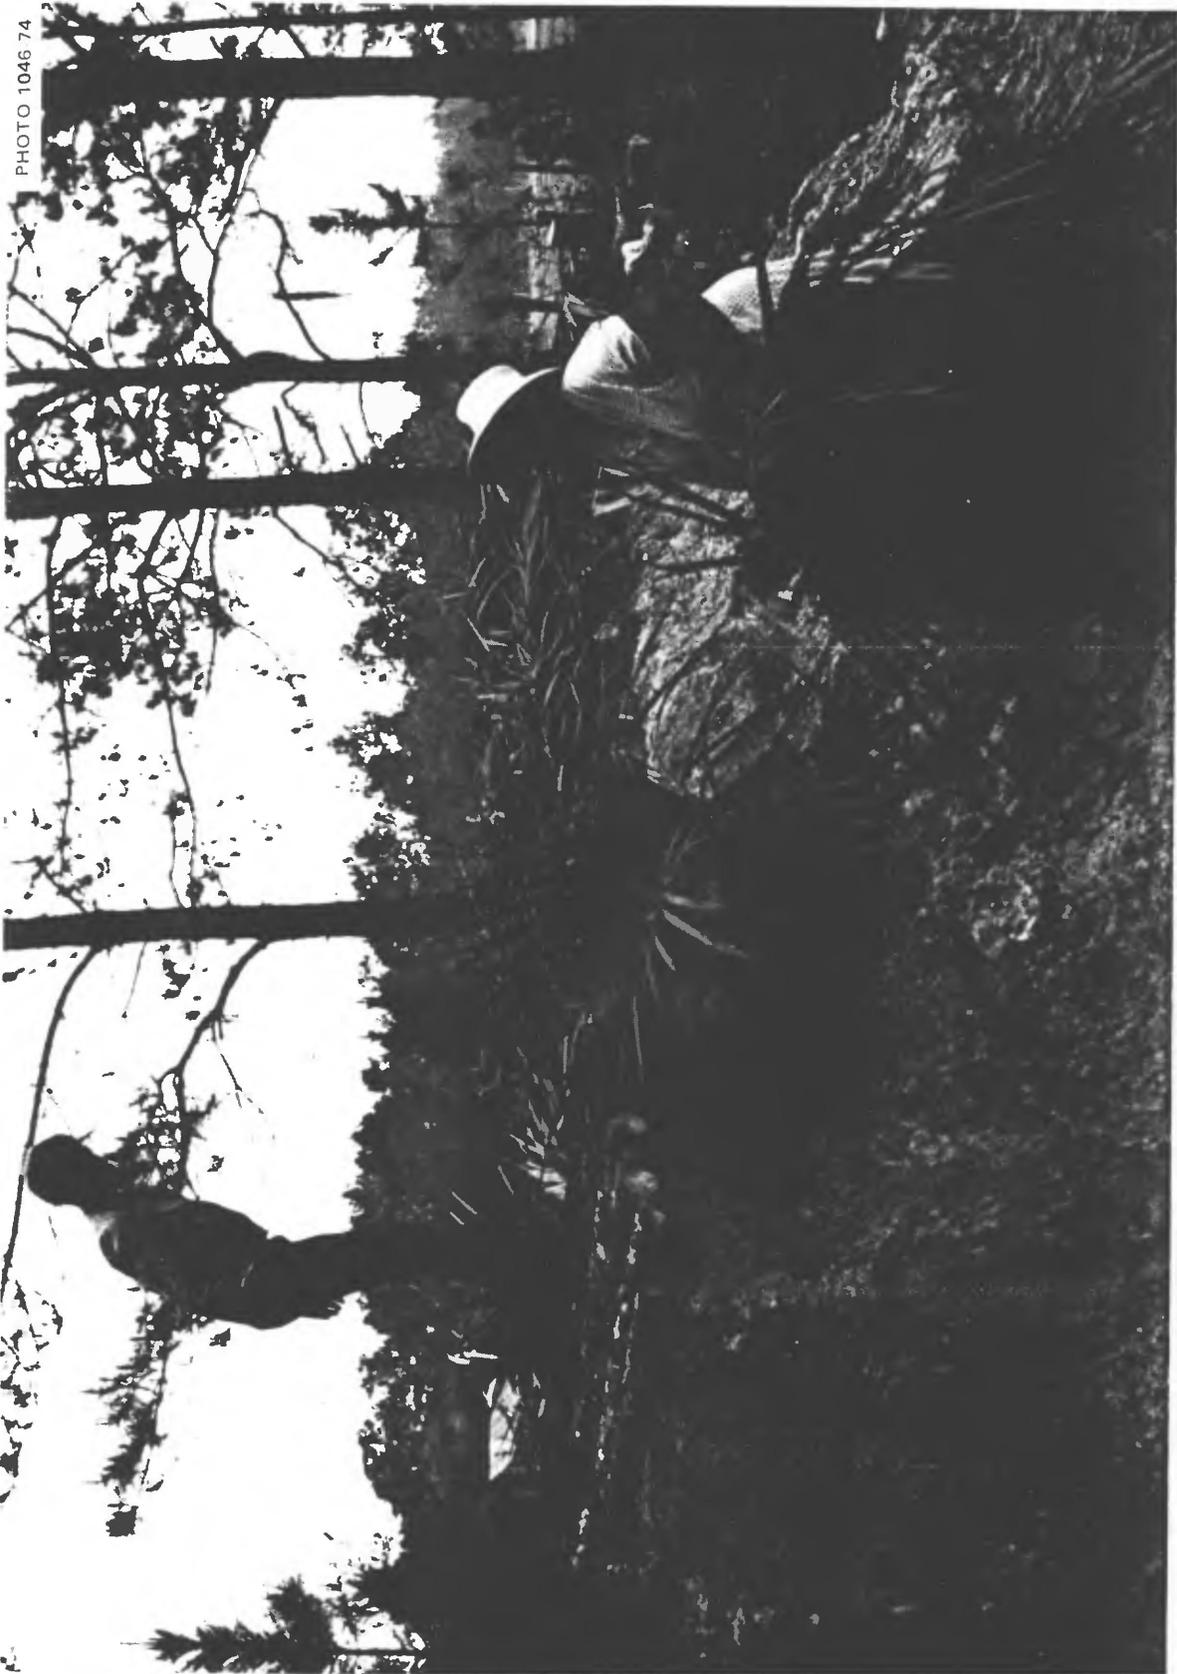
**Fig. 5.21.** Since this family lacked newspaper, cardboard, or other material to keep sand from sifting through the cracks between the roofing poles, they used palm leaves for this purpose. Grass or pine needles could have been used, but would have required more work, and might have contained ticks and chiggers.

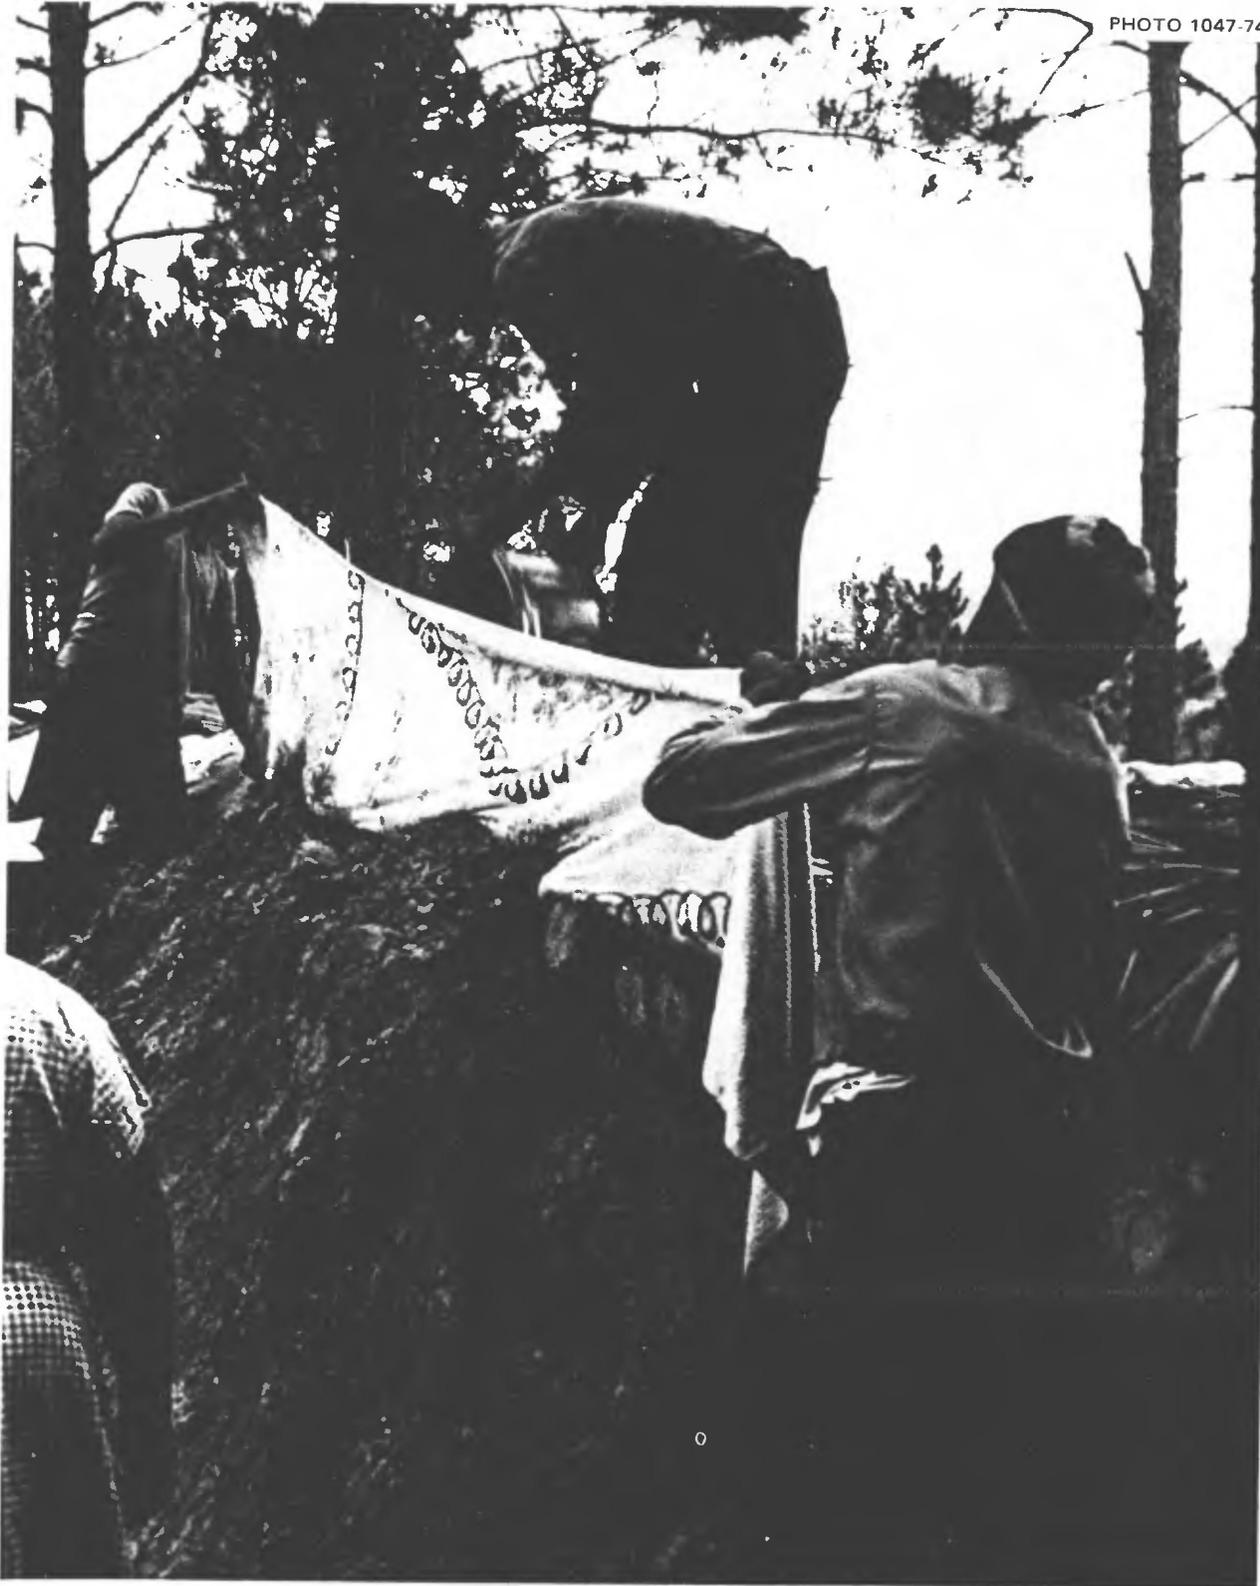
Fig. 5.22. Using an old bedspread to form an earth-filled roll along an upper edge of the essentially flat shelter roof of poles. The father is pouring earth out of a large bucket. These rolls made it possible to increase the stability of the earth covering around the edges of the roof, and also prevented heavy rains from washing any appreciable amount of shielding earth off the shelter roof.

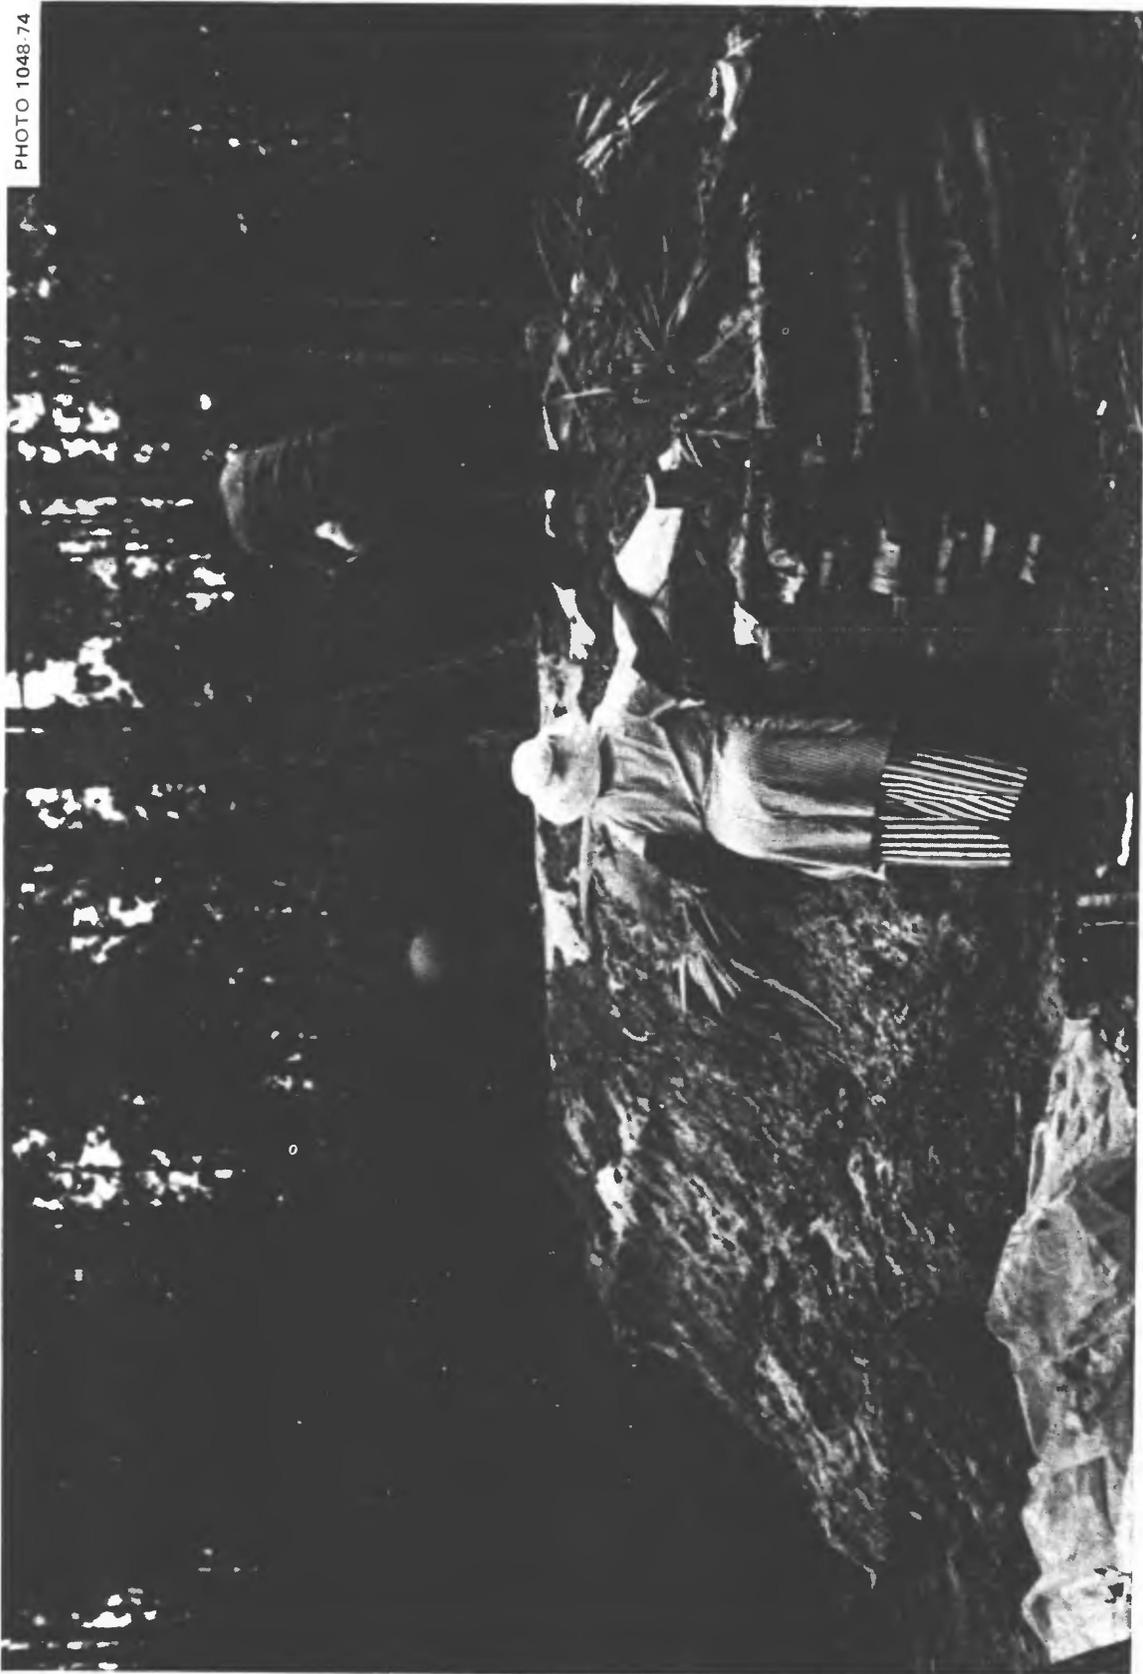
Fig. 5.23. After mounding earth over the shelter roof so that the earth was about 1 ft deep over its centerline, this family made a rainproof "buried roof" out of waterproof material. Since they had part of the north side of their home covered with a big piece of polyethylene film to keep the winter wind from blowing through cracks, they had enough waterproof material to bring with them to the shelter-building site to cover this entire shelter roof.

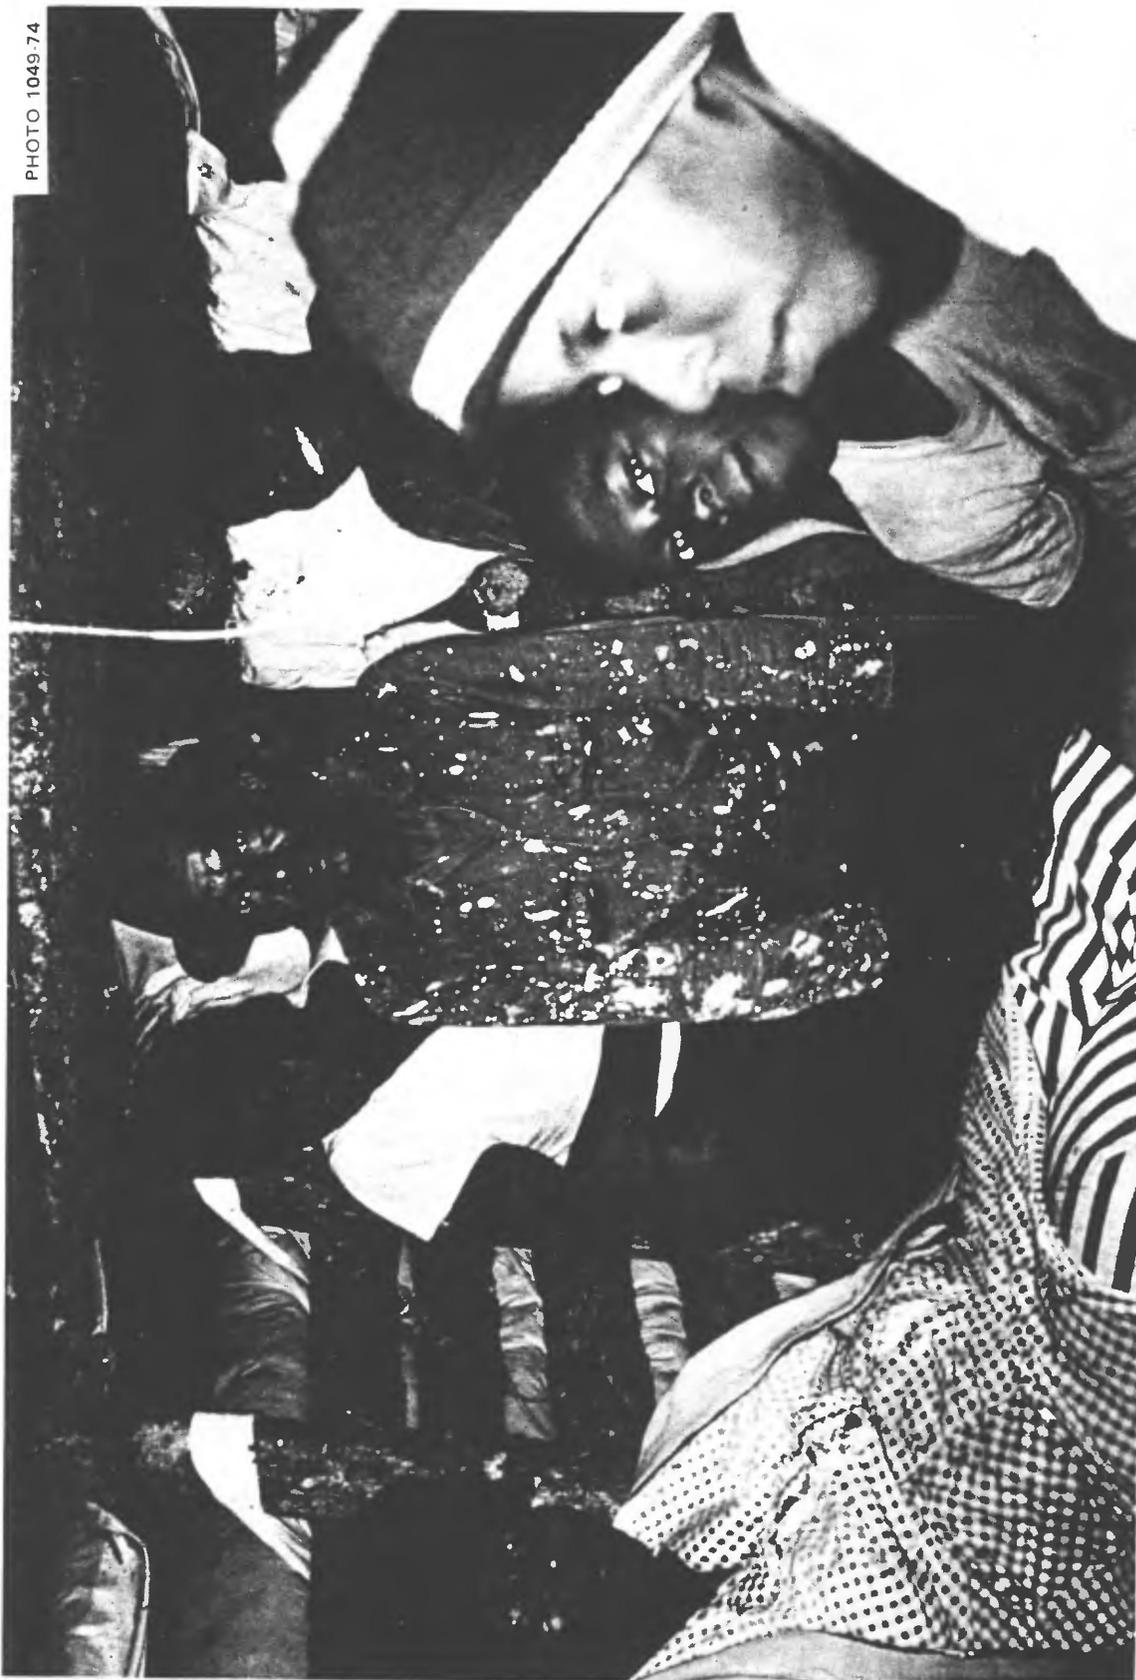
PHOTO 1049-74

5.25. Resting in the completed shelter, which inadvertently was built with its roof high enough to have permitted the occupants to sit on benches or boxes. The floor was carpeted with palm leaves. This family of six concluded their shelter was large enough for several additional persons, although the floor area of the well-shielded interior room was only 45 square feet.

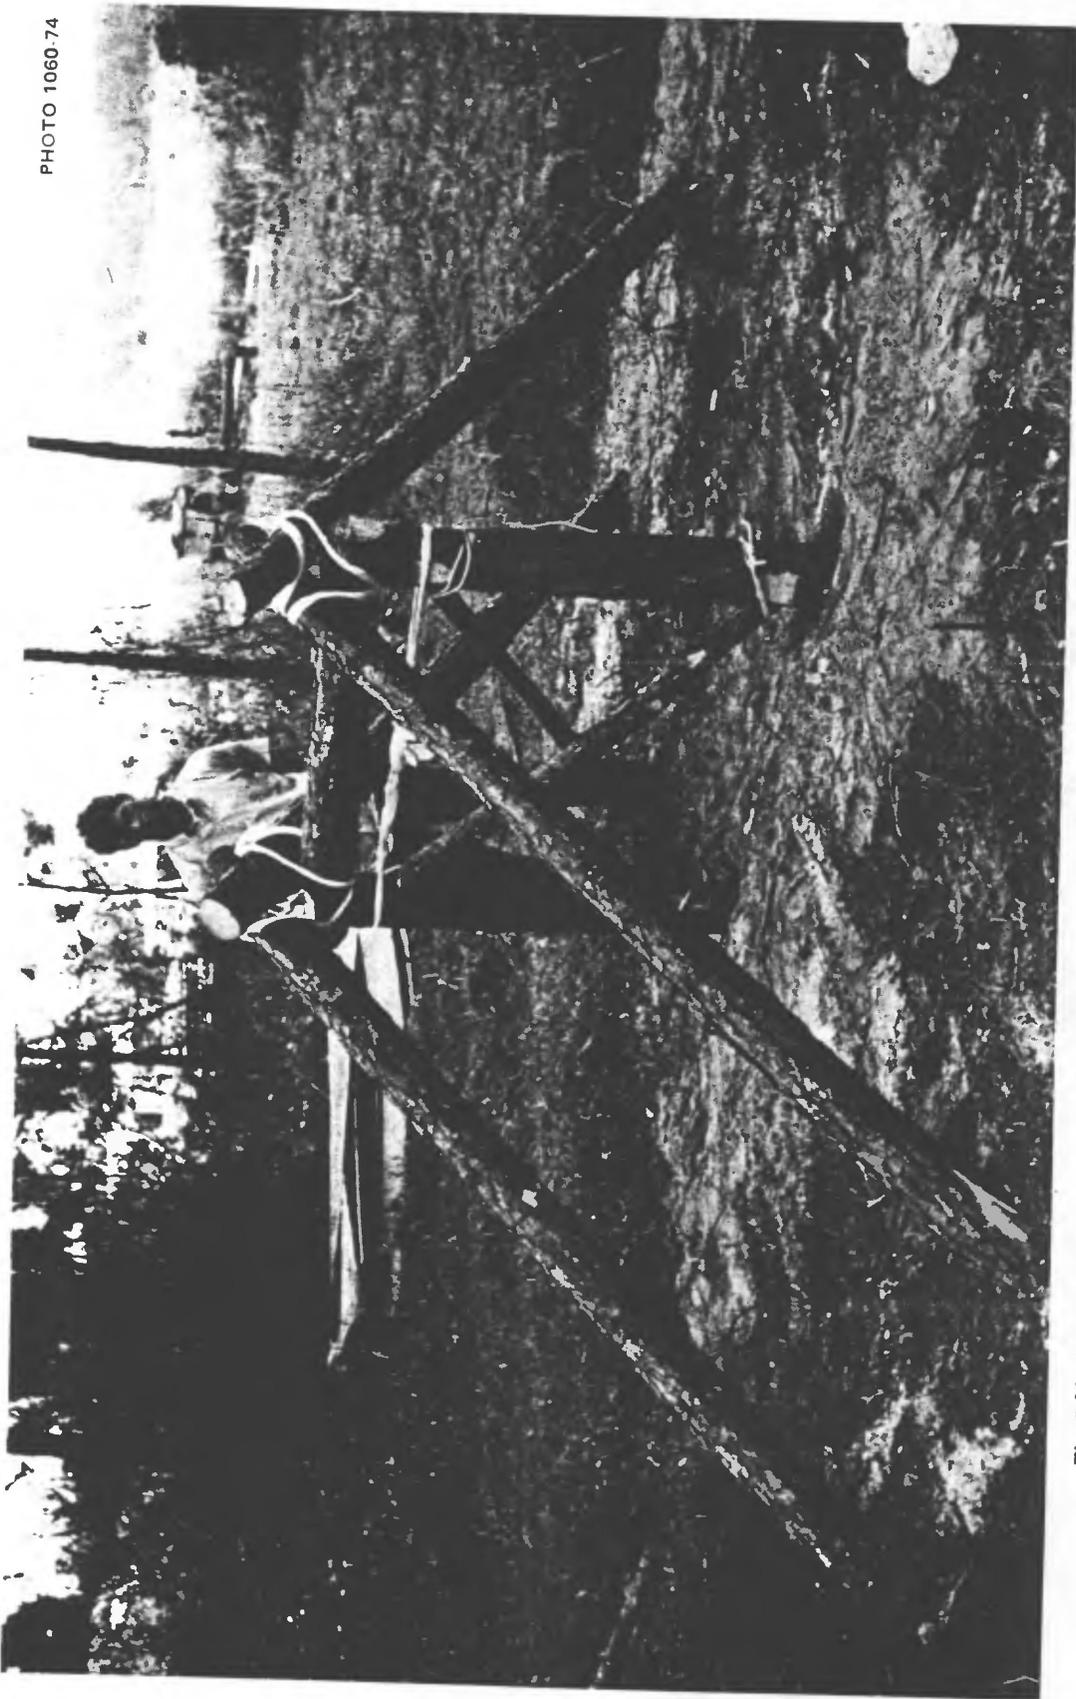
PHOTO 1060-74

**Fig 5.31. A second prototype of the frame of a Ridge-Pole Shelter, built without using a single nail. Slightly twisted strips of bed sheet, 1 ft wide, were used to hold this simple yet very stable structure together, and three pieces of rope were used to secure the notched cross-braces between the two vertical posts supporting the ridge pole. These vertical posts rested on flattened small areas cut on the upper side of a slightly below-ground footing log. Small poles on the outer side of the vertical posts, just below ground level, prevented any sideward movement of the bottoms of the vertical posts.**

Kearny concluded that this design is too complicated for some unskilled families to build, because of the notching and fitting required if no nails are used.

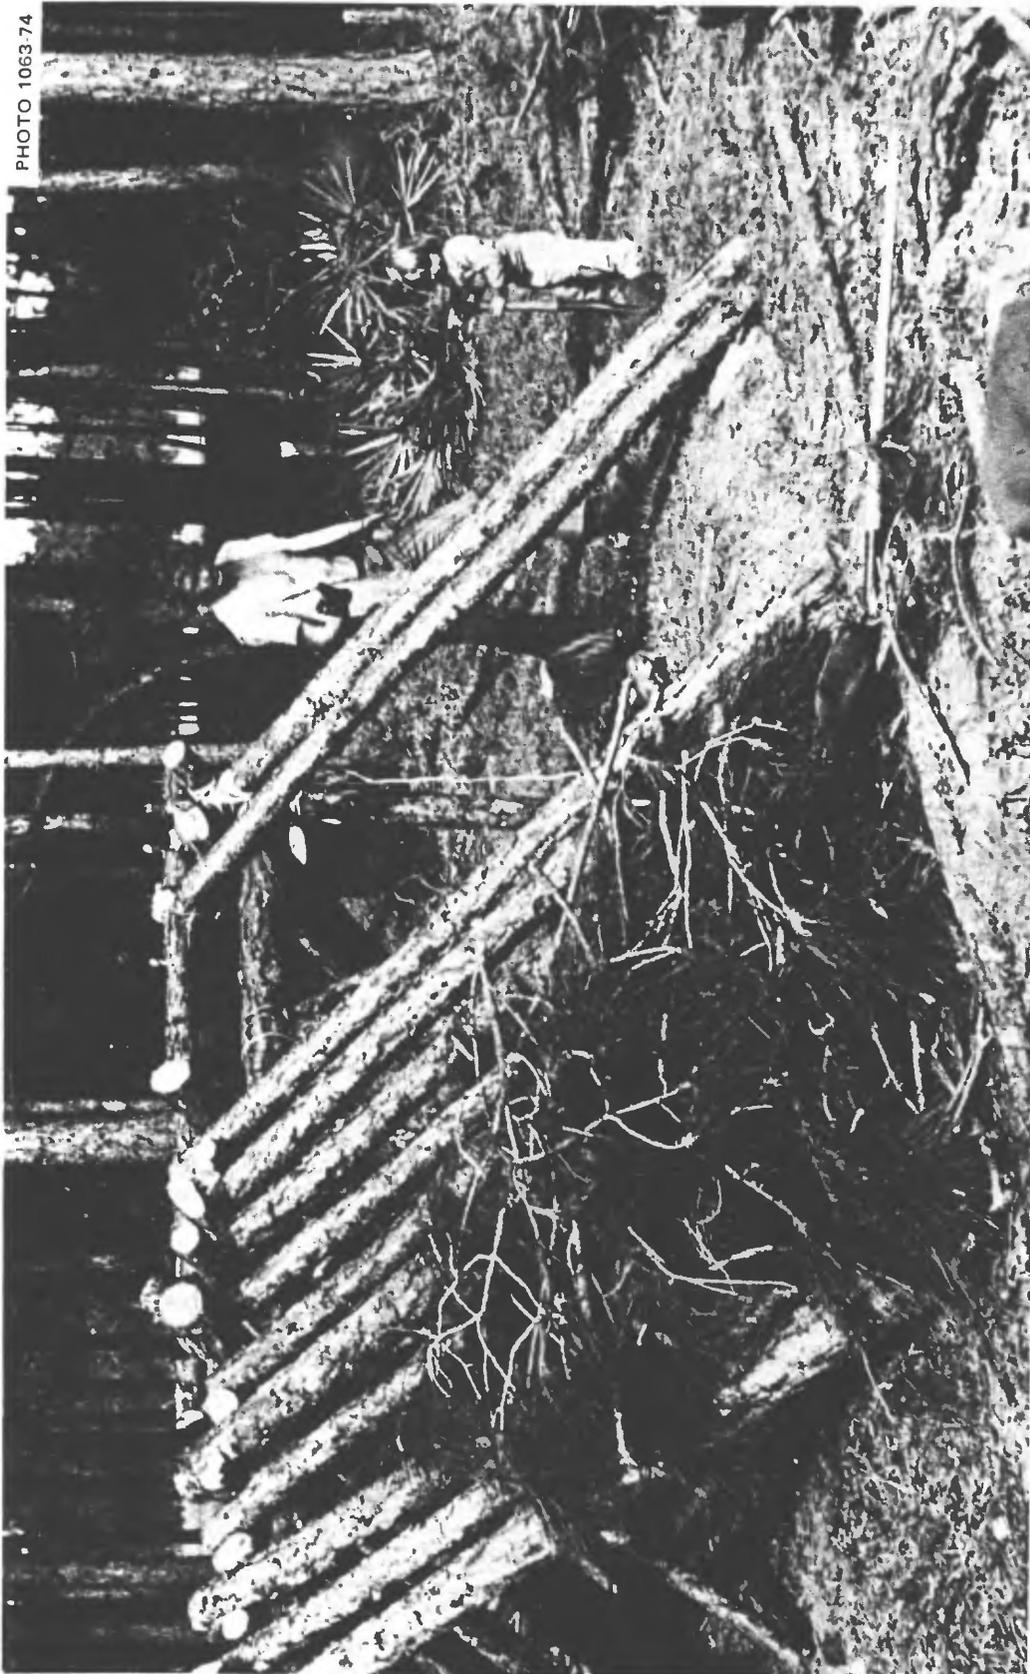
PHOTO 1063-74

Fig. 5.33. The Waldens' Ridge-Pole Shelter had a ridge pole 16 ft long, supported by 4 vertical posts, each with a shallow V notch in its upper end. The roof poles on the sides were each 9 ft long; their lower ends rested in a V trench only 4 in. deep. In these very shallow trenches were placed poles only about 3 or 4 in. in diameter, with one side flattened. The lower ends of the 9-ft roofing poles pressed against the flattened sides of these small poles that probably were unnecessary.

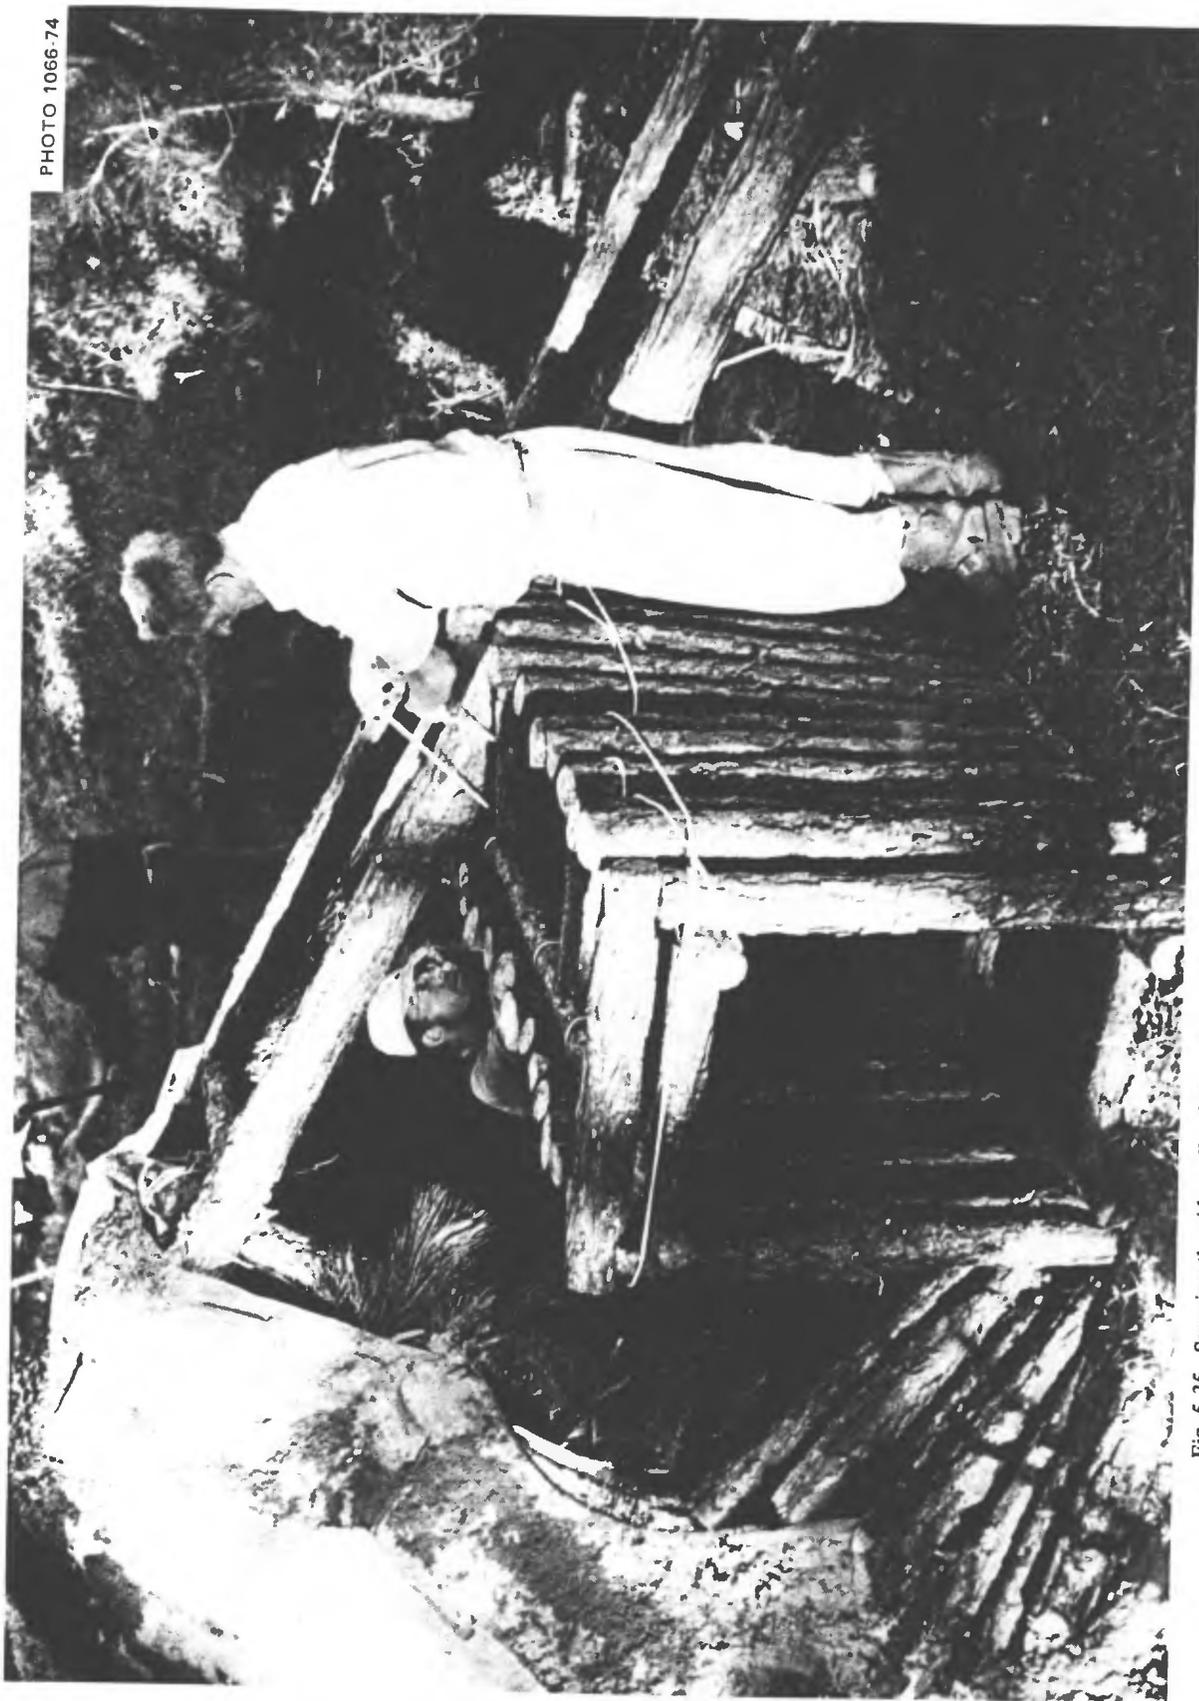
PHOTO 1066-74

Fig. 5.35. Securing the side walls of the outer part of an entryway that had a right-angle turn before it reached the main shelter room. This entryway was built like a miniature Small-Pole Shelter. When this photo was taken, the horizontal roofing poles of this entryway had not been placed on the upper ends of the vertical wall poles of the entryway. The vertical wall poles could have been held in place by piling earth against them.

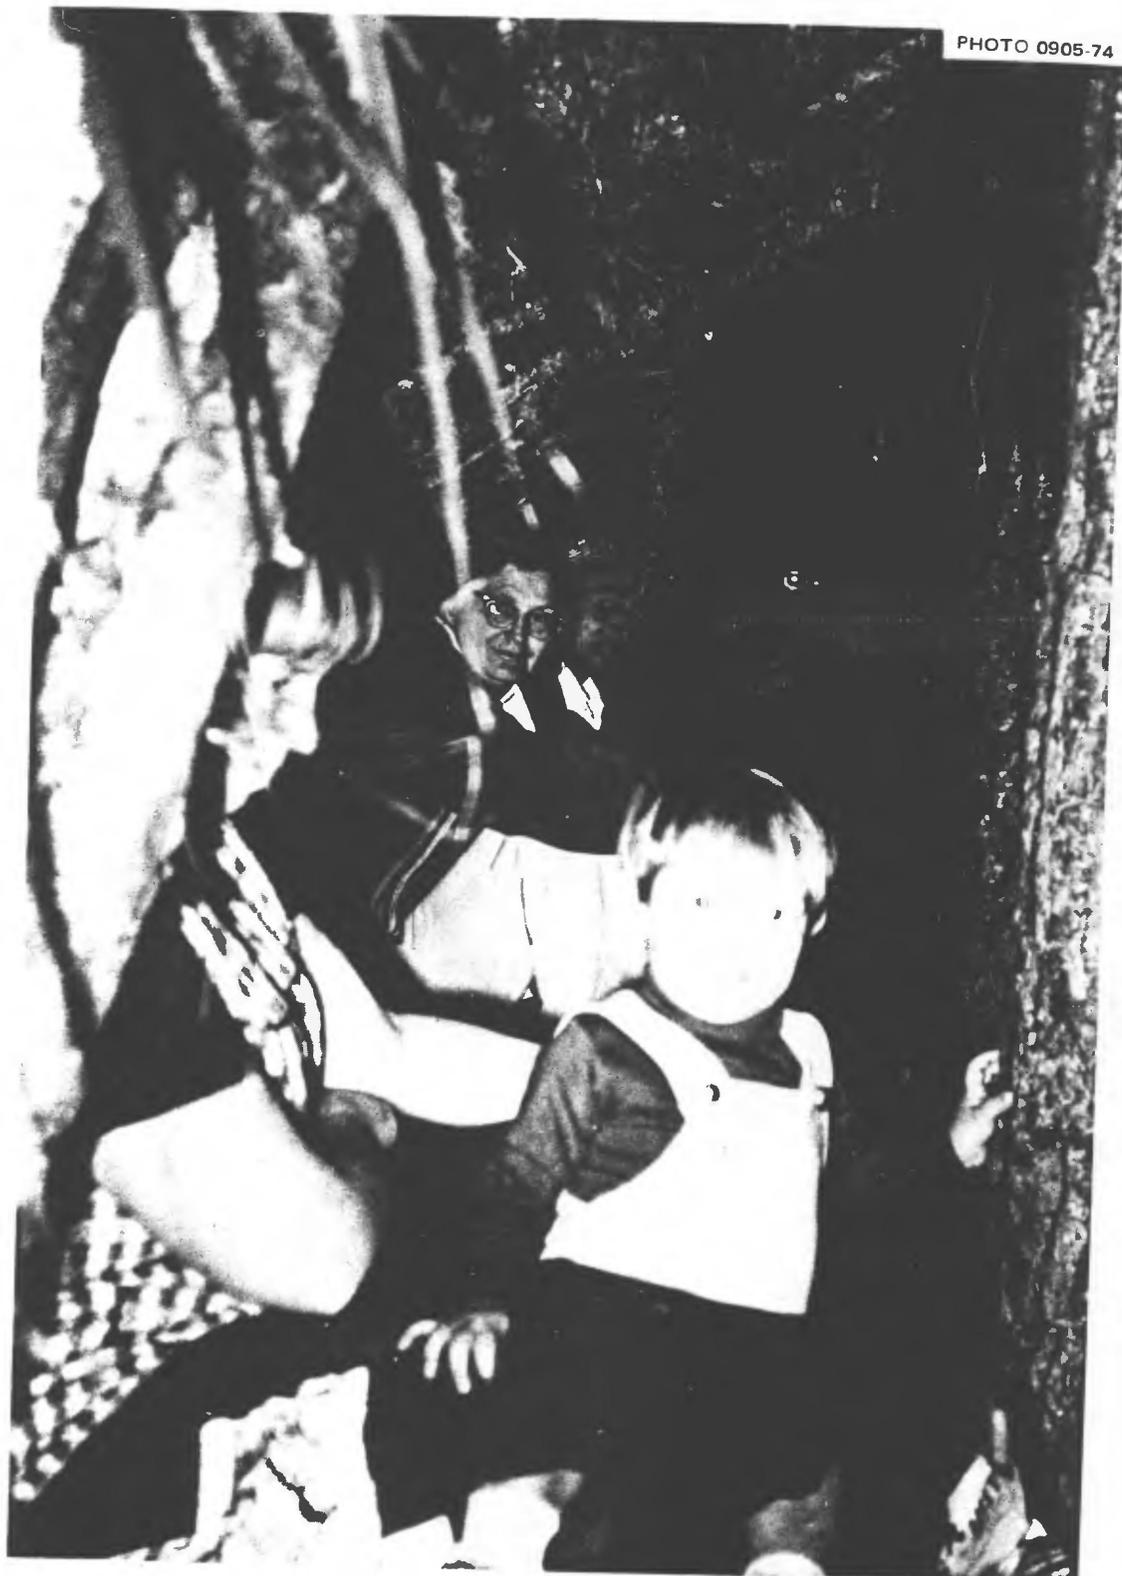
Fig. 5.38. View inside the Waldens' Ridge-Pole Shelter, showing a part of one side. This shelter had a main room 13 ft wide and 16 ft long. The Waldens concluded that it was big enough to shelter at least 20 people, with plenty of room for food and other possessions. The four centerline posts were not objectionable.

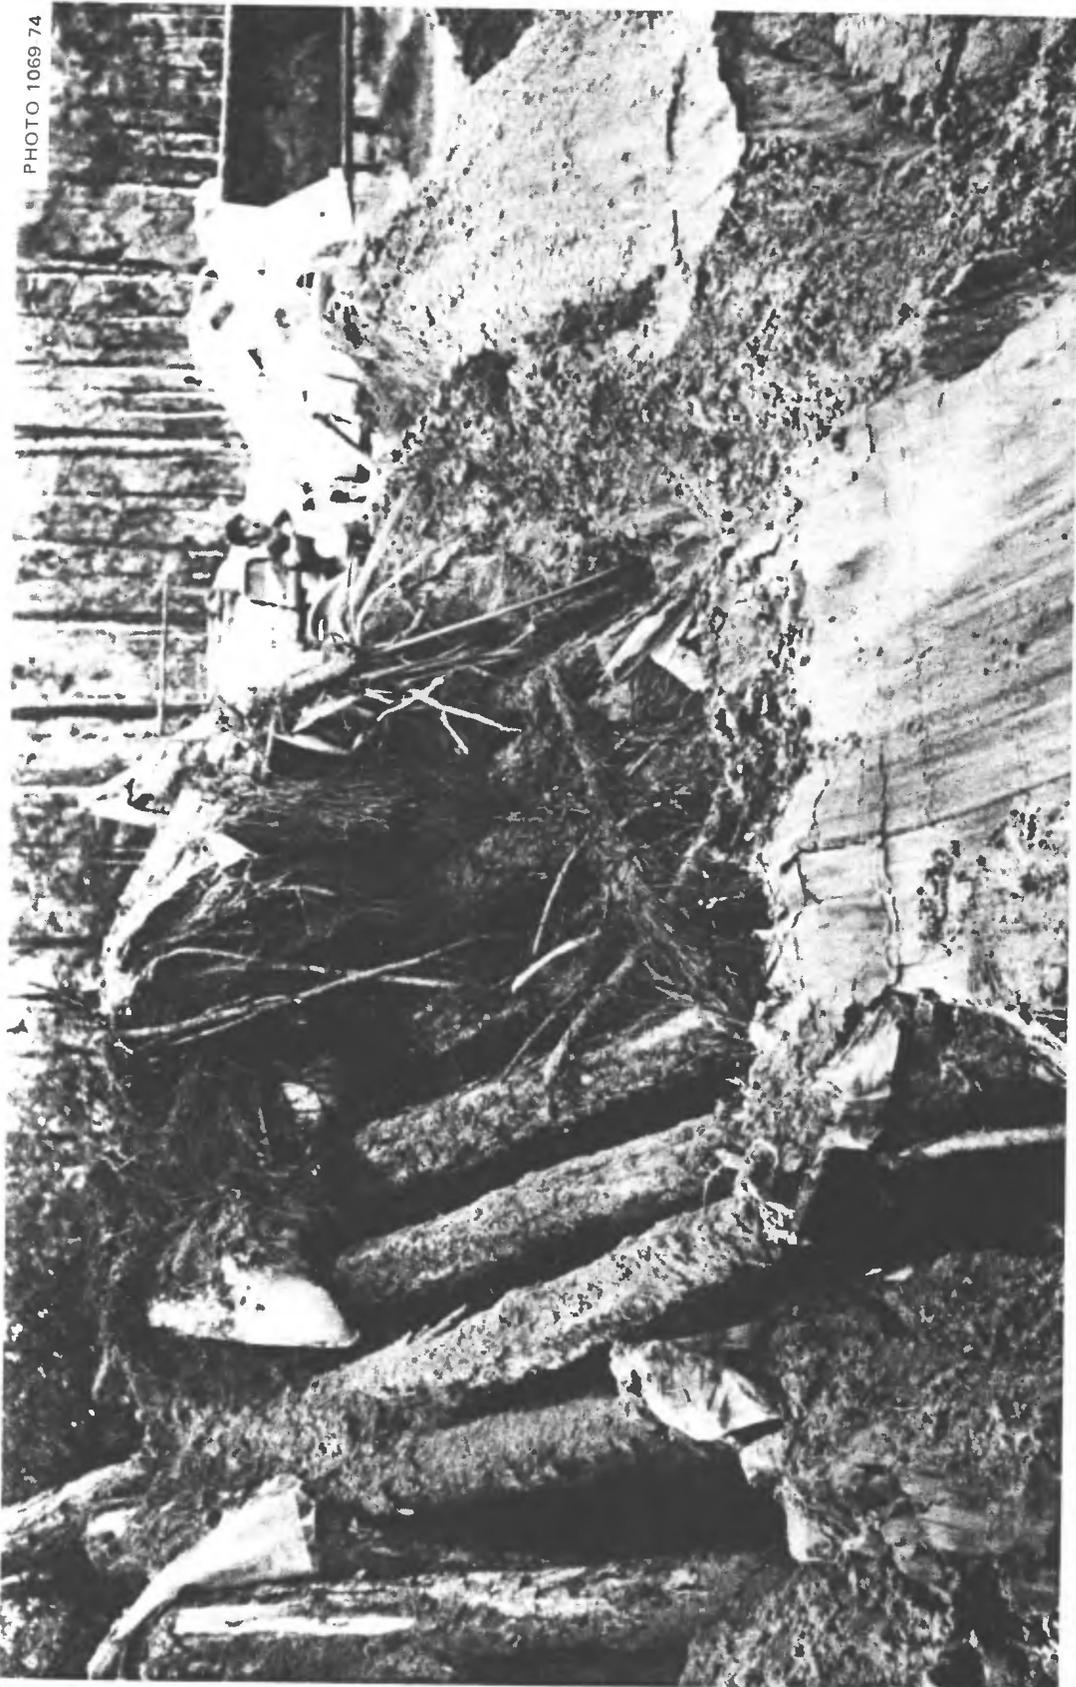
**Fig. 5.40.** View after a backhoe had started to demolish the Waldens' Ridge-Pole Shelter, which proved to be decidedly sturdy. Note that some of the wall poles were broken before they were moved off the ridge poles, or the ridge pole had been moved significantly.

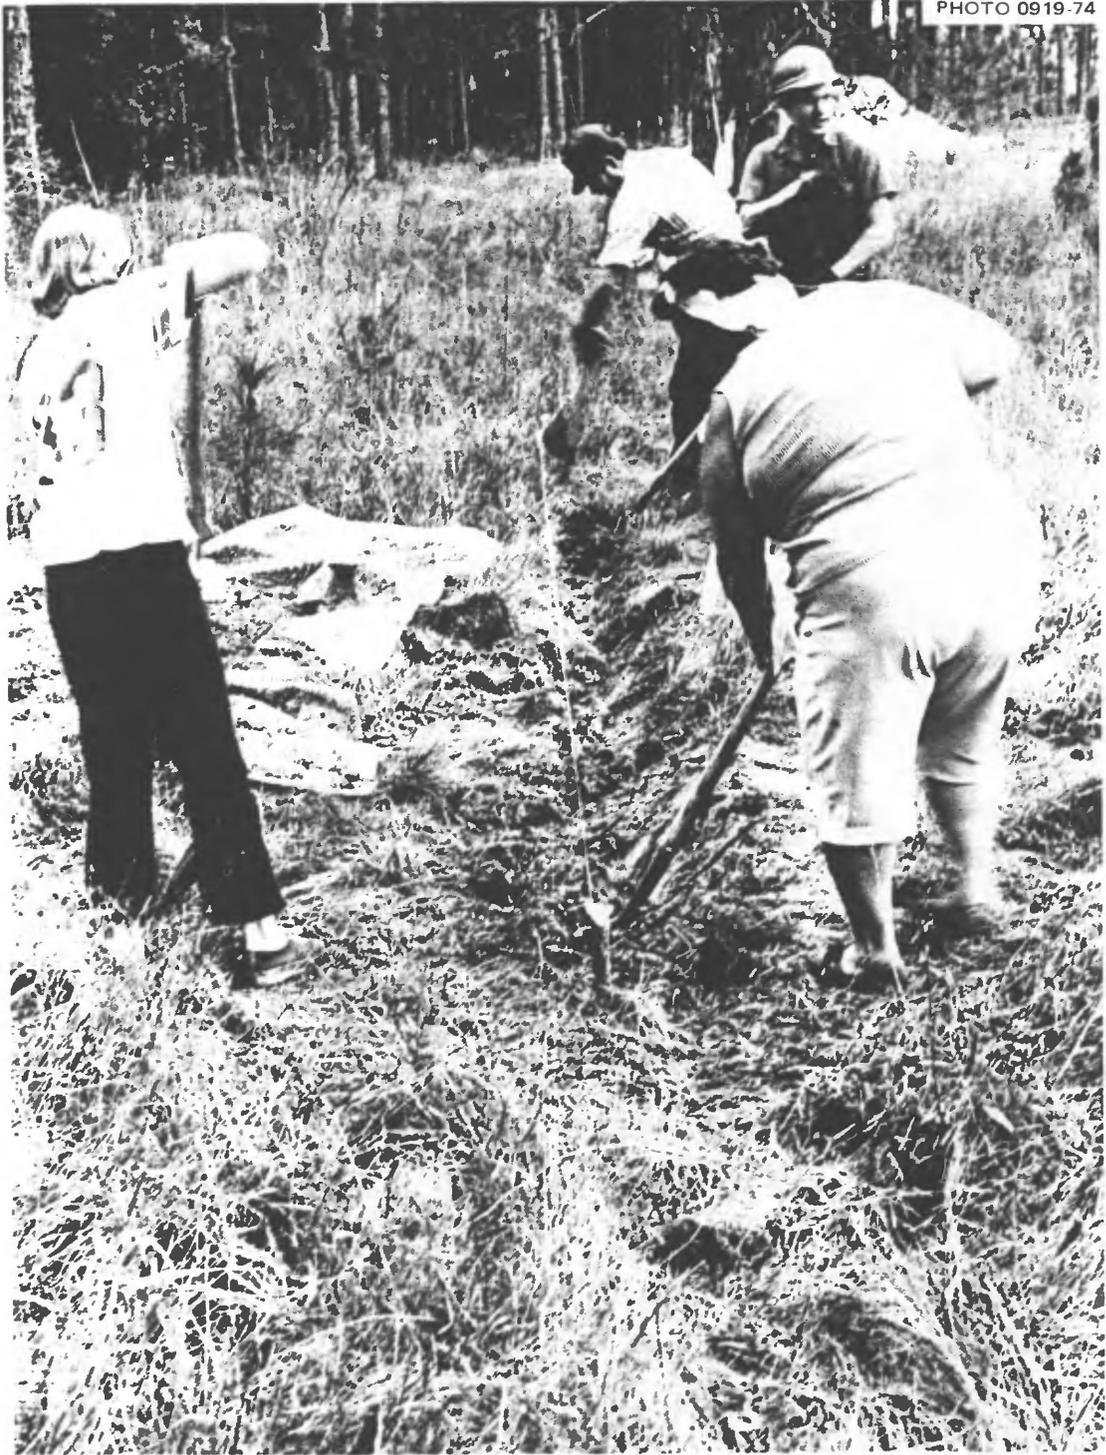
**Fig. 5.42.** Starting to build a 21-person above-ground A-Frame Pole Shelter. Five families, having 22 persons in all (including two babies and three adults unable to do heavy work) built this shelter with a main room 21 ft by 13 ft wide. The roof poles (not shown) had a minimum small-end diameter of  $3\frac{1}{2}$  in. and sloped approximately  $36^\circ$ . This photograph shows one of the 6-in.-deep, "V"-shaped trenches being dug to secure the lower ends of the 9-ft roof poles, that measured 9 ft on their short sides.

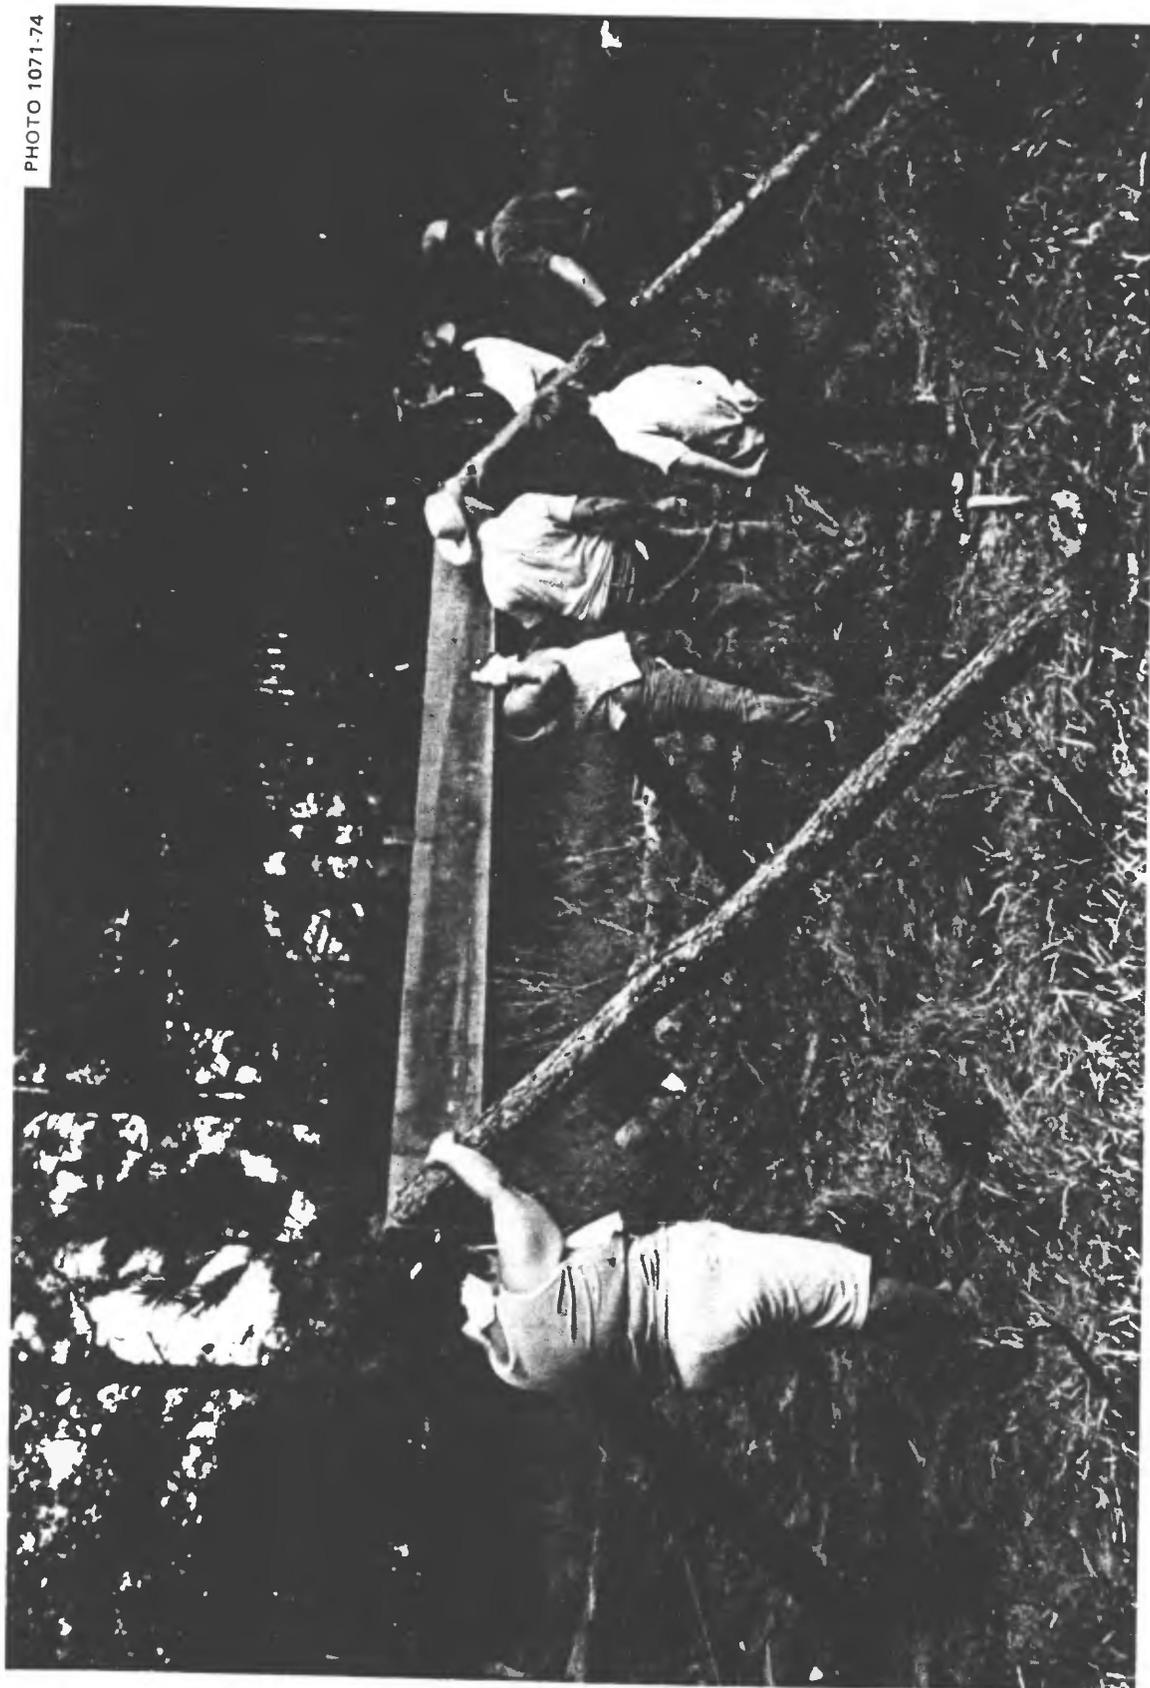
Fig. 5.44. Erecting a 16-ft-long section of the ridge board that later was extended to a 21-ft length. These decidedly competent rural people were so overconfident of their building abilities that they failed to read the instructions carefully. As a result, they made several errors that they had to correct. One of these errors was initially using a 5-in.-wide board for the first part of the ridge board; they found that the upper ends of some of the wall poles would not fit properly against a board so narrow.
