ORNL-5039  
UC-41-Health and Safety

HEALTH PHYSICS DIVISION  
EMERGENCY TECHNOLOGY SECTION

EXPEDIENT SHELTER CONSTRUCTION AND  
OCCUPANCY EXPERIMENTS

Cresson H. Kearny

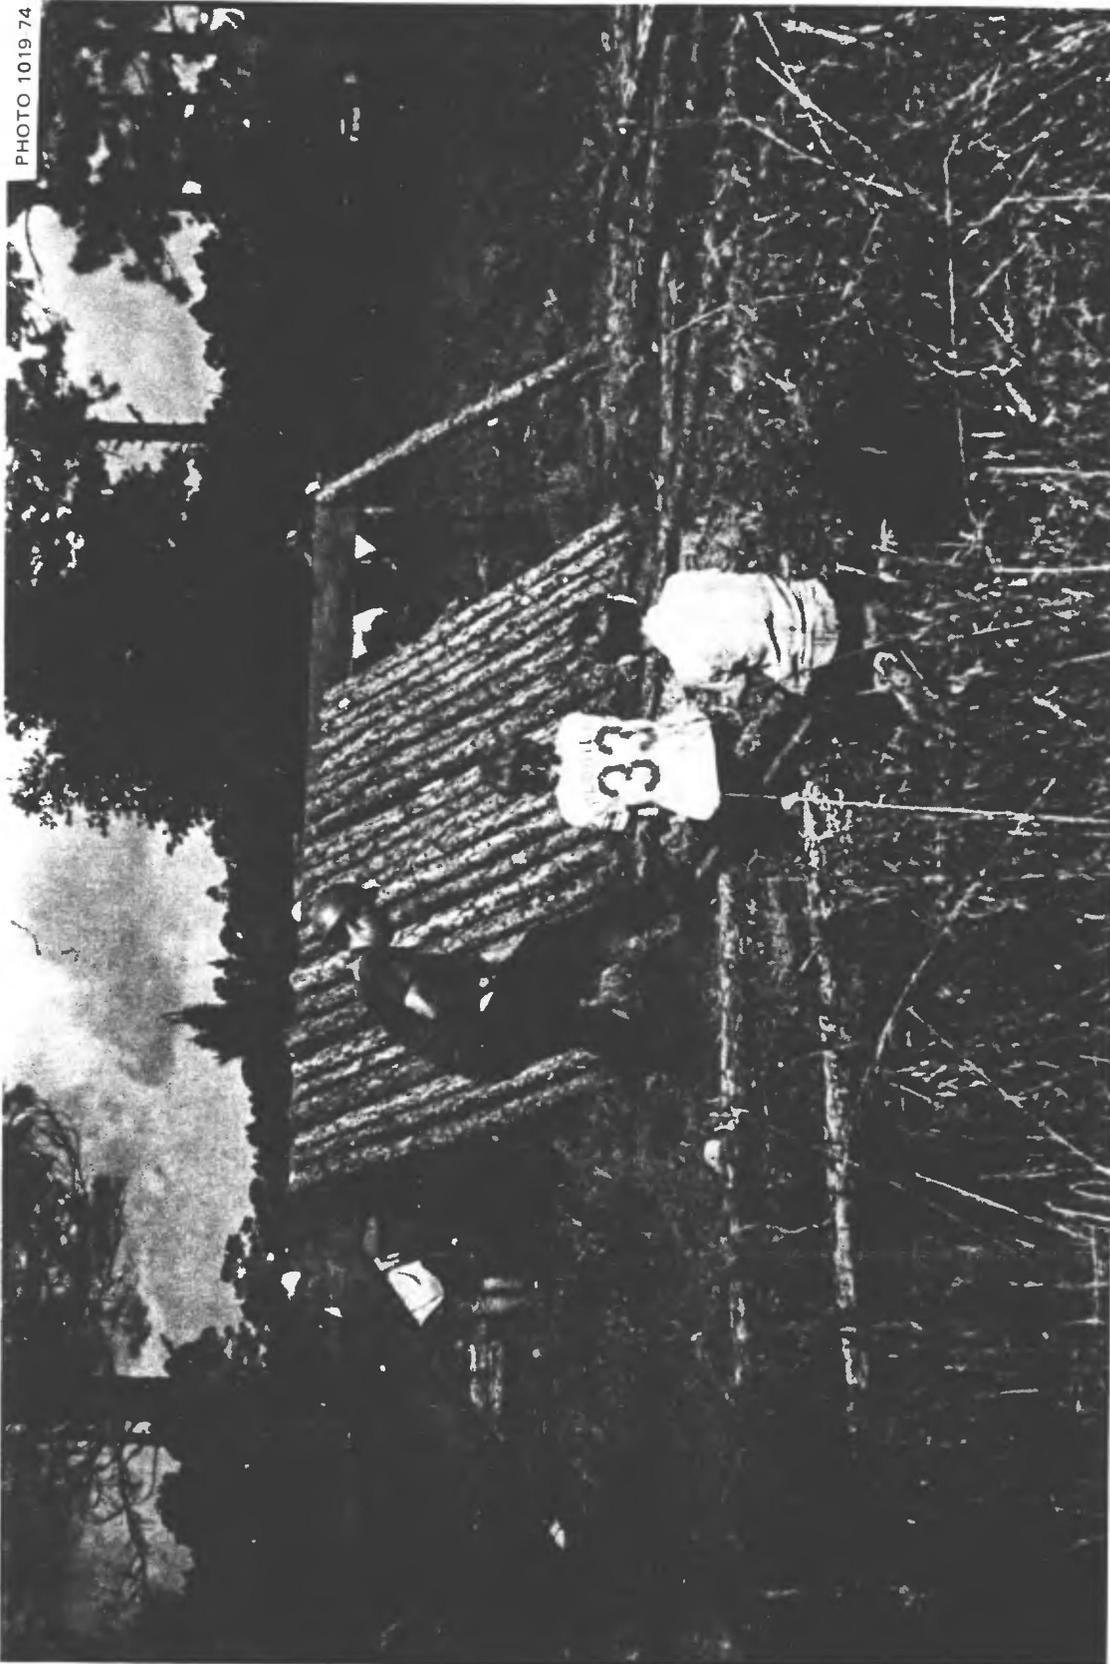
**Fig. 5.45.** Chain saw operator using a templet to cut an upper end of a wall pole at the specified  $54^\circ$  angle and 9-ft length on its short side. The templet was made from a wide 10-ft board, with one end cut at  $54^\circ$ . A nail was driven 9 ft from the end of this  $54^\circ$  angle; the squared-off base of the pole was placed against this nail.

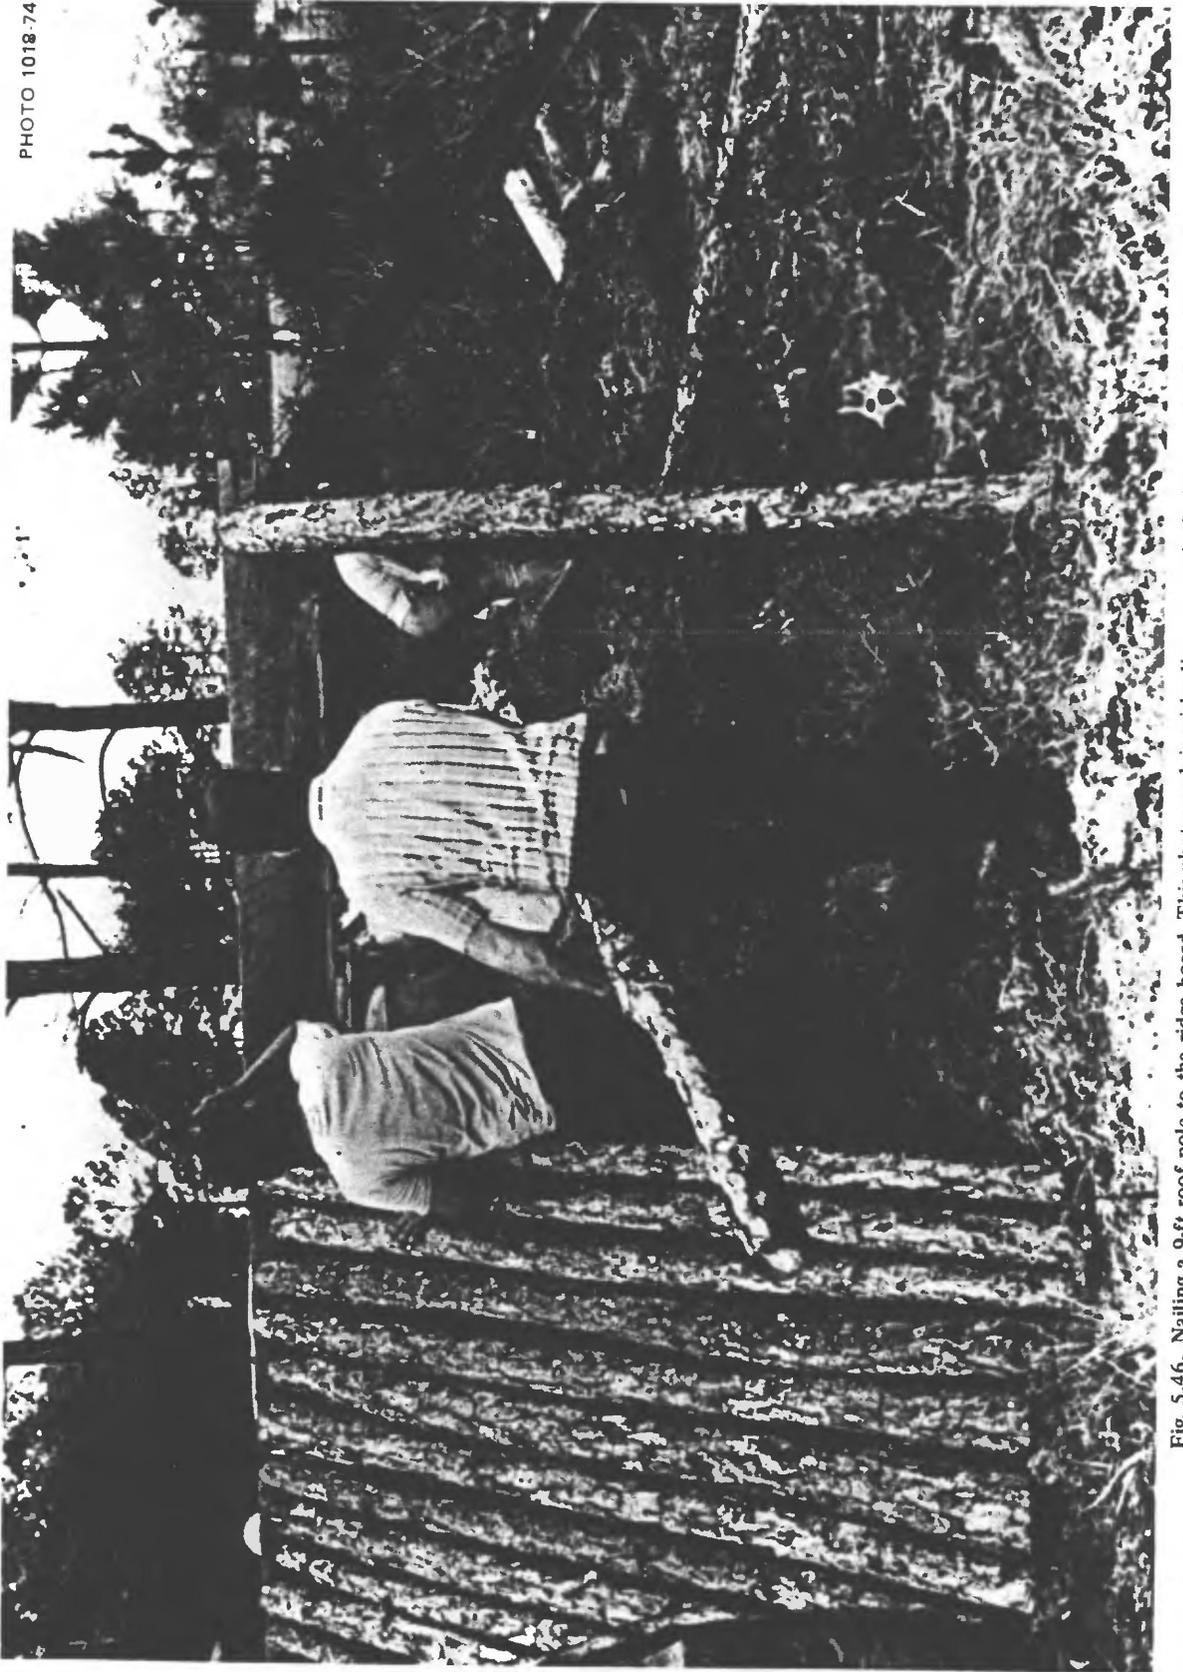
PHOTO 1018-74

Fig. 5.46. Nailing a 9-ft roof pole to the ridge board. This photograph is misleading as regards the lower ends of the ridge poles; actually the ends rested against a 1 x 6 board placed against the outer side of the 6-in.-deep V trench that marked the edge of each shelter side wall.

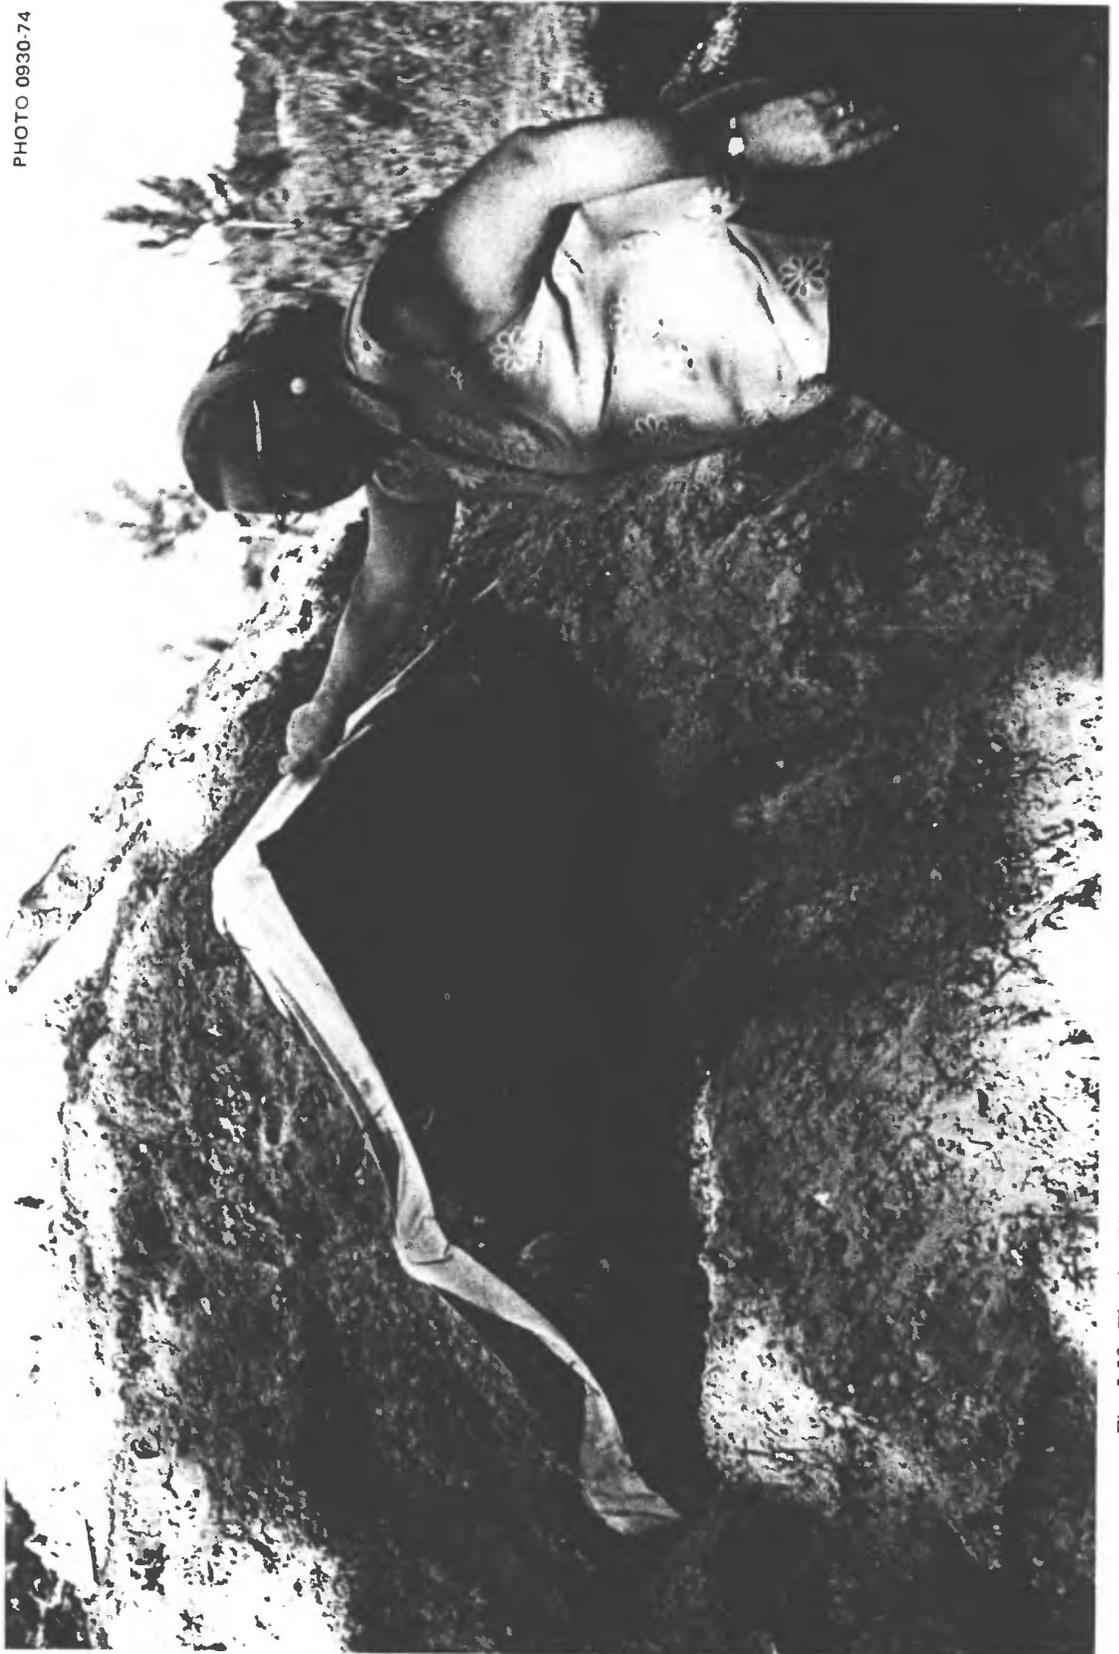
PHOTO 0930-74

Fig. 5.50. The simplified, but not as protective, ventilation opening constructed in what had been the end of the shelter toward which the skewing movement occurred. Seven-foot poles were placed on the roof poles, parallel to the ridge board and extending 3 ft beyond the outermost wall poles. Those 7-ft poles formed the overhanging gable shown in this photo. Later, the earth cover was thickened.

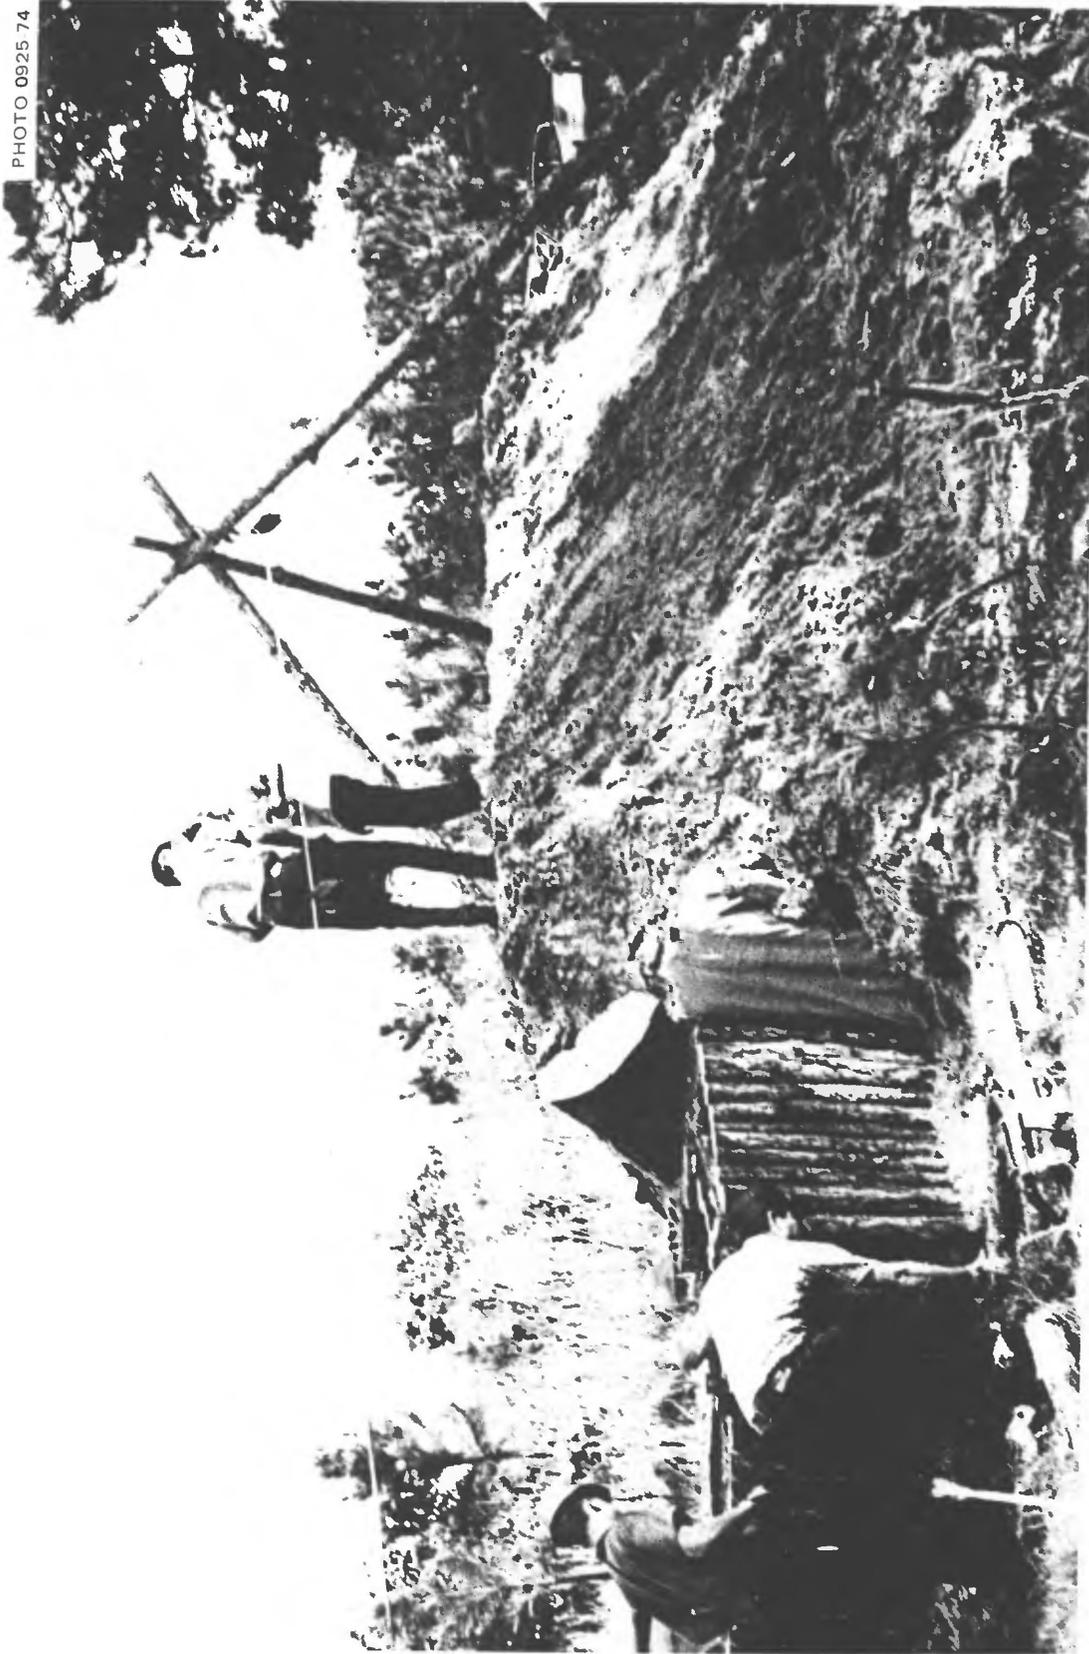
PHOTO 0925 74

Fig. 5.51. The pulley conveyor system actually wasted energy and time, since earth had to be lifted in a 5-gallon paint can up to the hook on the movable pulley; then the earth-filled can was pushed up the upward-sloping nylon rope to a position several feet above the top of the shelter. Then most of the earth rolled down below the top of the shelter, obviously wasting thousands of foot-pounds of work.

The entryway pictured is a miniature version of two small-pole shelters, joined so as to produce a 90° turn. The opening of this entryway faced away from the camera.

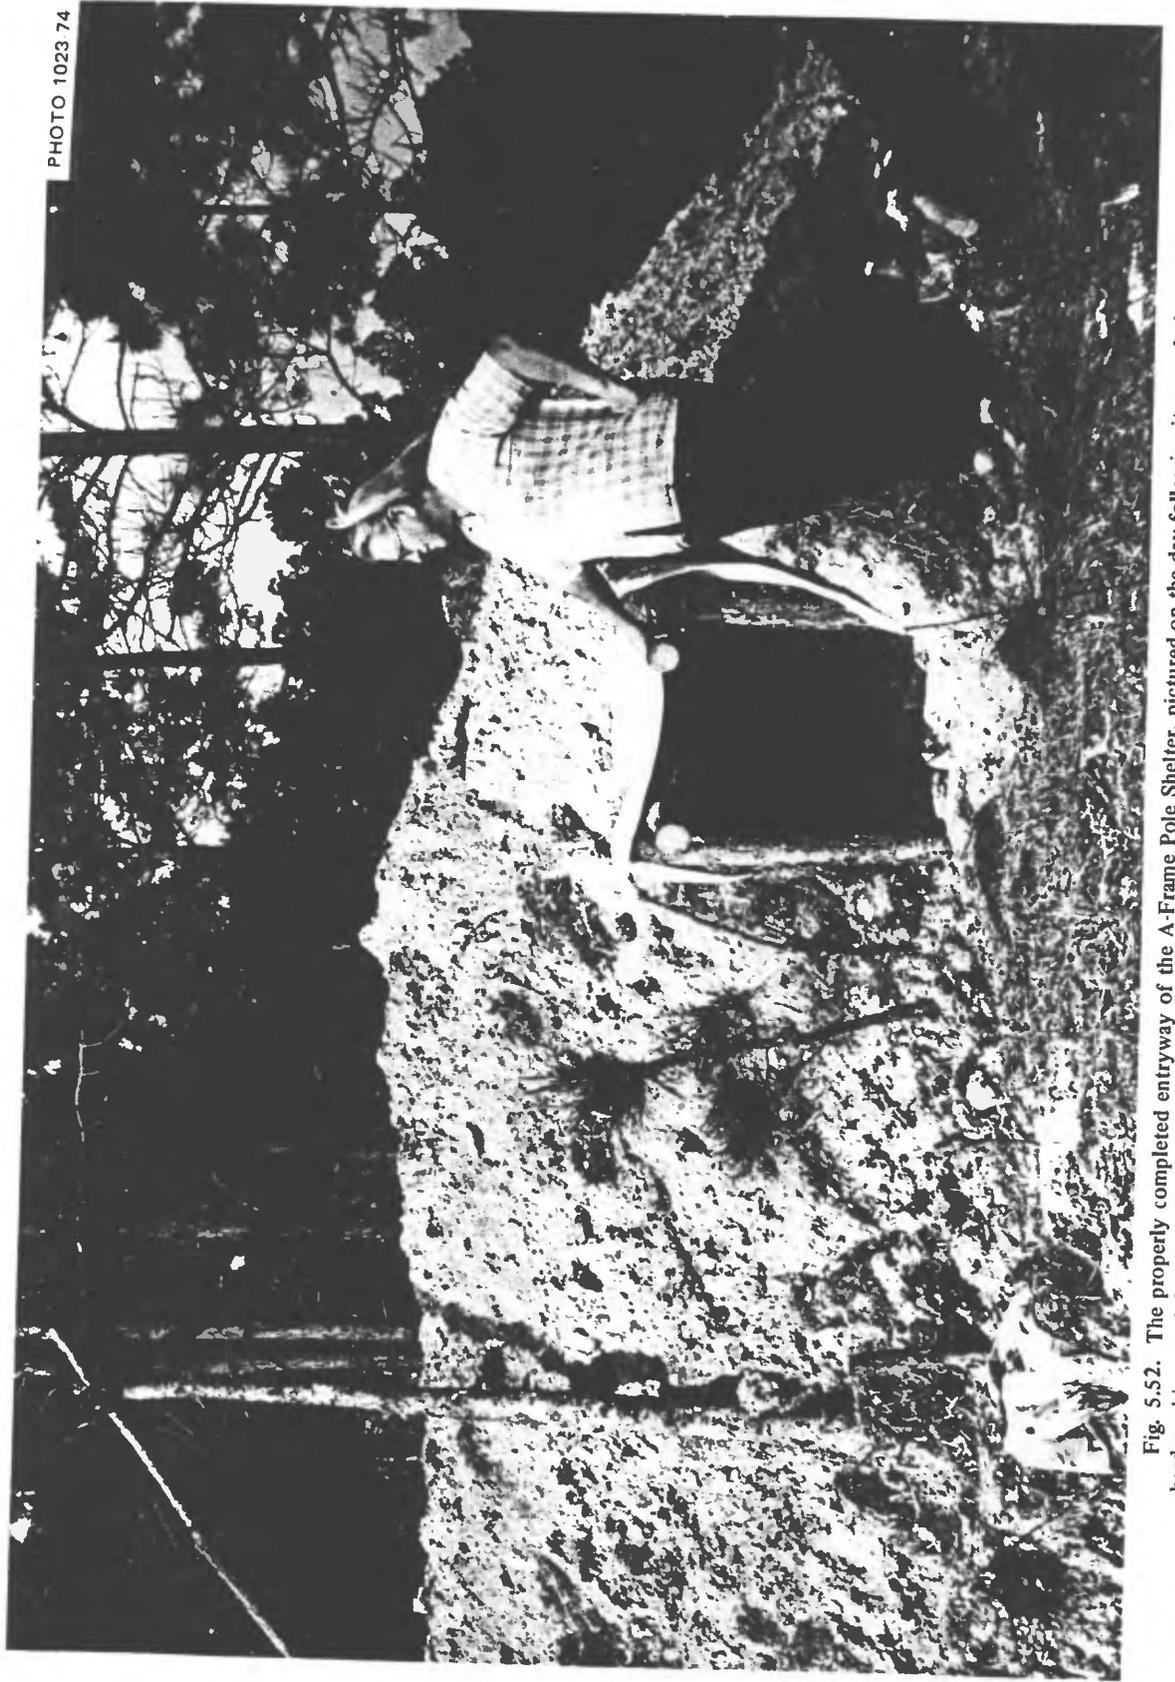
Fig. 5.52. The properly completed entryway of the A-Frame Pole Shelter, pictured on the day following its completion. These hard-working rural families built this 21-person shelter in 12 hours 14 minutes, from the time they received the instructions on a farm about 2 miles from the shelter-building site. The construction included moving and mounding some 80 tons of earth, using only manually powered tools to produce a covering having a minimum thickness of 2 ft.

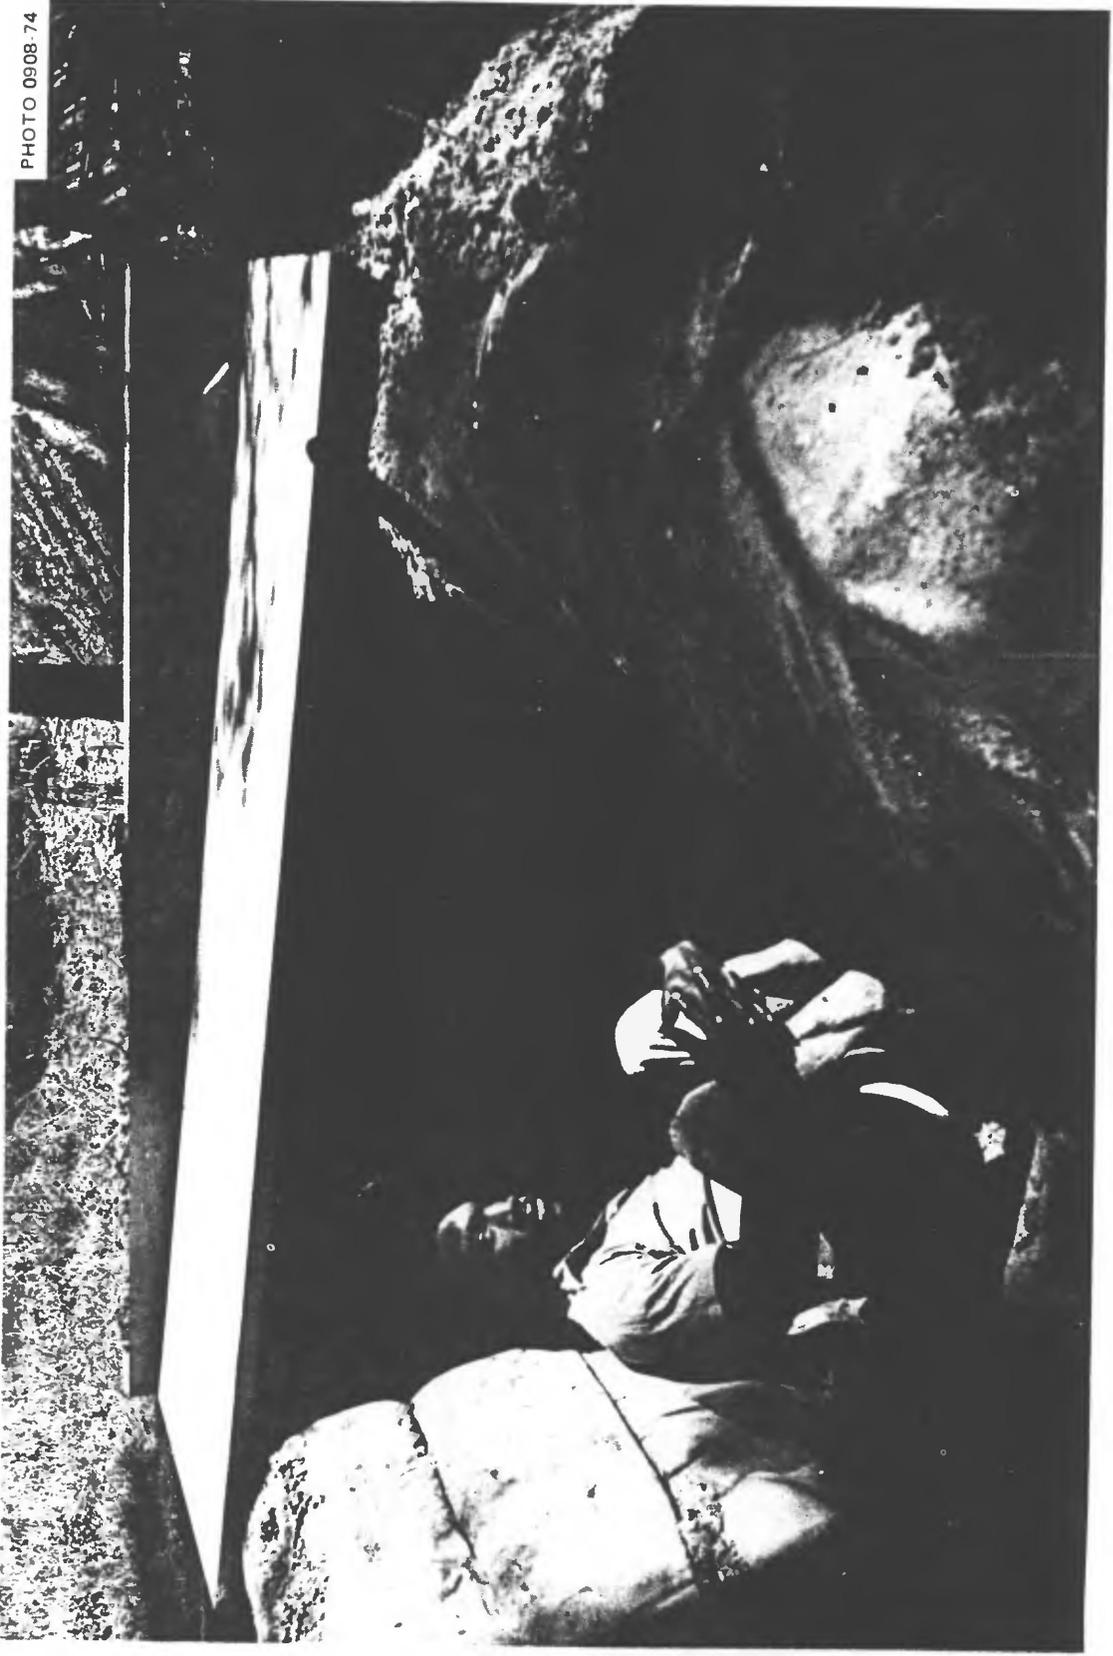
Fig. 5.55. The first of the hollow-core doors used to roof the initial prototype of an above-ground, door-covered shelter using earth-filled rolls for its walls. Since at this time Kearny did not realize that earth-filled rolls made of bed sheets or 4-mil plastic film could be used to form strong and stable *vertical* walls, these rolls were made sloping inward. This resulted in the free span of the roofing doors being about 5 ft wide. When the single-thickness doors of this roof were loaded with 15 in. of heavy, sandy soil, they broke within 1 to 3 days, although the earth was dry and no rain fell. Humidity, however, was high.

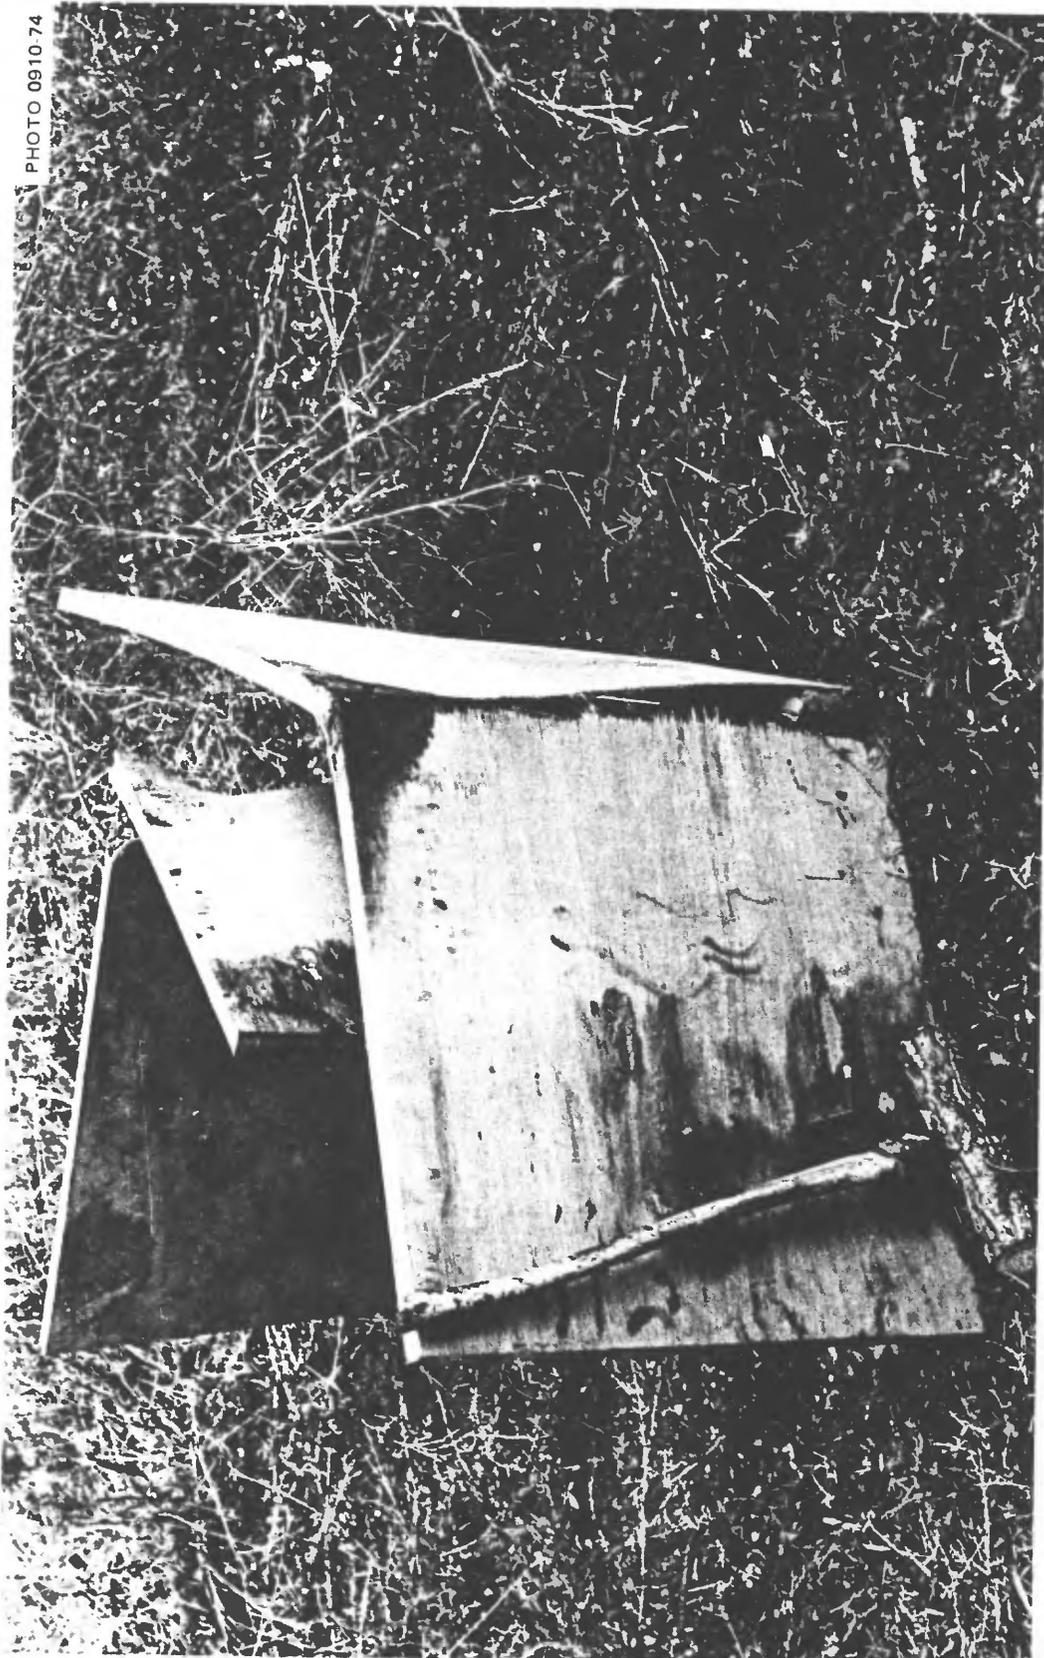
PHOTO 0910-74

Fig. 5.56. Two of the broken roof doors after they were moved from the previously described shelter. Because the ratio of the depth of earth cover over these doors to the width of free span was too small, the centers of these broken doors fell to the floor of the shelter.

Note that the upper,  $\frac{1}{8}$ -in.-thick plywood of these hollow-core doors was not broken. If the earth cover had been thicker in relation to the free span (with a thickness-to-free-span ratio of  $\frac{1}{2}$  or more), earth arching would have prevented these roof doors from being depressed sufficiently to injure occupants of the shelter, even if the plywood on the lower sides of these doors had been completely broken.

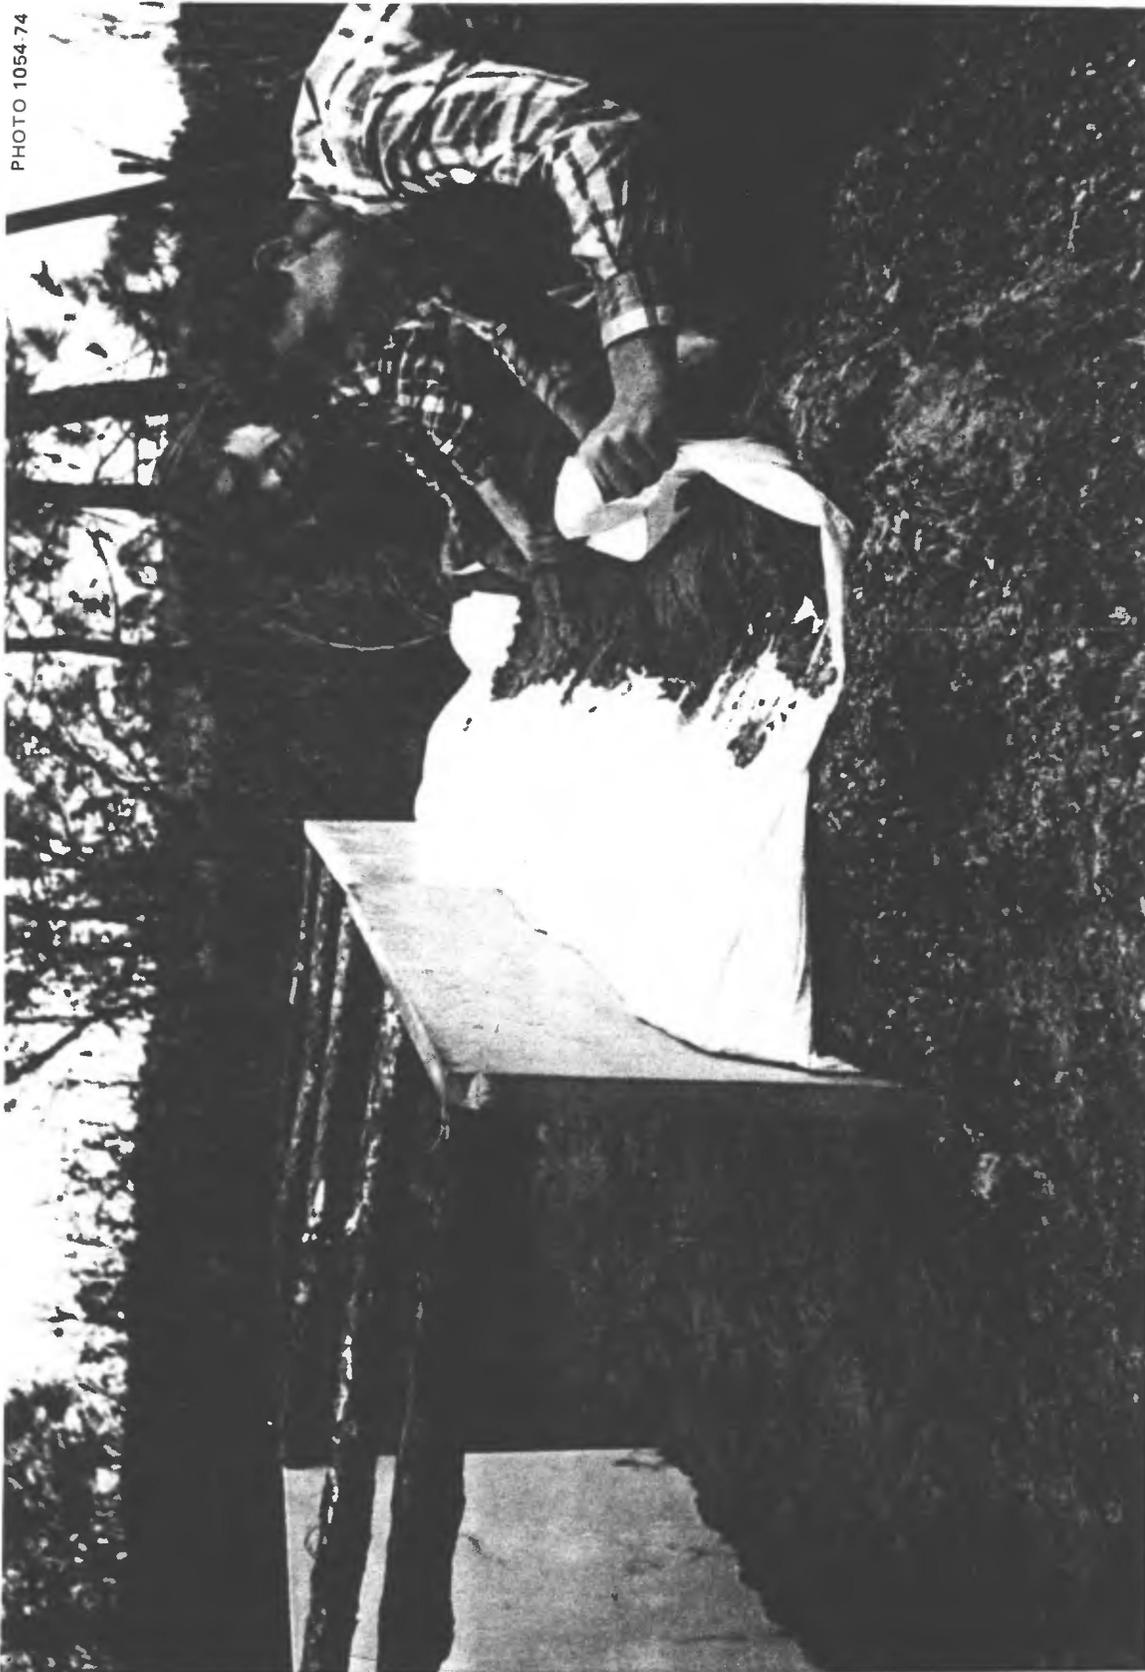
PHOTO 1054-74

Fig. 5.58. Workmen building the first prototype of a shelter with vertical interior walls consisting of 2 or 3 rolls, stacked one on top of the other. This photo shows the workers forming an earth-filled "hook," which holds the part of a sheet forming the upper side of a roll in place, so that especially the vertical inner side of the roll will remain in place when the door form is removed.

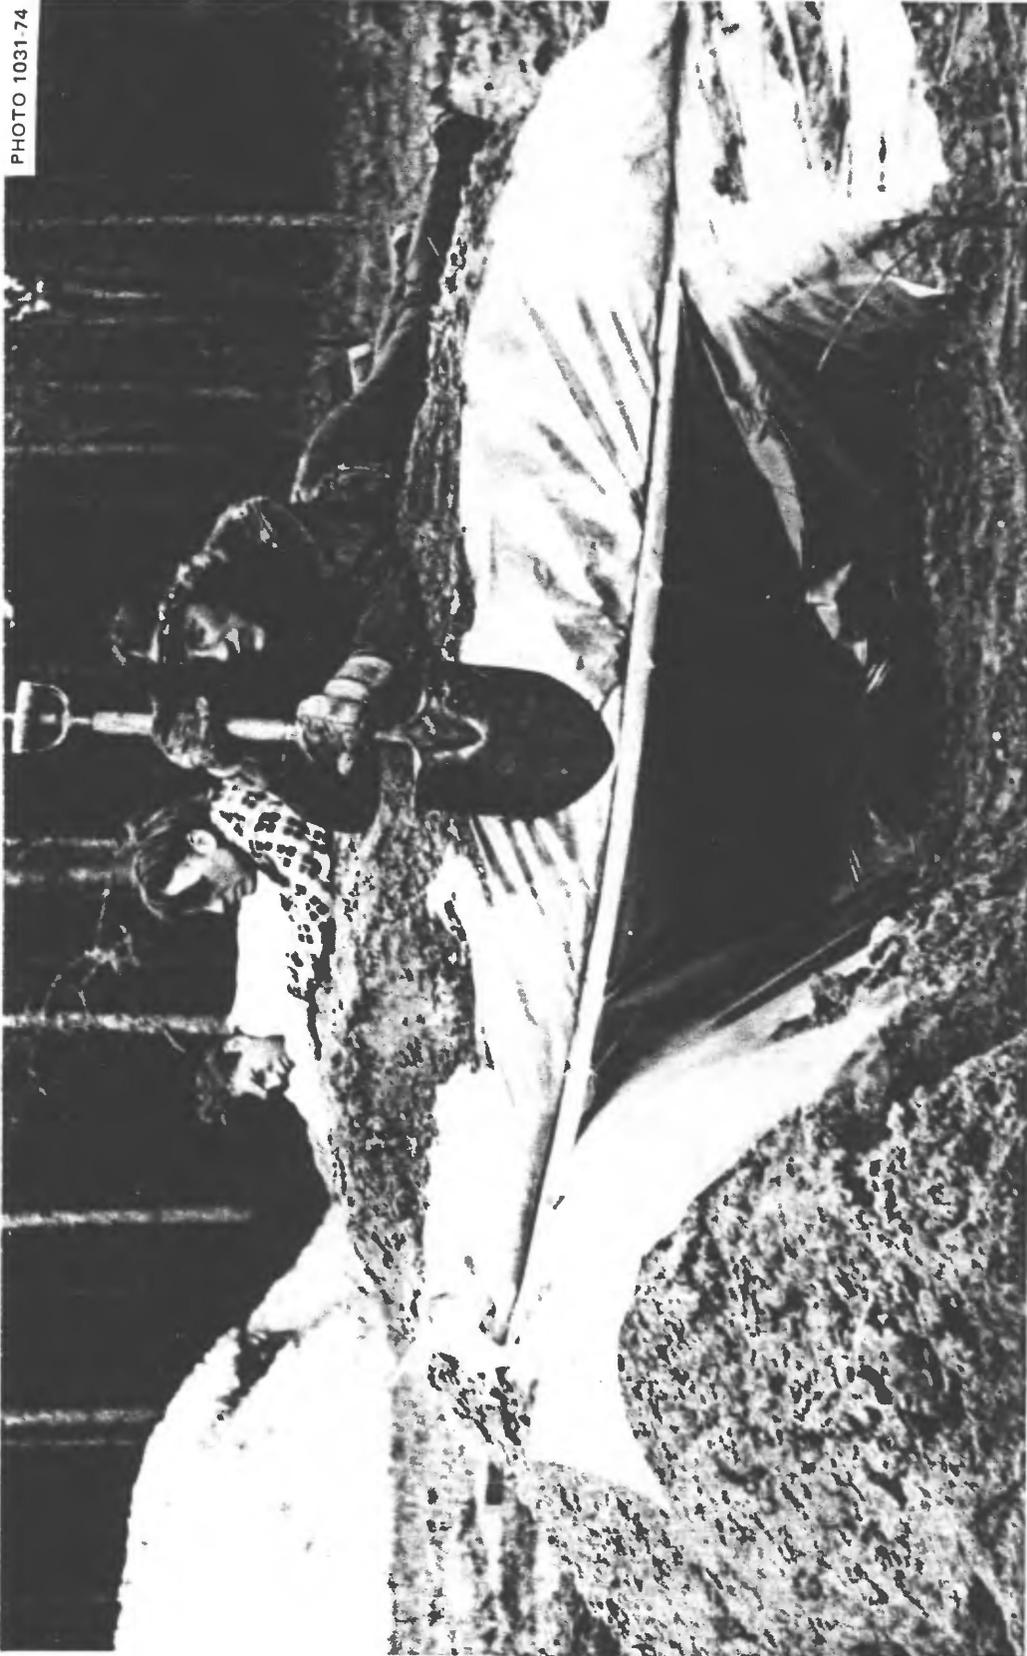
PHOTO 1031-74

Fig. 5.59. A view of one end of an experimental setup designed to test the strength and dependability of hollow-core doors used to roof an above-ground shelter with vertical walls made of earth-filled rolls, under humid, wet conditions. Two doors that had been painted with two coats of interior-type latex paint were only slightly bowed after being subjected to the pictured loading for almost a month. The doors were protected from moisture by a sheet of 4-mil polyethylene placed directly on them. Note that this roof slopes to the right, so that water will not leak through the plastic.

Heavy rains fell during the test period, but the cardboard honeycomb structures inside these painted doors were found to be only slightly damp at the end of this successful test. The earth at the edge of the pictured door was held almost vertical by being contained in an earth-filled roll extending the full length of the door.

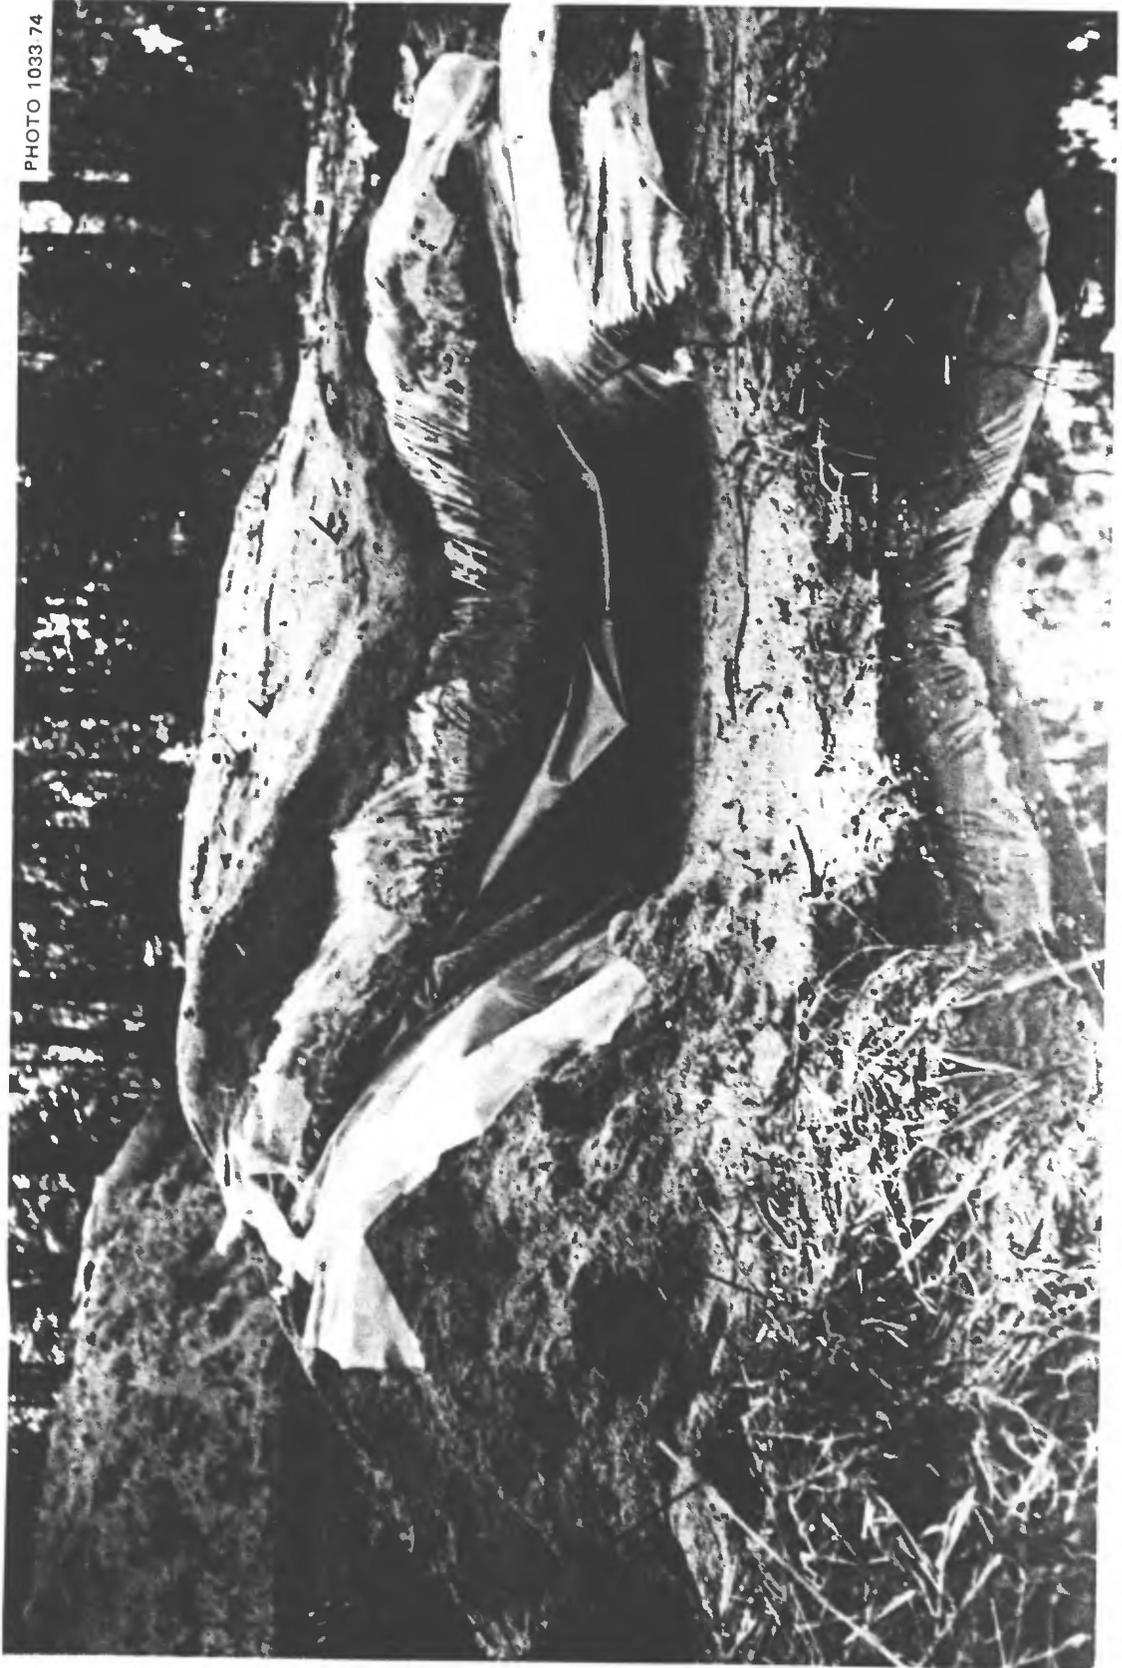
PHOTO 1033 74

Fig. 5.61. The opposite end of the roof-door experimental setup, photographed almost one month after the beginning of this experiment. This broken-in door was unpainted. The same type of polyethylene film covered all the doors in this test. The unpainted door absorbed more moisture and was broken by the same thickness of wet earth cover that the painted doors survived. However, if the roof broke in this manner, occupants of a shelter would not have been injured, due to the fact that earth arching prevented the broken door from being dangerously depressed into the shelter.

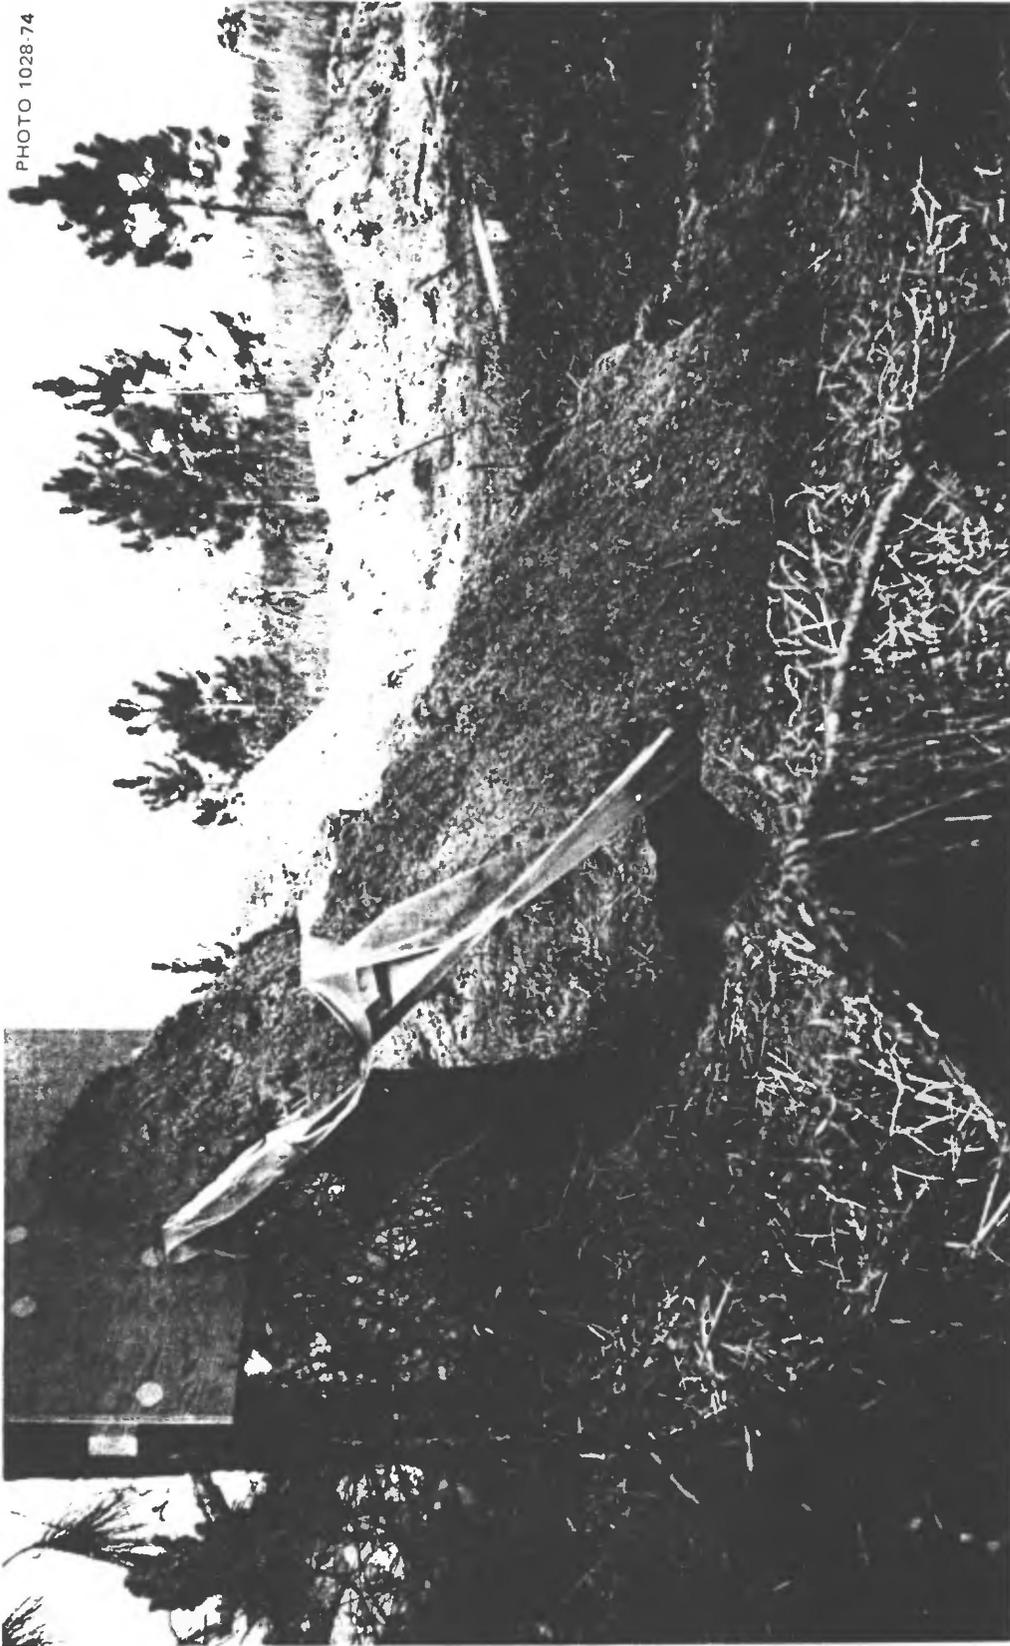
**Fig. 5.63.** Preparing to test a hollow-core interior door used as a roof door of an expedient Tilt-Up Shelter, built following instructions received from Donald A. Bettge, DCPA. The plywood (that was nailed to the horizontal  $2 \times 4$ s connecting the two pine trees) represented the side of a house. The door slopes  $45^\circ$  and is secured at its base by stakes.

No trench was dug below the door, since the water table in this area is only about 1 ft below the surface. The shelf nailed to the door was made of the specified lumber. Careful nailing with small box nails was required to connect it to the thin side-reinforcements of the hollow-core door, to avoid weakening the door.
