ORNL-5039  
UC-41-Health and Safety

HEALTH PHYSICS DIVISION  
EMERGENCY TECHNOLOGY SECTION

EXPEDIENT SHELTER CONSTRUCTION AND  
OCCUPANCY EXPERIMENTS

Cresson H. Kearny

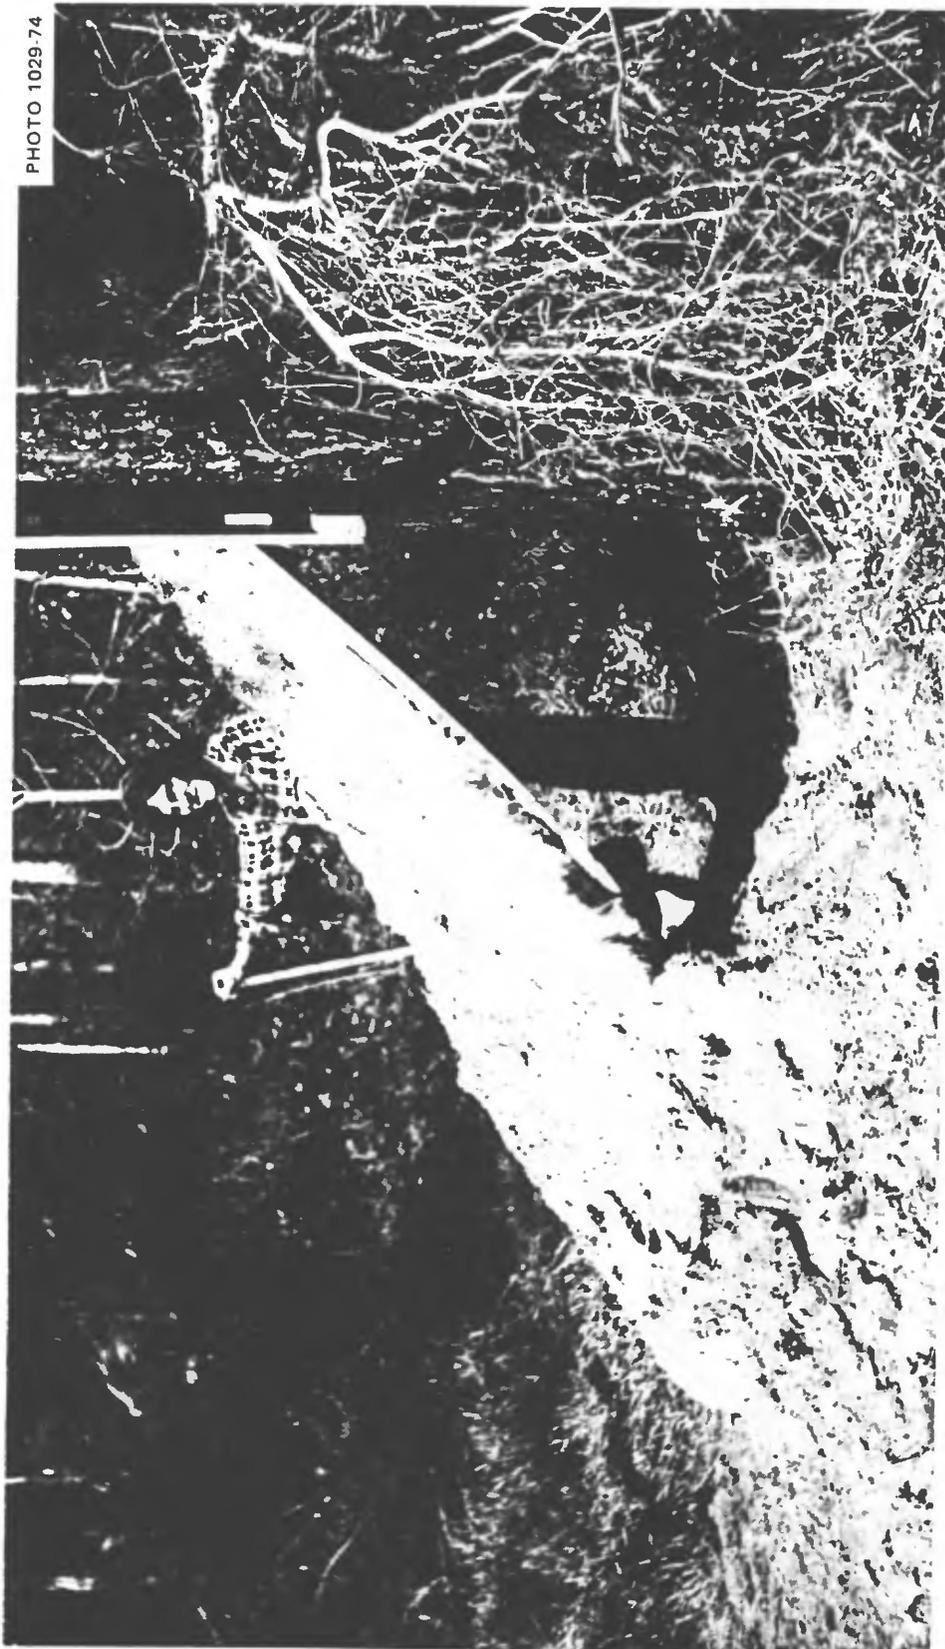
**Fig. 5.64.** The door was loaded with about half the specified average thickness and weight of earth, due to earth falling off the sides.

Note the protective covering of 4-mil polyethylene film placed directly on the door. Prior tests in this humid part of Florida showed that if waterproofing material is not placed directly on a hollow-core door, the cardboard honeycomb of the door becomes damp, and the door fails much sooner than if the damp, wet earth is not in direct contact with it.

When this single roof door was thus loaded with approximately half the weight per square foot of earth specified for a double-thickness door roof, this door was not over-stressed, and the downward bow did not increase for the three days of testing before the earth was removed.

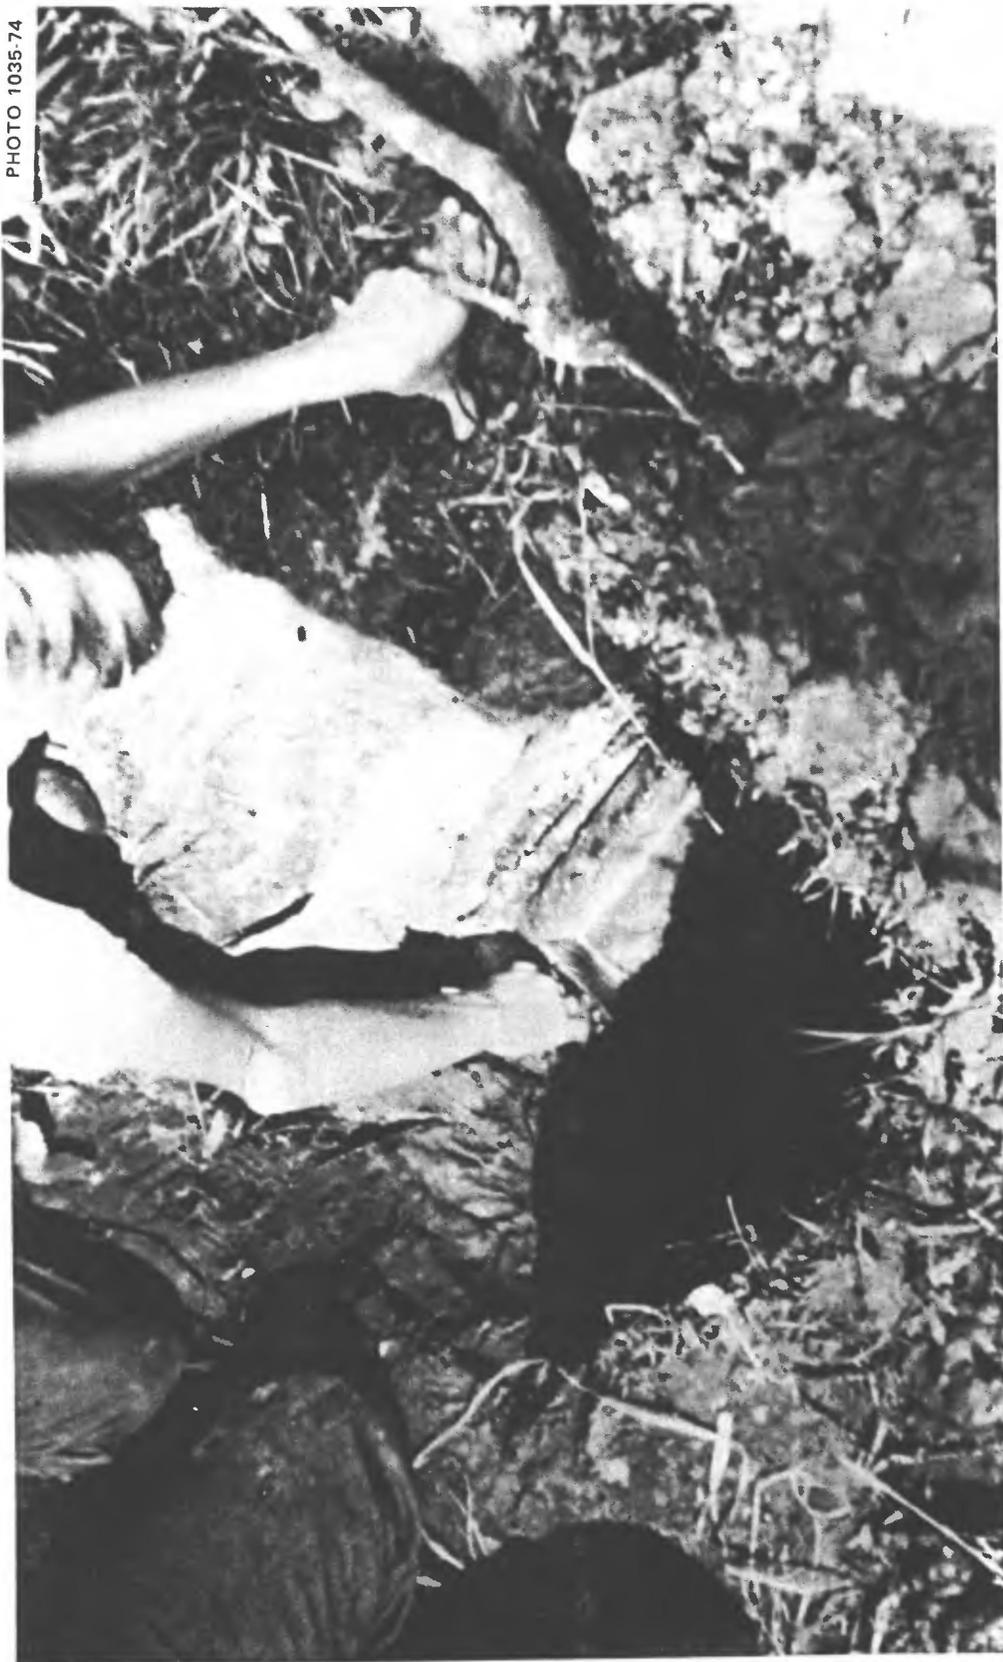
PHOTO 1035-74

**Fig. 5.70. A shallow well for drinking water, dug into the free-flowing sand below the water table. Note the rectangular board shoring, which was forced downward as the free-flowing sand was dug out from inside and below this shoring frame. Twigs and leaves were stuffed in behind the frame, to help check the inward flow of sand, that otherwise would have led to the collapse of the sides of this well. Without instructions, average Americans would not be able to dig a well inside their shelter, from which they could dip water repeatedly without causing disastrous caving.**

Kenny successfully dug another shallow water well in this area, by driving eight 3-ft pole stakes in a circle 18 in. in diameter. He drove these stakes from the bottom of a 2-ft-diameter hole after first digging to the top of the water table, which was 15 in. below the surface. He placed thin saplings and grapevines behind the eight stakes, as the well was dug deeper, to prevent sand from flowing into the well.

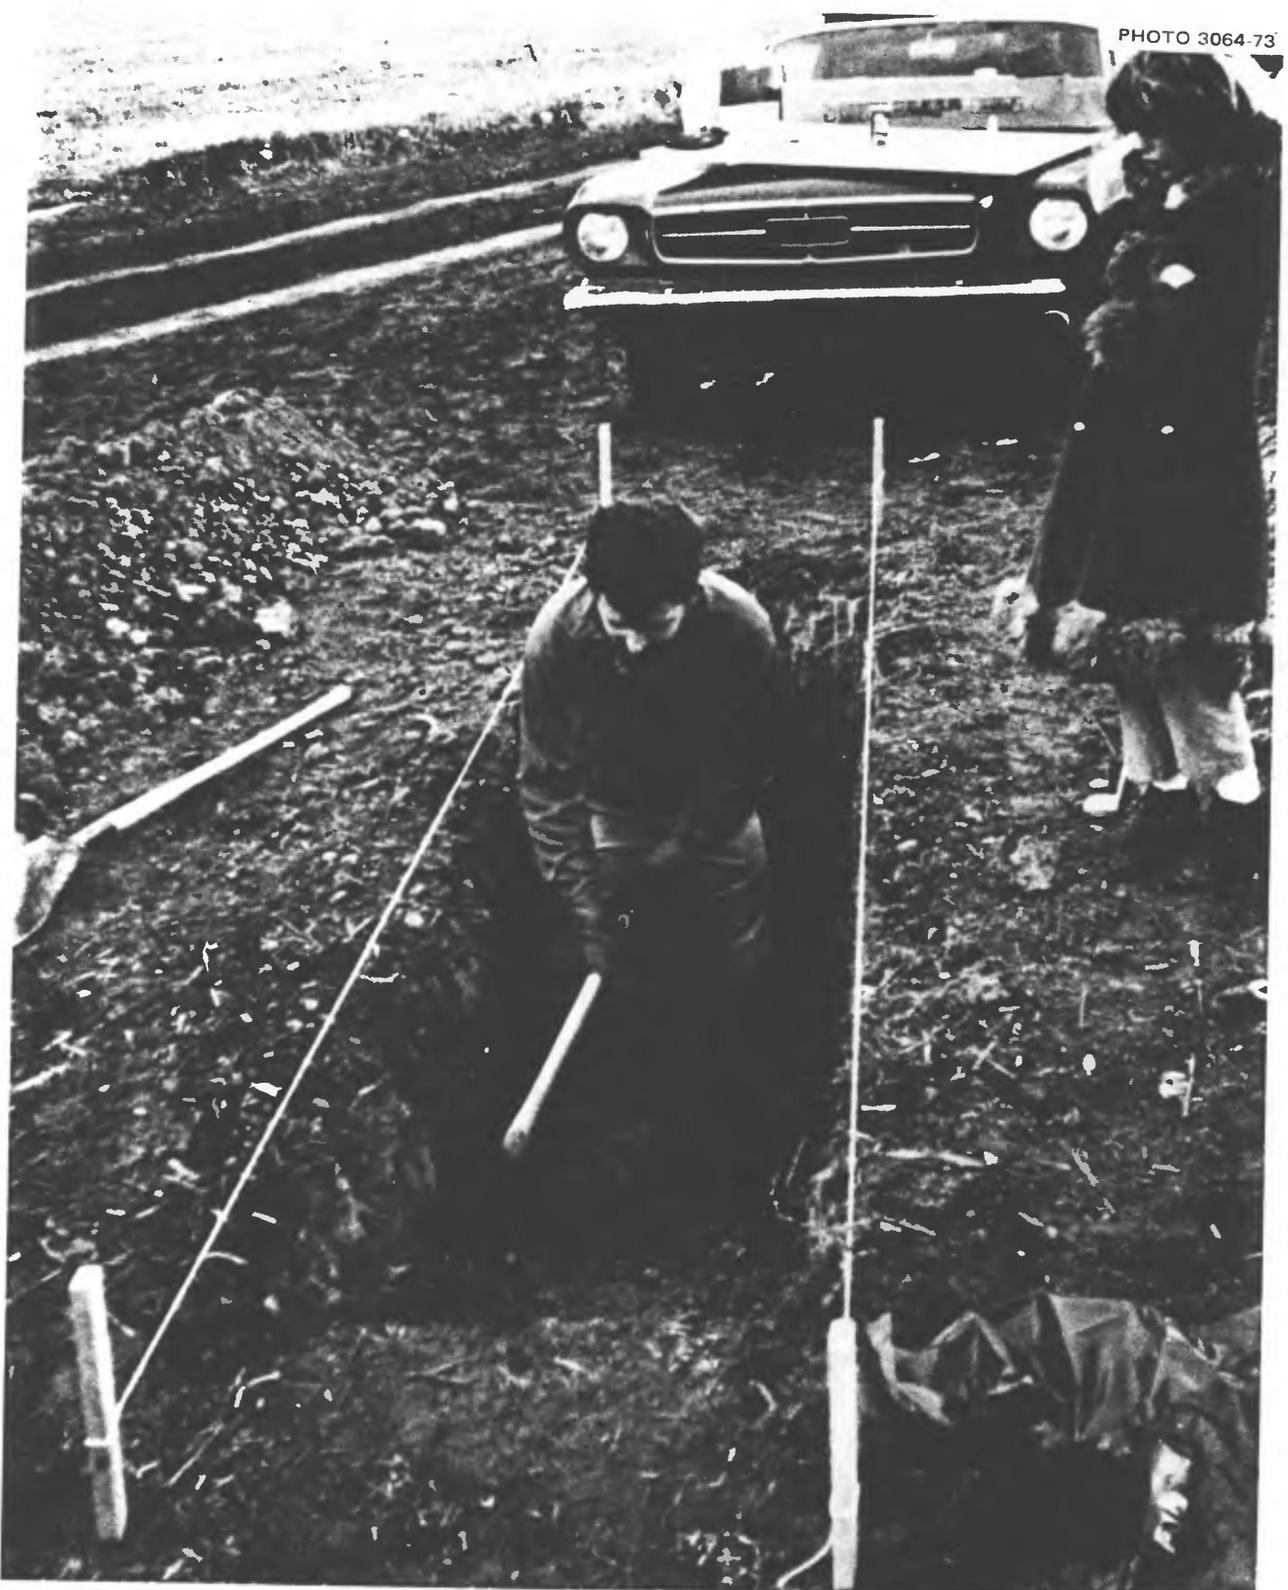
Fig. 6.6. The father swung his pick properly, a result of his learning to use an ax as a boy of 12, when his family spent a while in rural Oregon. However, he tied unnecessary strings between the stakes, and left them tied, and dug the trench too narrow. Later, he spent about two hours inefficiently widening it.

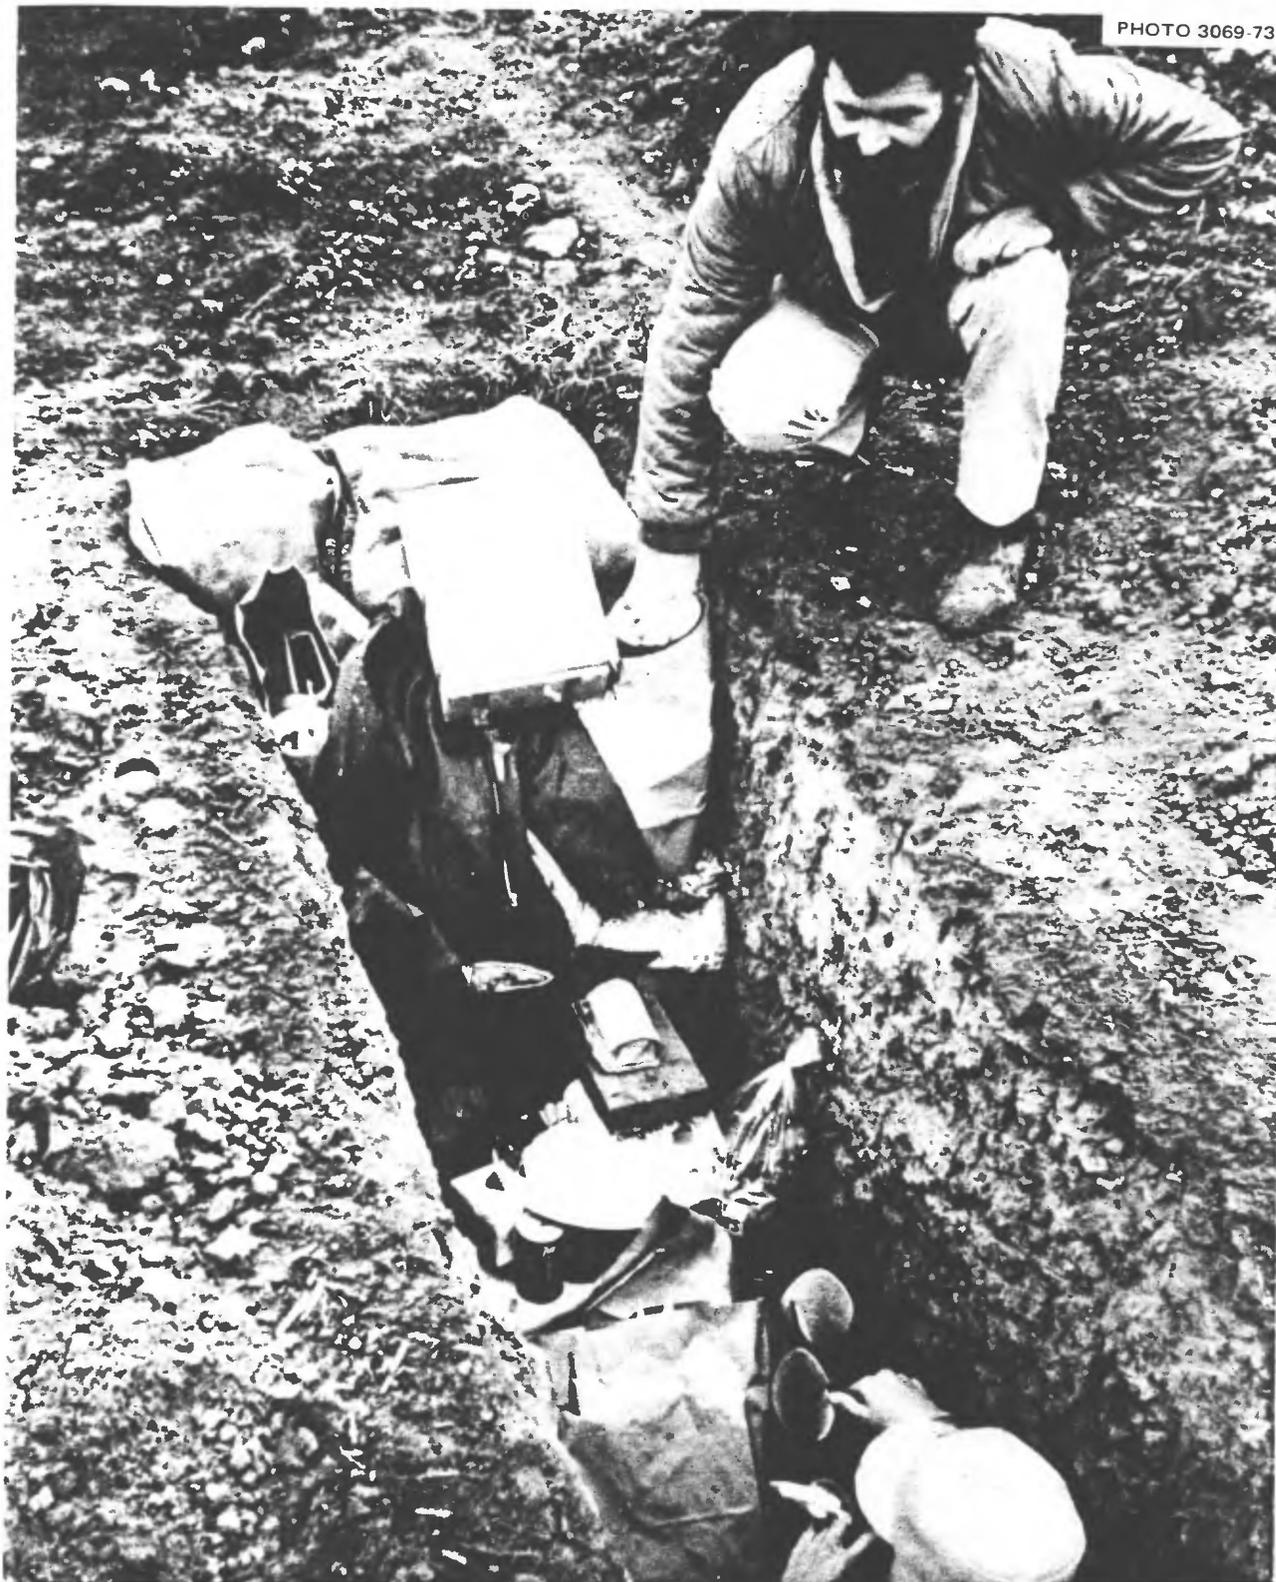
Fig. 6.8. Some of each category of survival items stored for the night in the completed and very dry main trench. The family was parked for the night over the stocked trench. The father, tired, quit at 5:33 PM, and was driven to his apartment in town to join his half-sick wife and daughter.

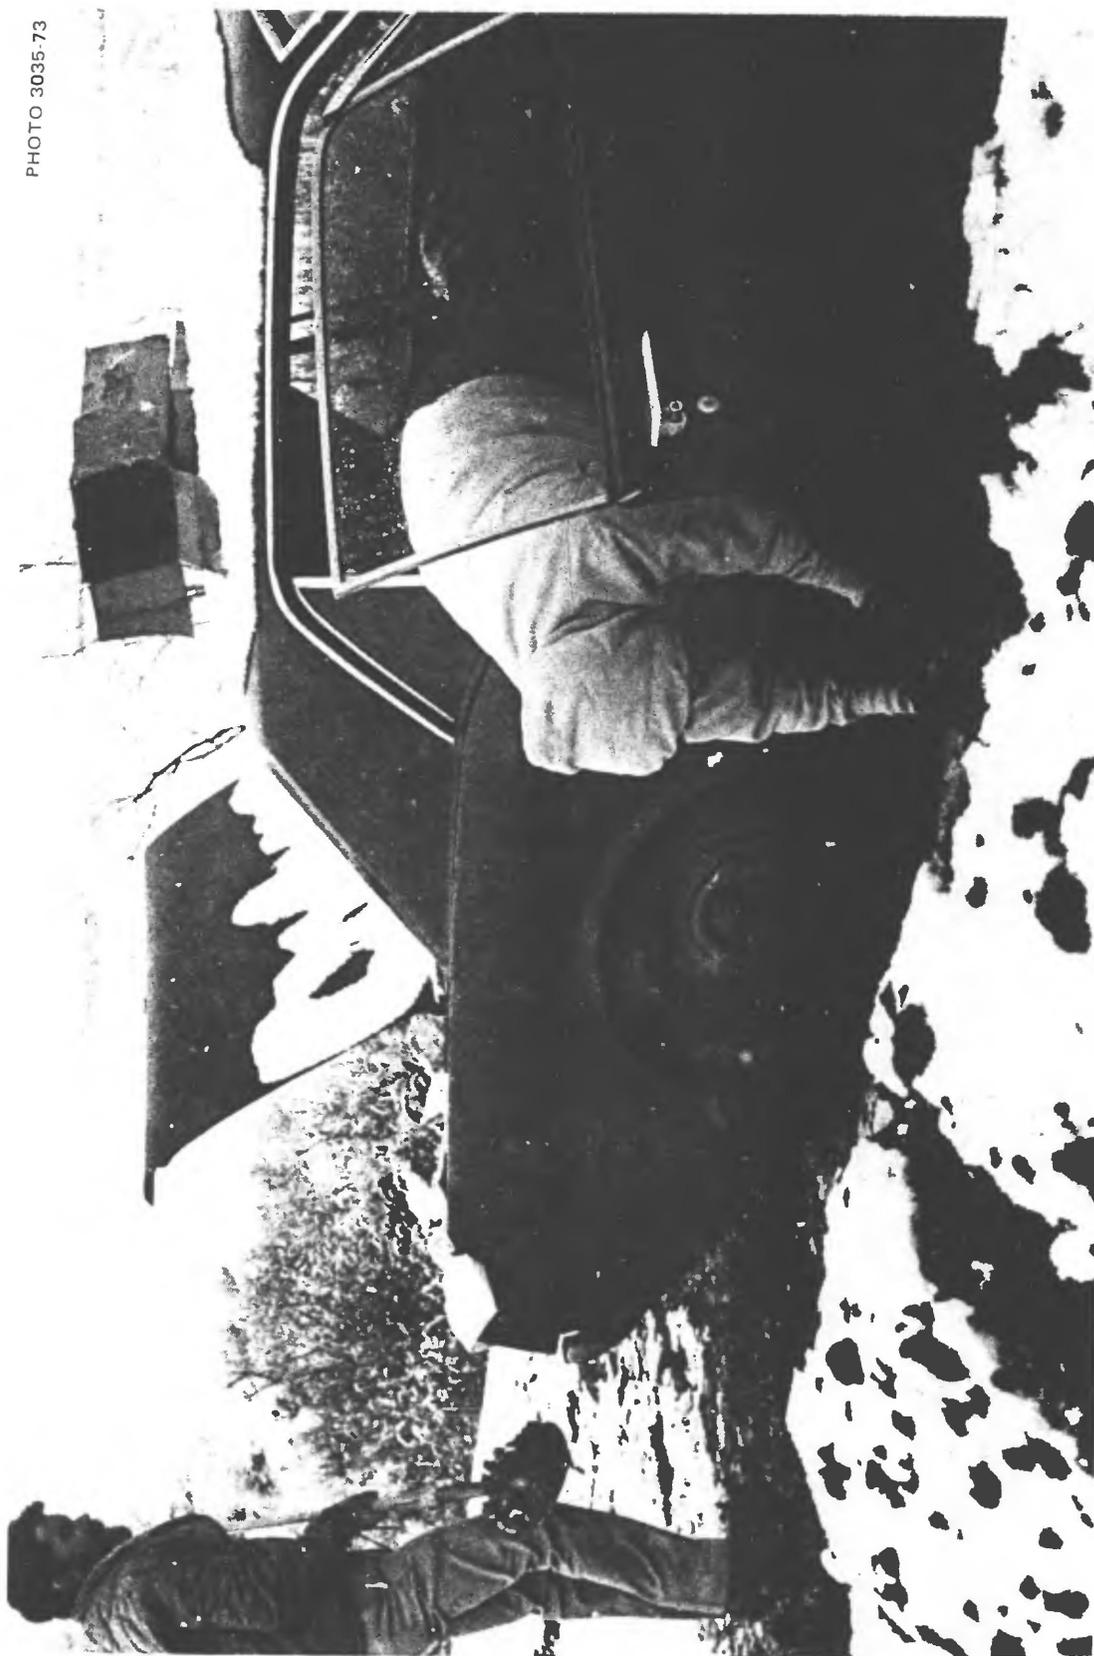
PHOTO 3035-73

Fig. 6.10. Putting a foot of earth inside the car and in the trunk. Unfortunately, before loading the car with about 2 tons of earth, the father and mother put many of their possessions under their car and on the surface of the ground around the edges of the trench. As a result, when the car body was depressed by its earth load, potatoes in a bag were crushed and cans were pushed into the wet earth near the surface.

For want of a second shovel, the mother used an empty can to help dump earth inside the car.

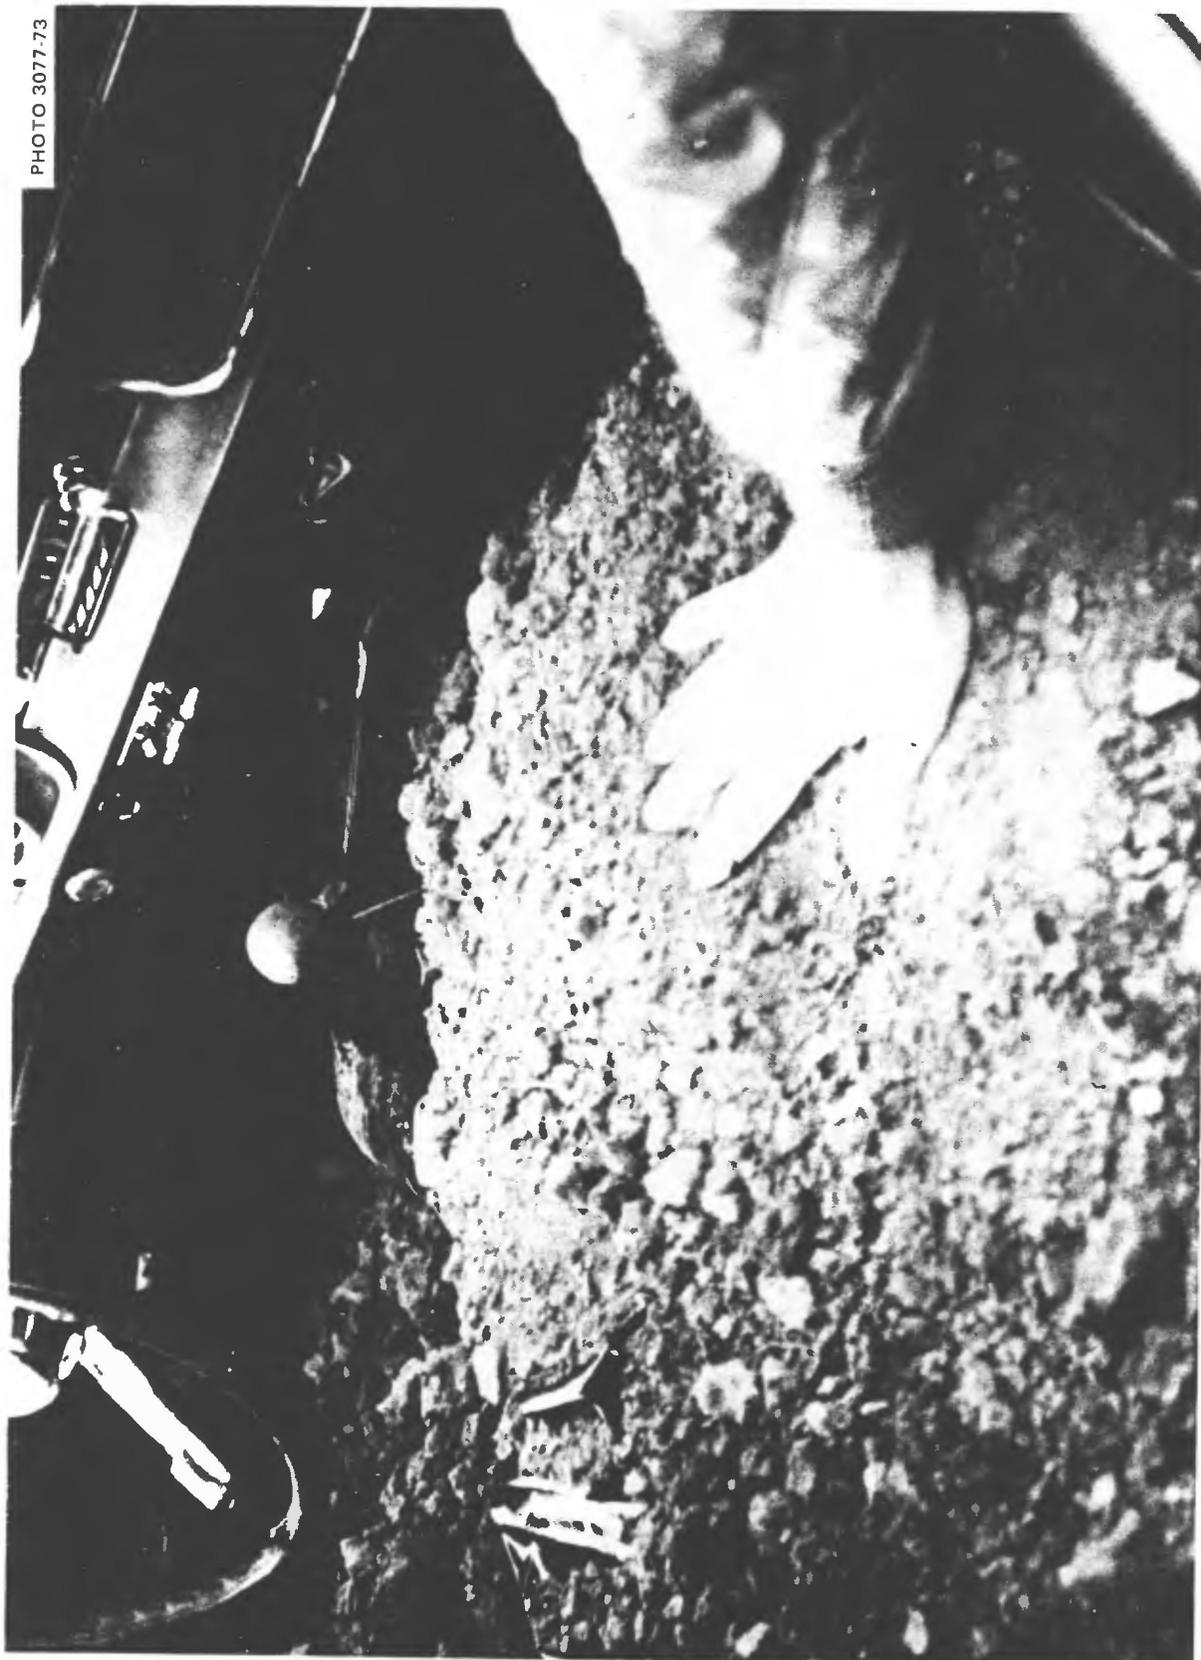
PHOTO 3077-73

Fig. 6.11. About a foot of earth inside the car. Note the black plastic lining under the earth. Kearny, after several families had refused his offer of \$950 to build a Car Over Their House.

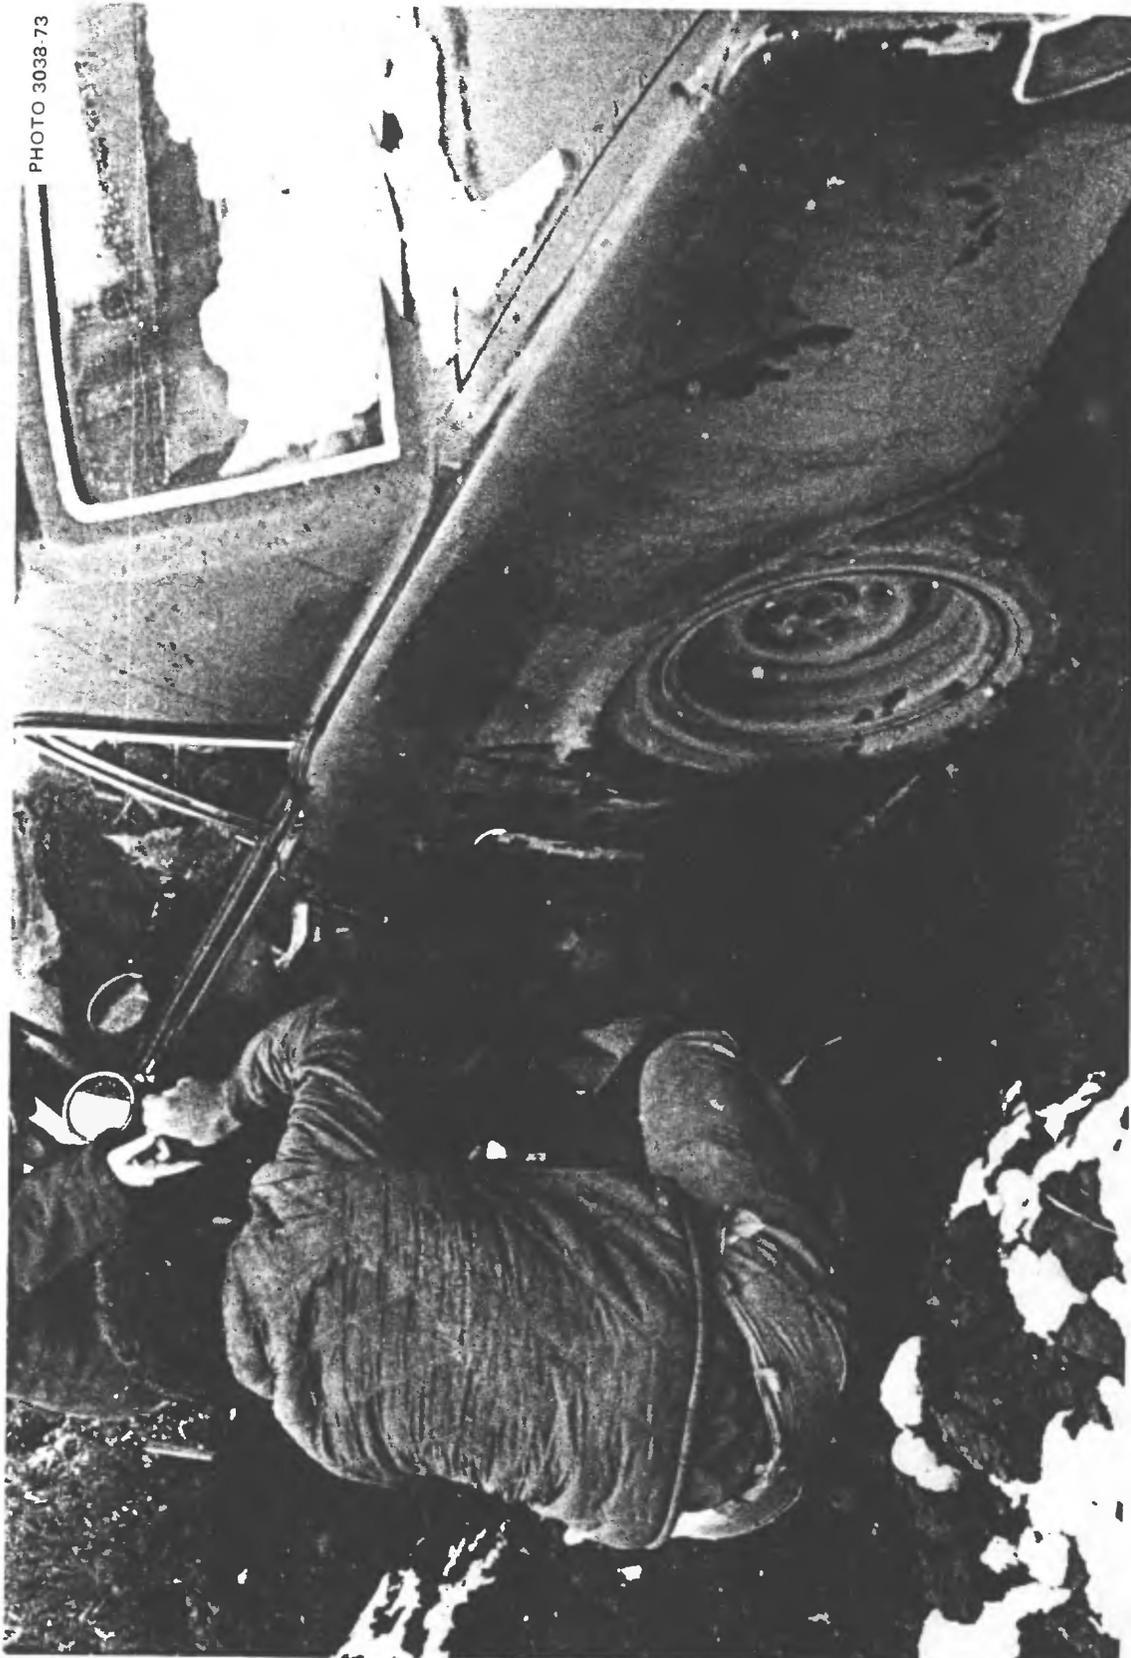
PHOTO 3038-73

Fig. 6.12. Taping split-open plastic garbage bags to the sides of the car, for want of other waterproof material to keep some of the dry earth to be mounded around the car from running under the car onto the storage "shelf" areas around the edges of the trench, or into the trench. Fortunately, the father had some waterproof duct tape, and cleaned the dirt off the spots on the car to which he planned to tape the plastic. However, because he did not tape all of the upper edges of the pieces of plastic, if water had run down the sides of the car, much of it would have run under the upper edges of the plastic and into the shelter space under the car.

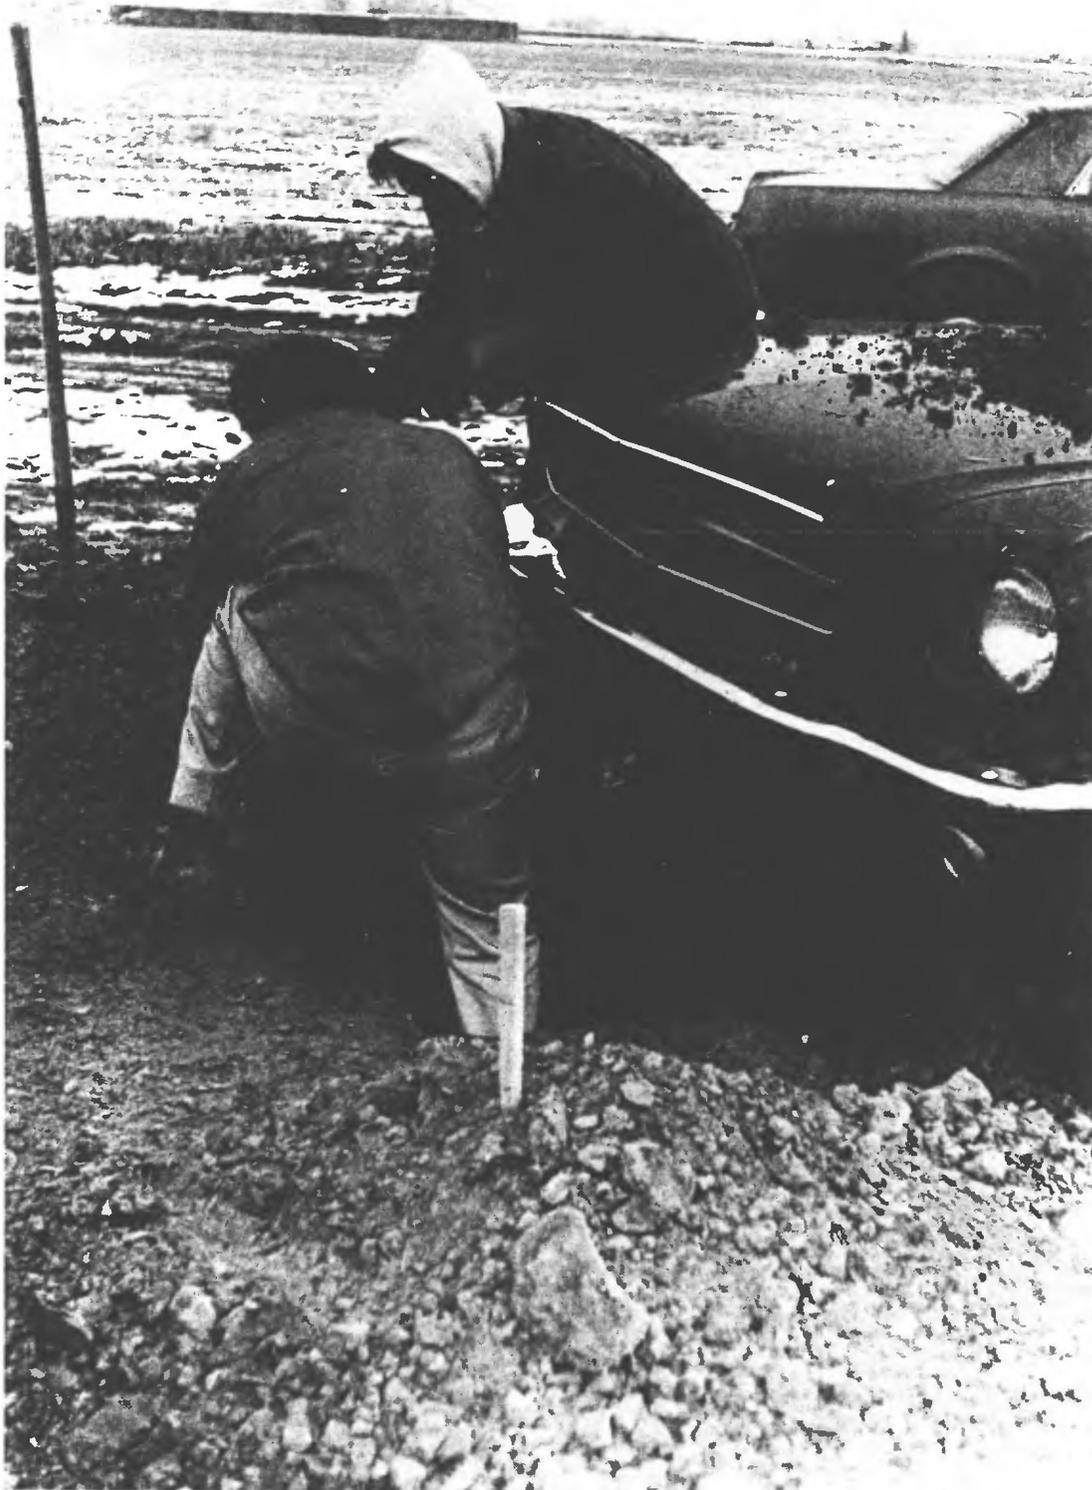
**Fig. 6.13. Placing earth-filled plastic garbage bags around the edges of the entryway trench.**  
The mother was able to remain on the site all of the second day and do some work – thanks to a borrowed pair of insulated boots that kept her feet from getting painfully cold.

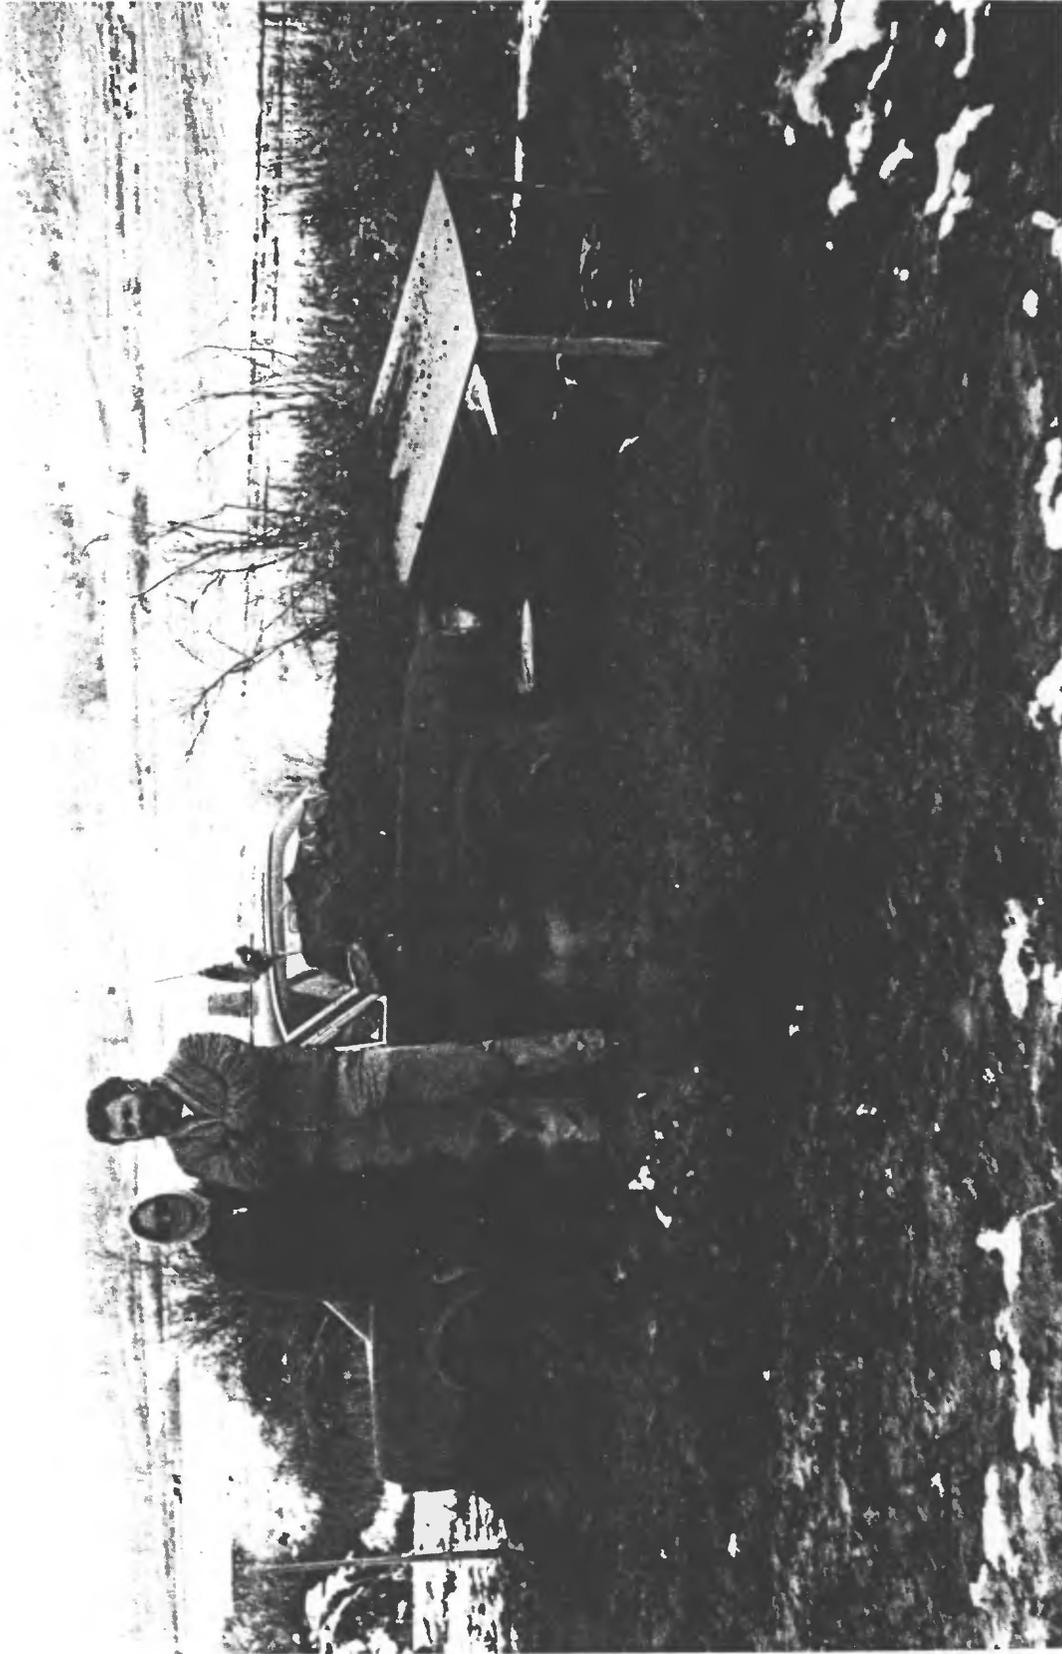
PHOTO 3044-73

Fig. 6.14. The Car-Over-Trench Shelter was completed at 4:15 PM on the second day. The father did about 95% of the work; 14 hours and 27 minutes were spent working at the site. This family did not win the bonus for completion within 24 hours from the time work began.

Note the plywood "awning" over the entryway opening, used for want of better rainproof material to be found in this family's modest apartment.

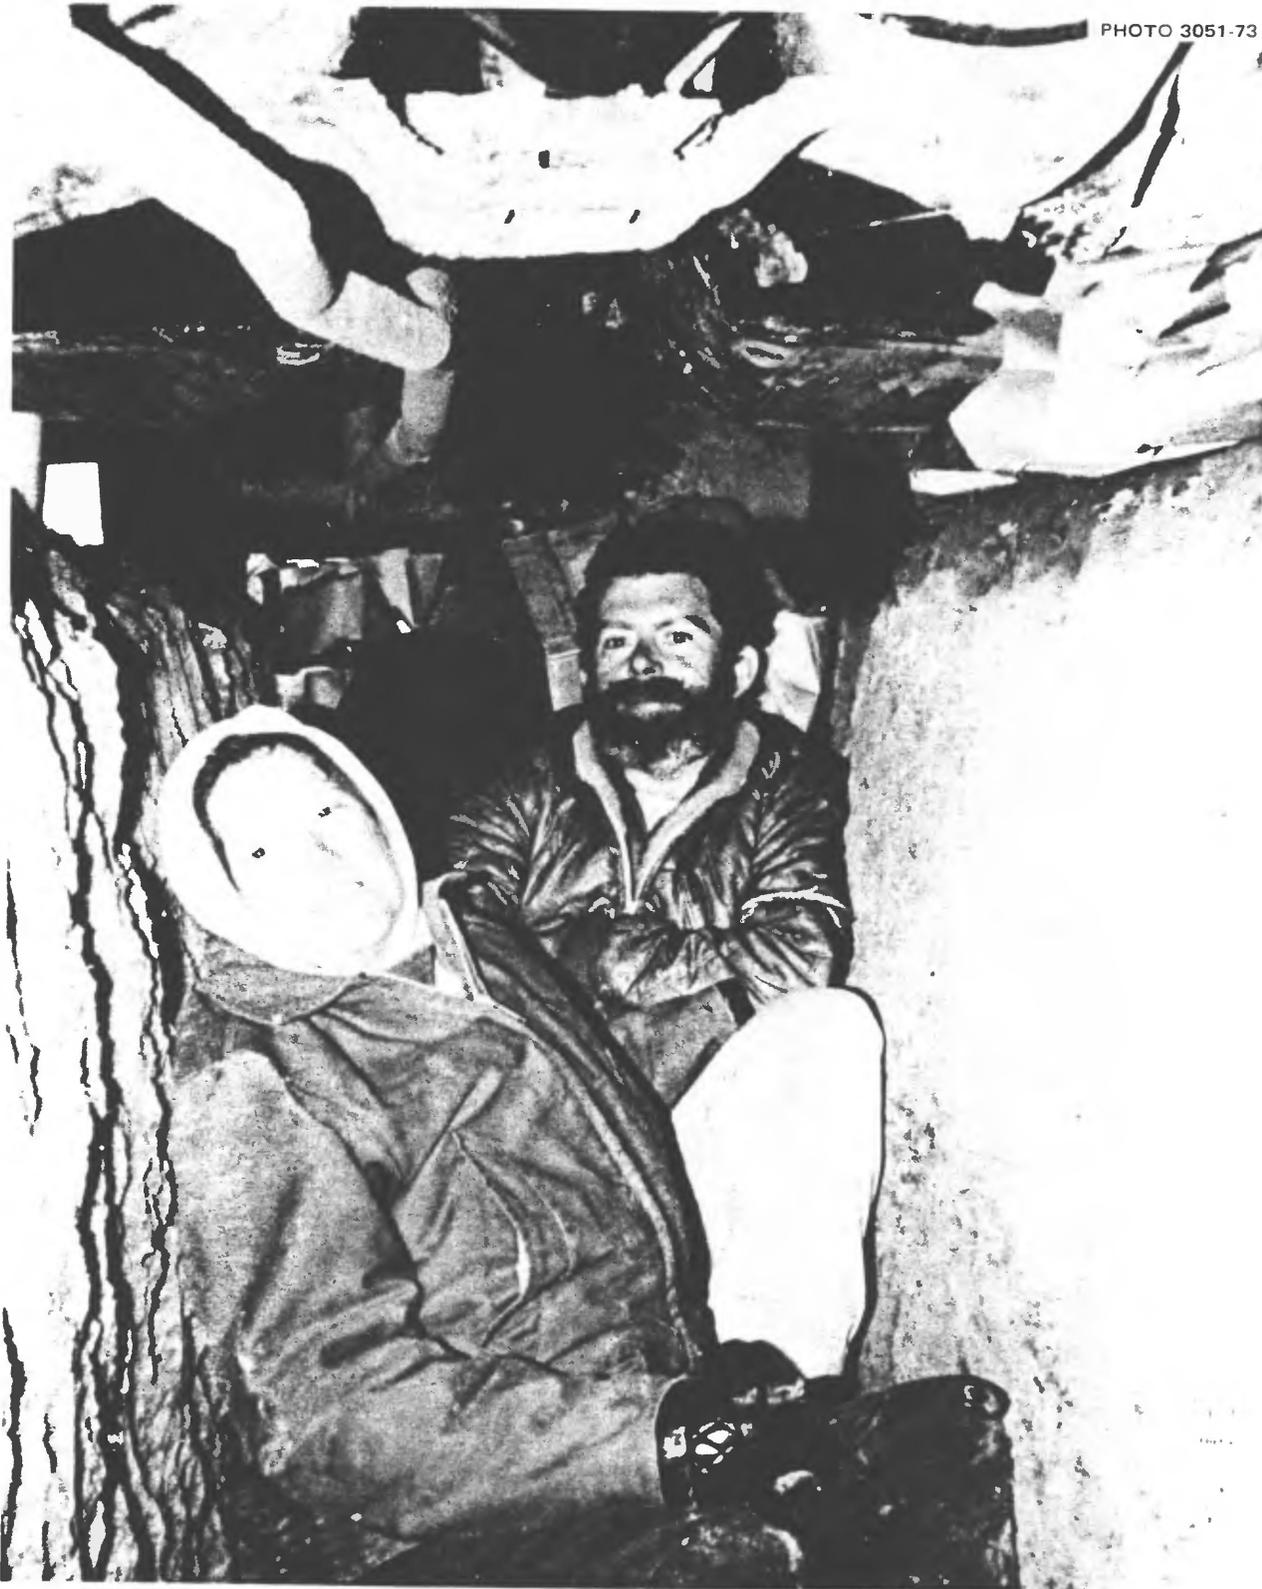
Fig. 6.15. The father (sitting on a box) and the mother in their 40-in.-deep, 28-in.-wide shelter. Enough room remained (occupied by the photographer's leg when this picture was taken) for the small daughter and the family poodle. All of their supplies had been placed under the car.

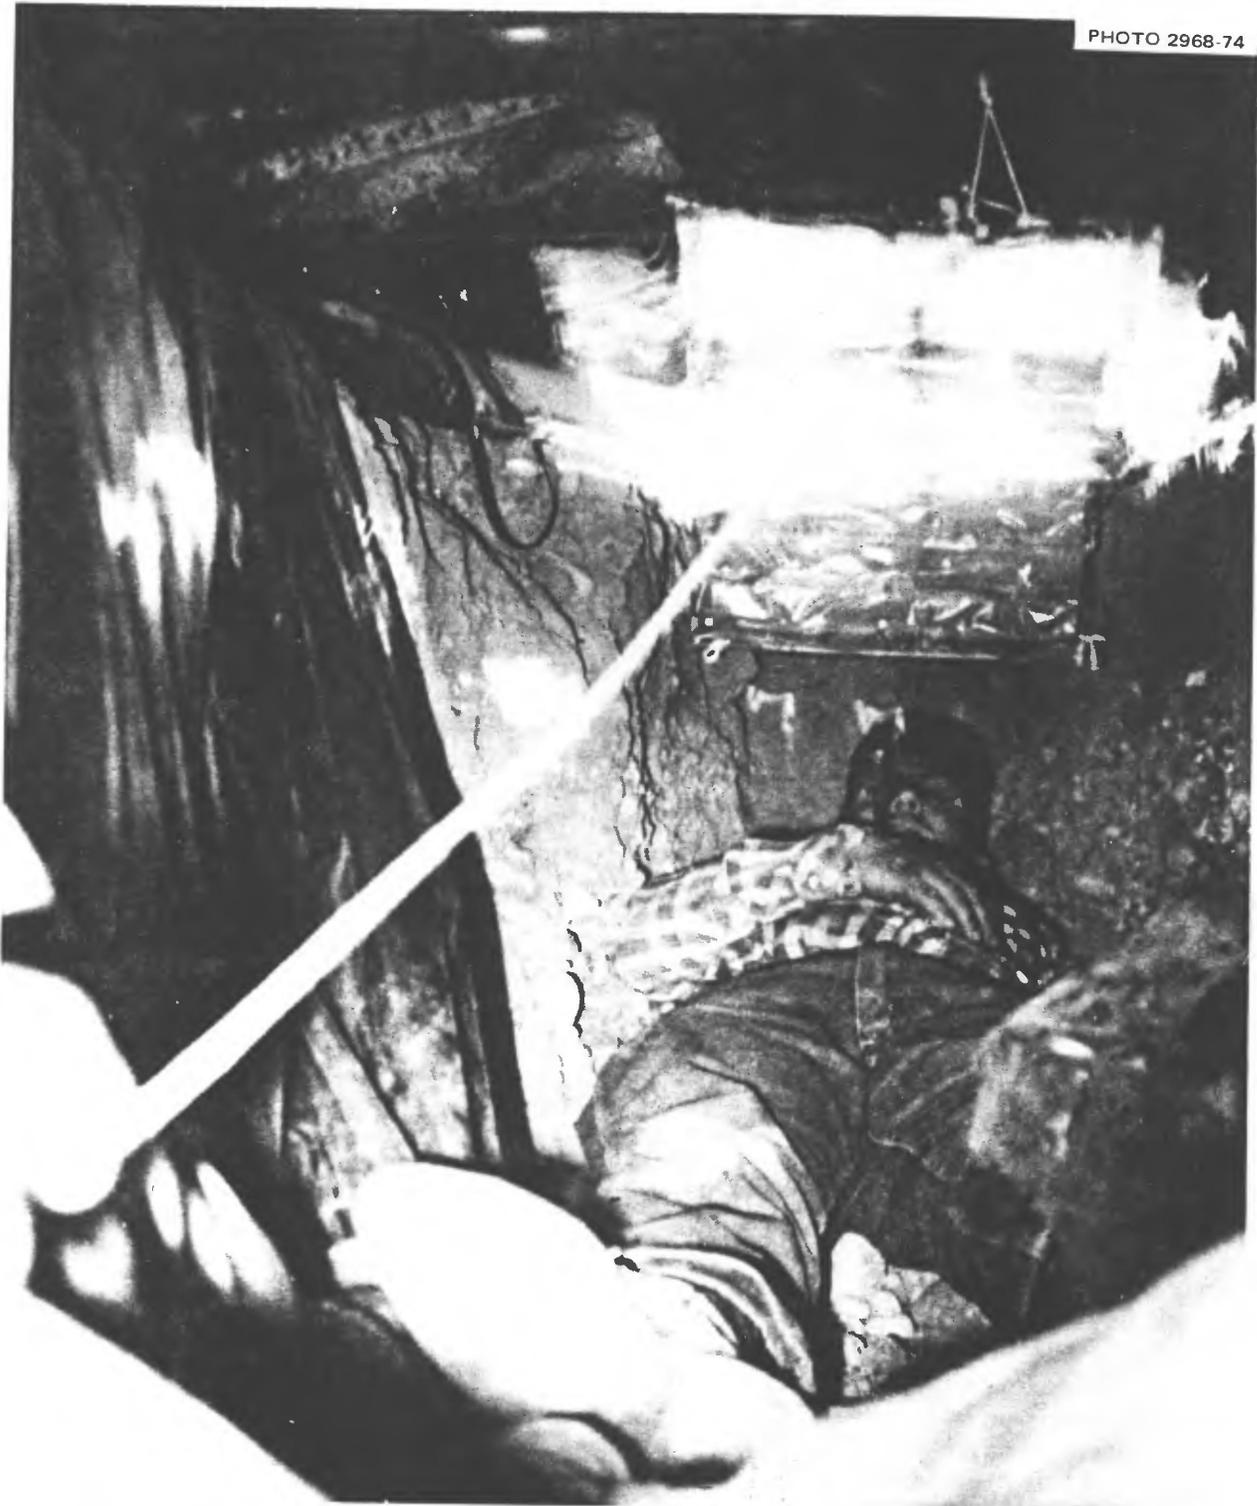
**Fig. 6.16.** A 17 x 19 in. KAP being used to pump about 100 cubic feet per minute through a Car-Over-Trench Shelter, and out through the 110 square inch exhaust opening. Especially during hot, sunny weather, temperatures inside a Car-Over-Trench Shelter would become intolerable without adequate forced ventilation.

This small pump was built by a boy who was guided only by the well-illustrated, written instructions. He used sticks cut from bushes for the frame, and polyethylene cut from trash bags for the seven flaps. The pull cord runs through the greased fork of the forked-stick "pulley" suspended in front of the KAP. Thus pulled, the KAP swings evenly on its looped-wire hinges.
