ORNL-5039  
UC-41-Health and Safety

HEALTH PHYSICS DIVISION  
EMERGENCY TECHNOLOGY SECTION

EXPEDIENT SHELTER CONSTRUCTION AND  
OCCUPANCY EXPERIMENTS

Cresson H. Kearny

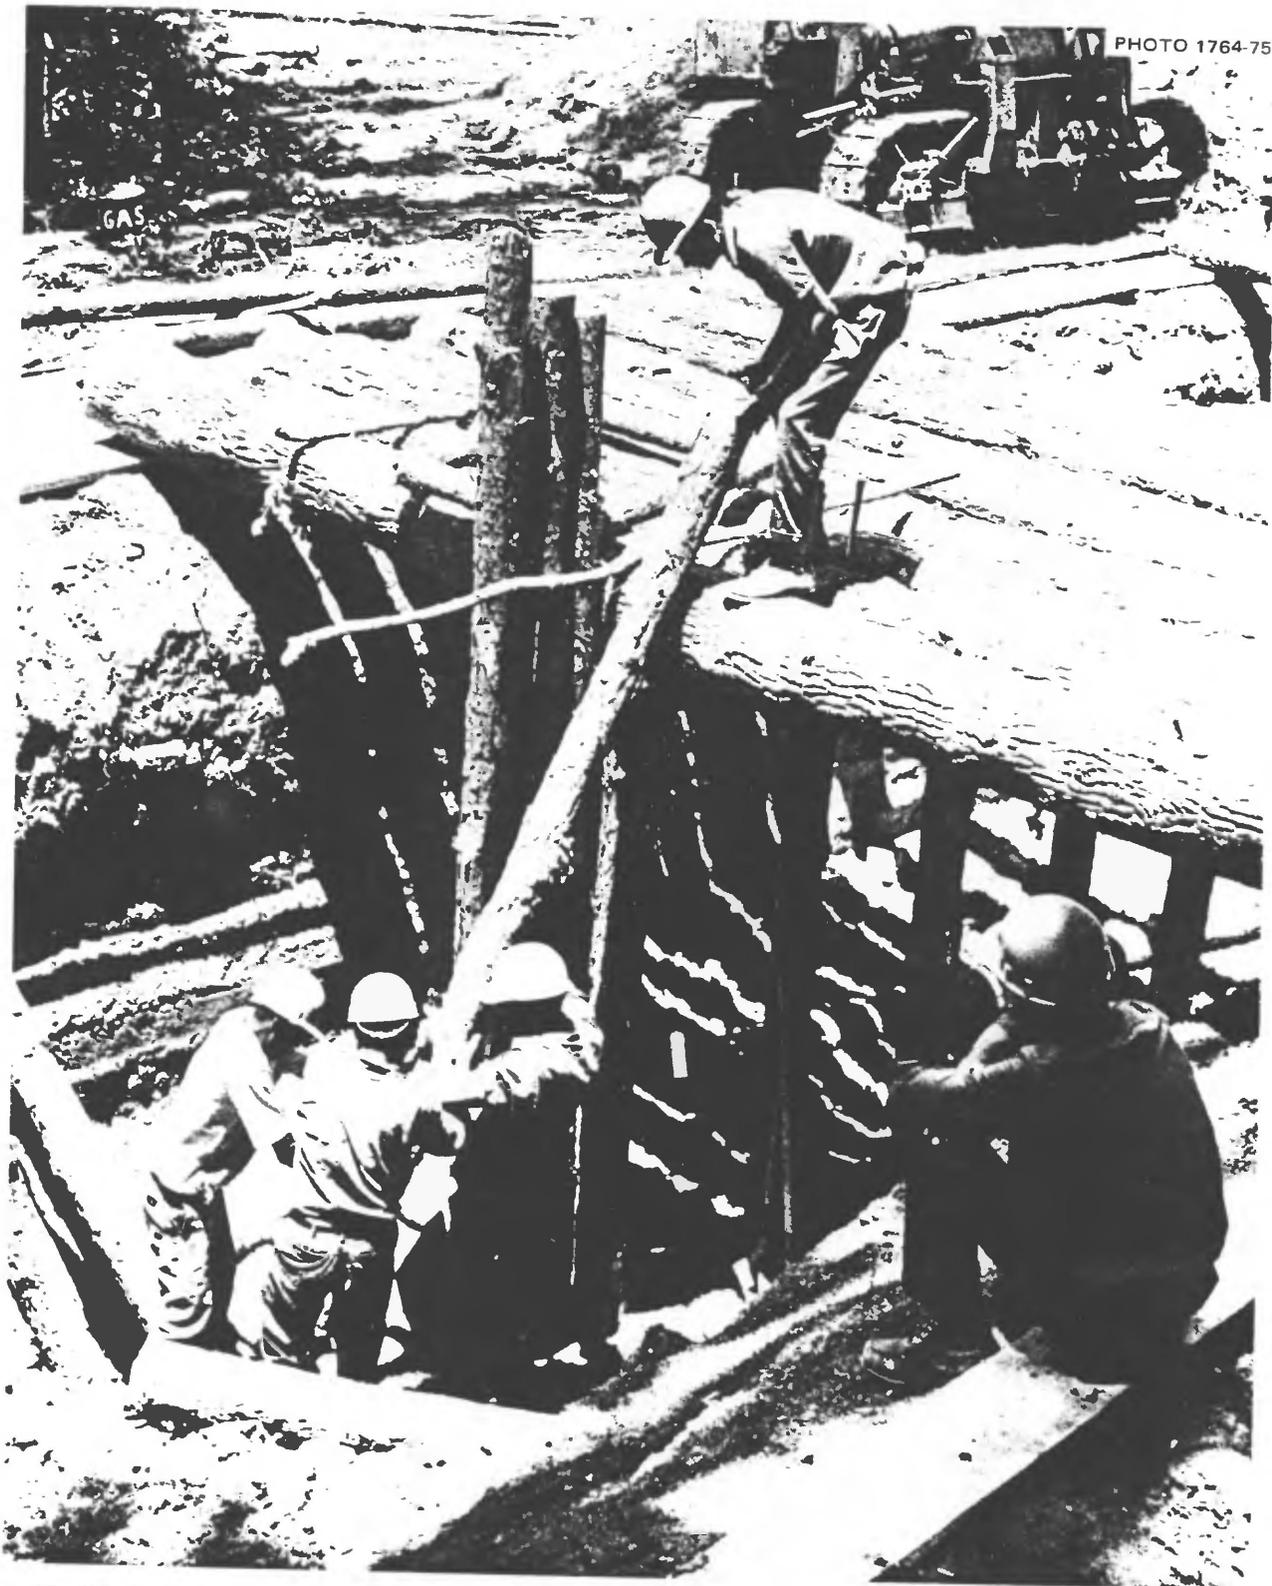
**Fig. 7.2. Starting to erect one side of an entryway, after all of the 22-ft roofing logs had been positioned. A vertical entryway was placed at each end of the 12 × 42 ft shelter room.**

Note the line of log columns down the center of the trench. These log columns, which rested on a plank footing and were spaced 4 ft apart, supported a horizontal center log. The centers of all the roof logs rested on this horizontal center log.

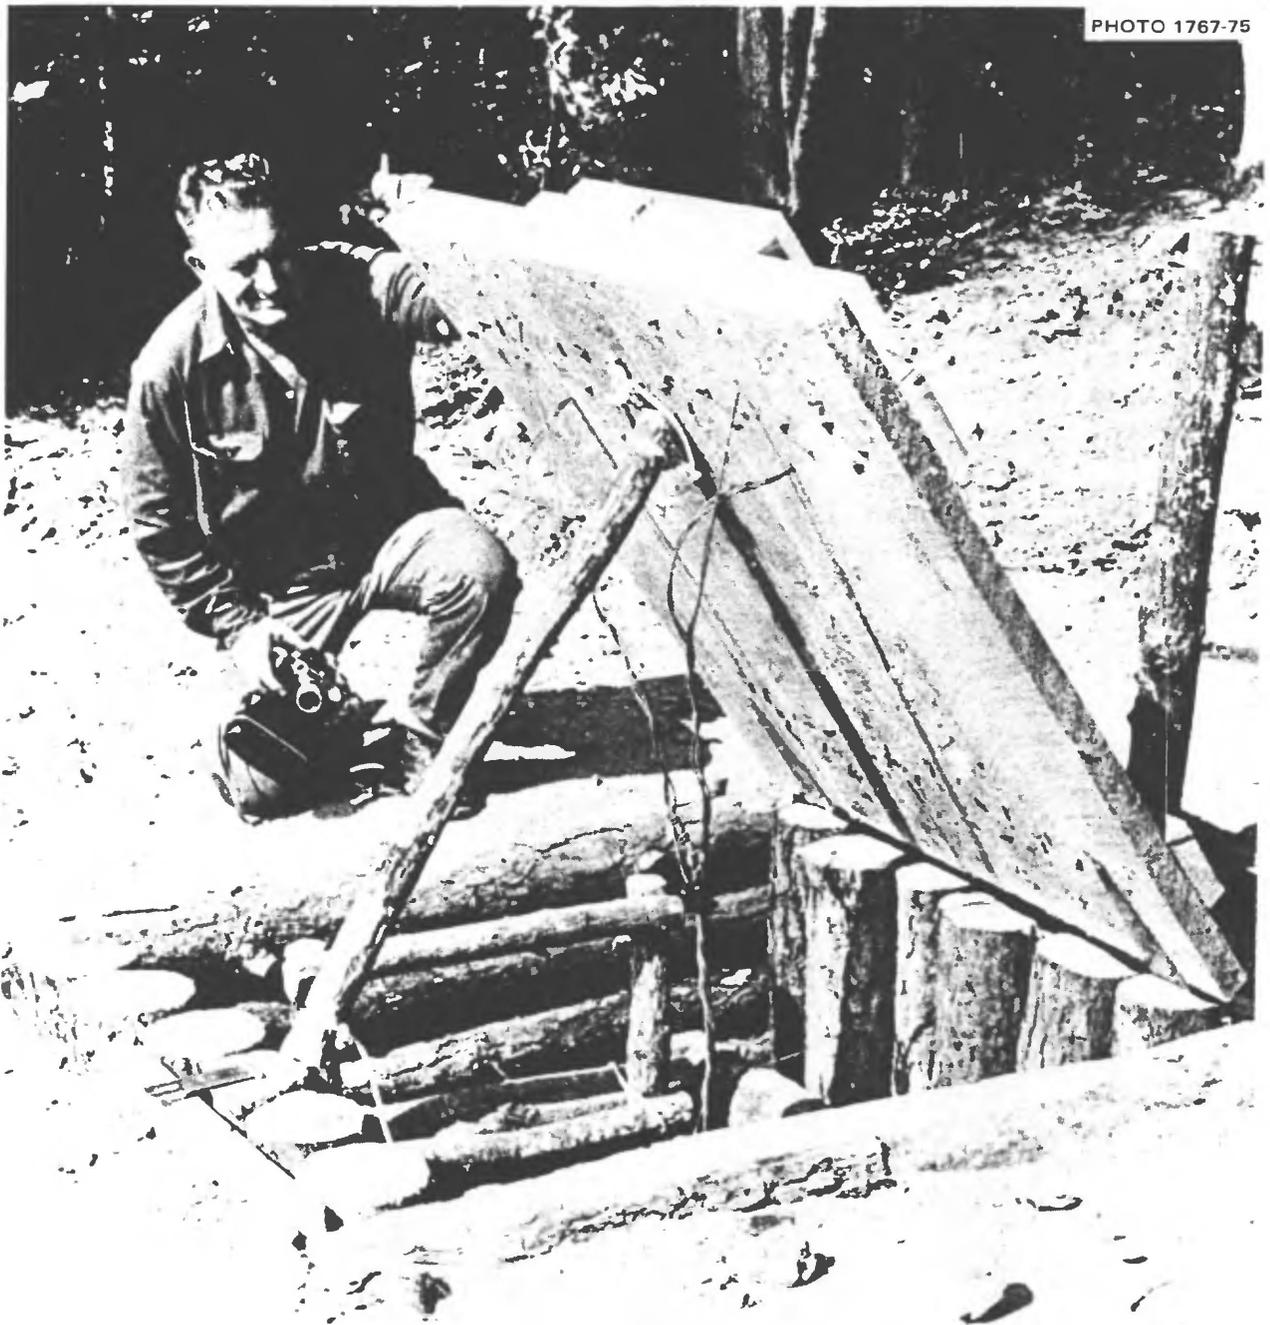
Fig. 7.4. One of the two completed vertical entries, with its expedient blast door made of 2-in.-thick rough lumber. Its hinges were made of strips of worn auto tires, spiked to each of the vertical entryway posts on the hinged side. A door of this type successfully withstood a blast overpressure of 17 psi.\* The other blast door was made of 3-in. planks and may have been able to withstand higher blast over pressures than would collapse the earth walls of this covered-trench shelter.

The roof logs had been covered with roofing to keep earth from falling through the cracks. Then about 2 ft of clayey earth had been packed over the whole roof, on which a sloping "buried roof" of 4-mil polyethylene film had been laid for waterproofing. Finally, another 1 to 2 ft of earth had been placed and packed over the "buried roof."
